WASH for Shelter - Rapid Assessment for IDPs relocation in Pauk Taw and Myebon townships

Introduction

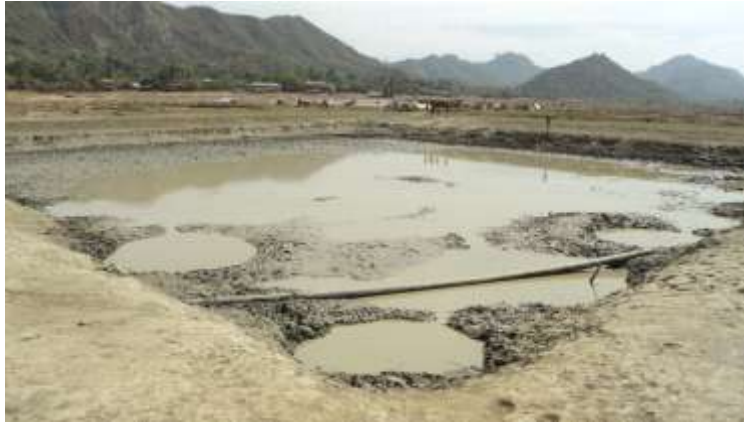
Fig. 1: Existing pond – paddy field area

1. **Water ponds rehabilitation:** the two water ponds are presently used by the IDPs as main water source for drinking and domestic purpose. The proposed rehabilitation aims to decrease the water turbidity in order to increase the effectiveness of the water treatment at HH level (Fig. 1-5).

- Scarification of the first 10 cm of the sediments on the bottom;
- Reshaping of ponds slopes and to increase embankments high (1 m max);
- Reshaping bottom profile and to increase the storage capacity as per water needs by elevating the pond banks and extending the pond area but not by increasing the depth of the pond;
- Slopes lining with PVC sheets - tarpaulin (3 m overlap between two sheets);
- Installation of rubble stones and gravel pack on bottom surface (40 cm thickness);
- Installation of 3 wells (RC rings) with 40 cm gravel pack at the bottom;
- Installation of pulley frames for water lifting;
- Installation of fence around the water ponds.

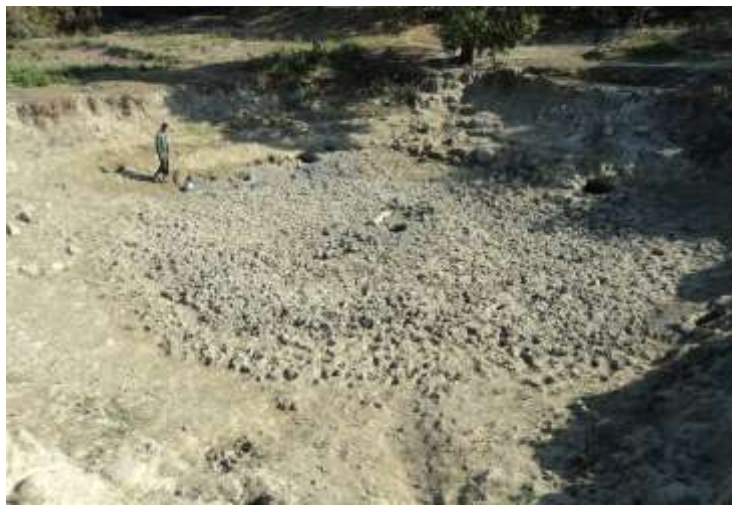
Fig. 2: Existing pond – foot hill area

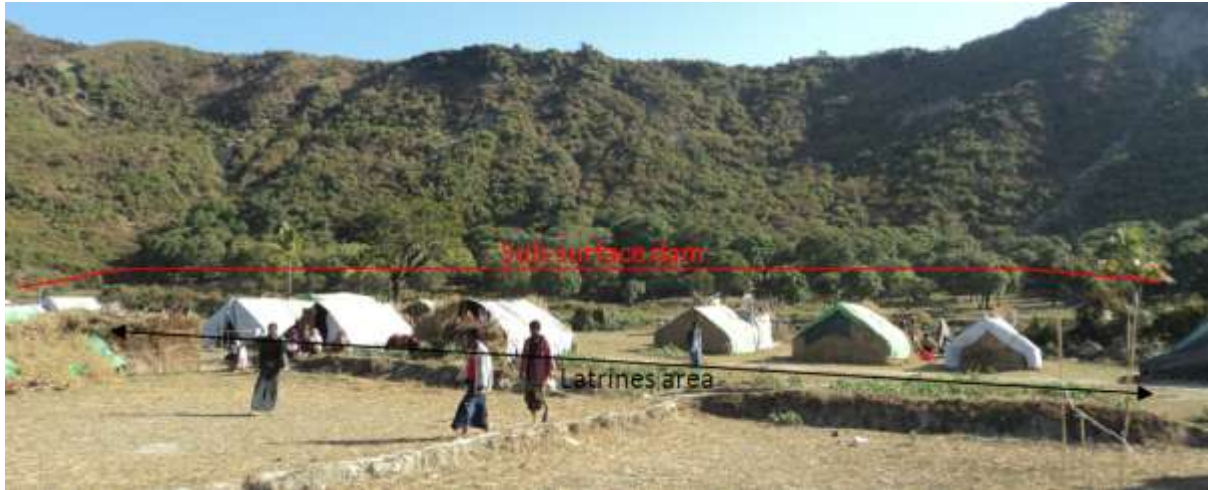
Fig. 7: Proposed WASH site planning

- Construction of about 200-250 m of subsurface dam 4-5 m high along the foot of the hills. Impervious barrier constructed with PVC sheets (1 m overlapping);
- Excavation of shallow trenches parallel to the contour lines to decrease water runoff velocity and facilitate infiltration ;
- Construction of RC water wells 2-3 m uphill the subsurface dam.

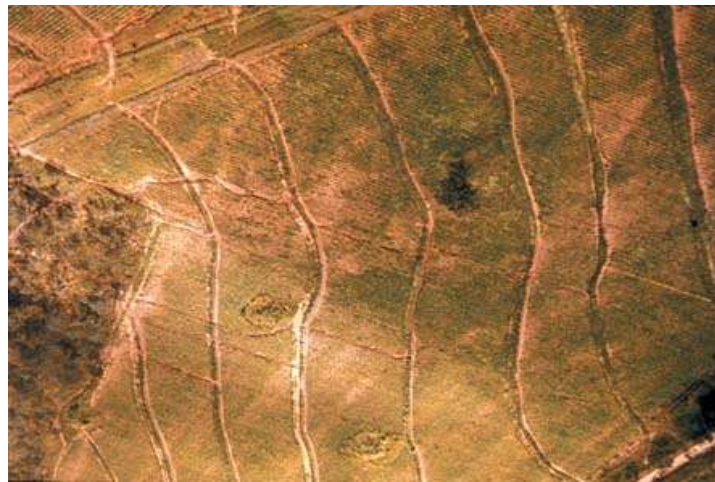
Fig. 10: Example of contour line trenches

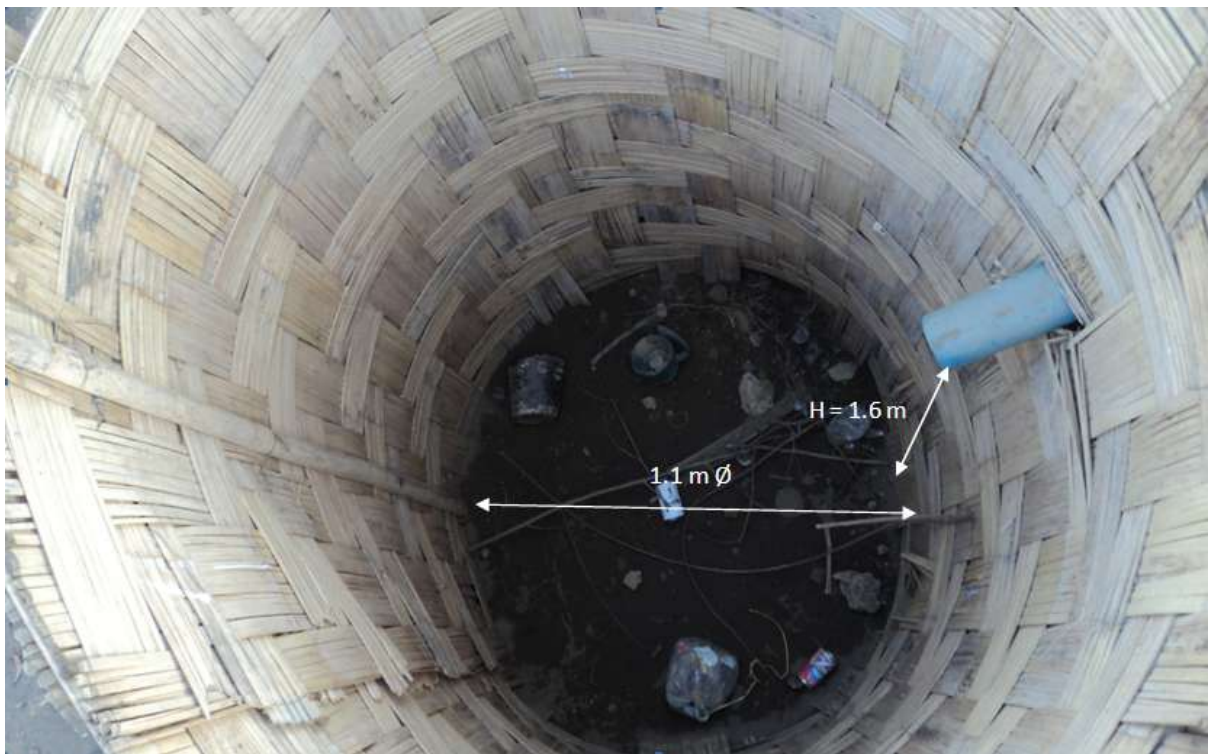
Fig. 12: Inner view bamboo lined pit latrine

It is well known that the high water table doesn't allow the excavation of deep pit latrines. Septic tanks and soakaway would be flooded after the first days of the wet season. An improved version of the bamboo pit latrines (double bamboo liner) and shallow trench latrines seem the only sanitation option. The camp area allows the construction of new latrines when the pits are filled up. As per WHO recommendations, once the content of the pit reach 0.5 m from the top of the pit, the pit should be filled with soil and new pits dug.

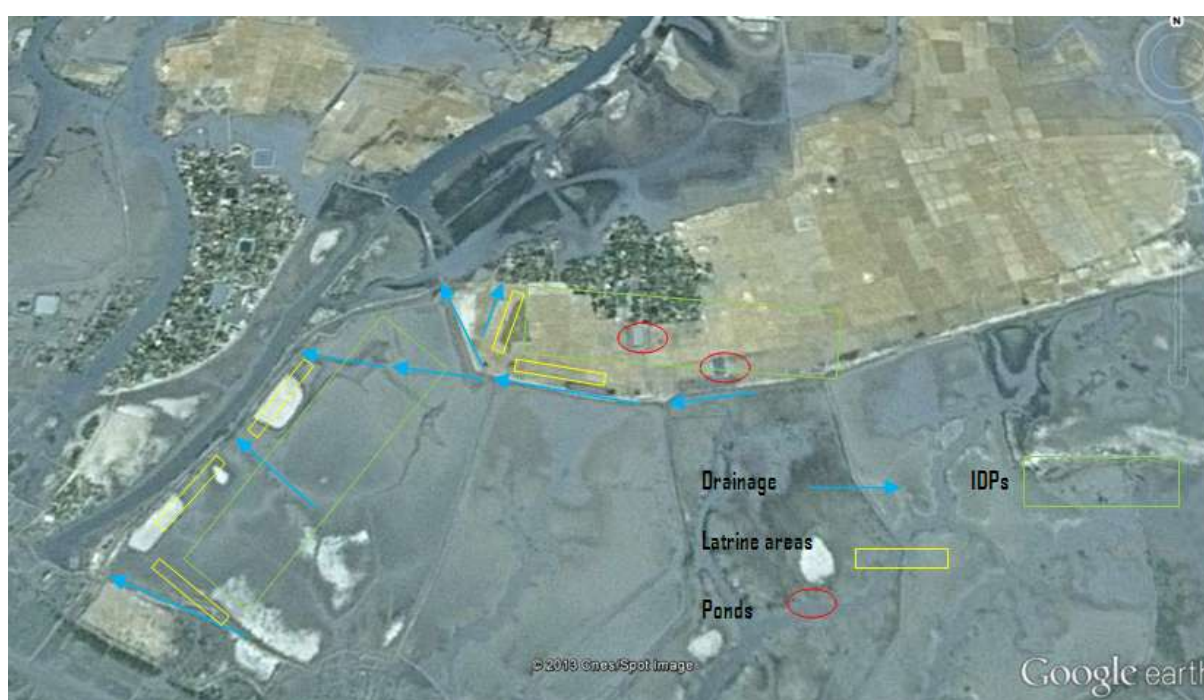
Environmental features in Nget Chaung camp are extremely adverse to any fair option for water, sanitation and drainage management. It is a low land that in a recent past also the farmers tried to protect by river flood and rain water flood by the construction of long and massive embankments to protect their crop and the prawn farms. Fig. 13 summarizes the proposed WASH scheme.

Fig. 13: Proposed WASH scheme for Nget Chaung camp

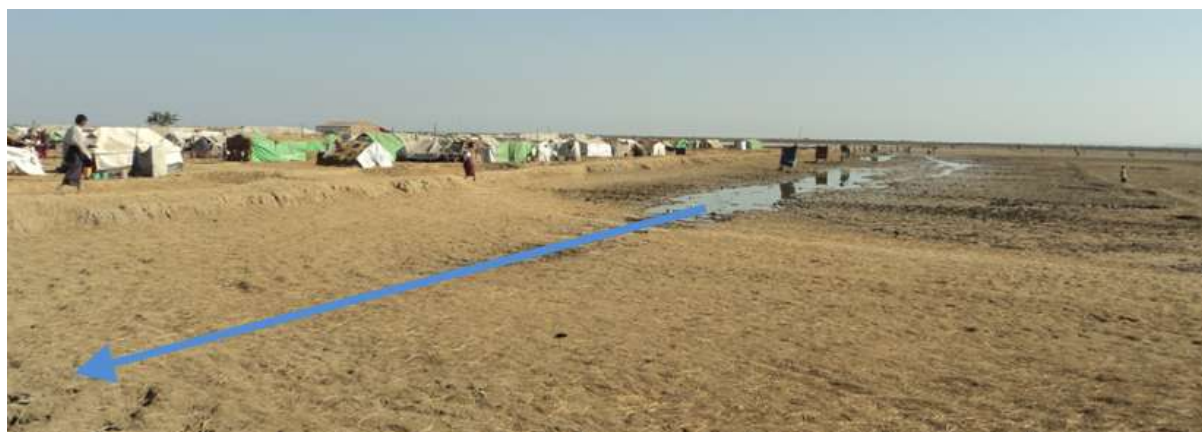
Fig. 15: Proposed tidal channel to be rehabilitated

The construction of basic drainage network is not feasible in this camp. The excavation or rehabilitation of tidal channels (“drainage channels”) is the only realistic option to manage stagnant water and human organic waste: the tide flow would wash them away twice a day. This was a normal option locally utilized before the present emergency and it is the only feasible strategy during wet season.

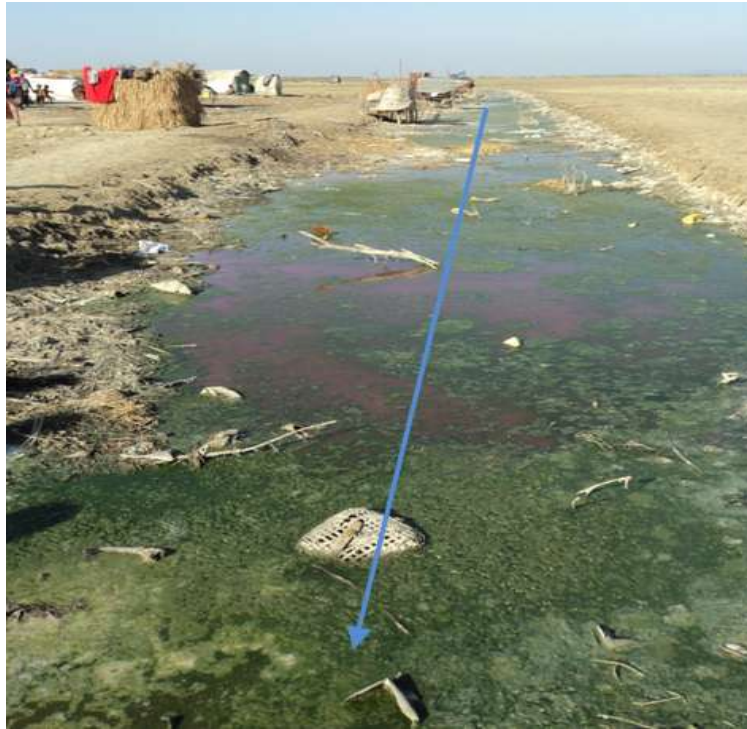
Fig. 16: Silted tidal channel to be rehabilitated

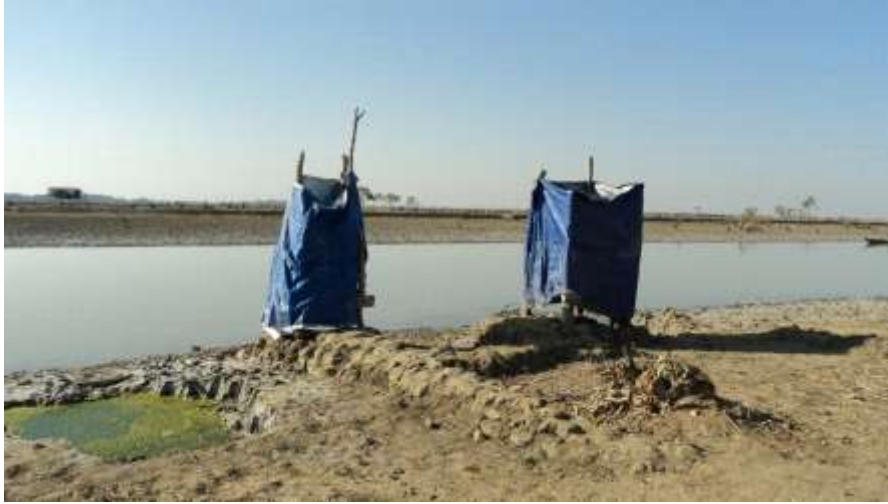
Fig. 17: Pan-PVC pipe latrines discharging into the river

The camp area is not suitable for the construction of indirect pit latrines: after few days of rain the infiltration capacity will drop from 10-15 mm/h to 0 mm/h. The saturated soil and the precipitations will not allow any infiltration of the liquid fraction of the excreta making the pits overflowing. In the delta regions and Rakhine fisherman villages the local population utilize pan-PVC pipe latrines that discharge directly into the rivers. The site should be prepared as per excavation and deepen the river bed around the latrines to guarantee water presence also during low tides. This represents the only sustainable solution of sanitation management in the camp during wet season. Shallow trench latrines, gender segregated and provided of partition for privacy can be adopted until the beginning of the wet season. Moreover, a massive clean-up campaign should be carried out in the area to avoid environmental contamination by the latrines already filled up and abandoned. Any humanitarian WASH actor involved in the area should secure a budget for this activity to be performed before the rainy season.

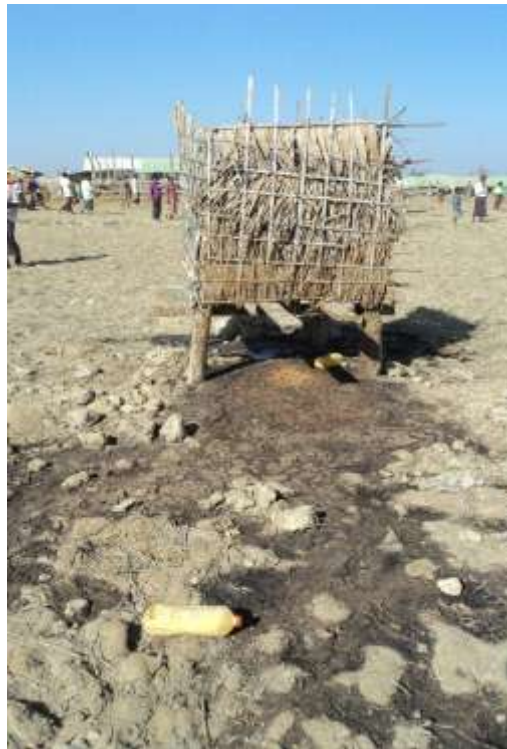
Fig. 18: Abandoned latrines need to be decommissioned before wet season

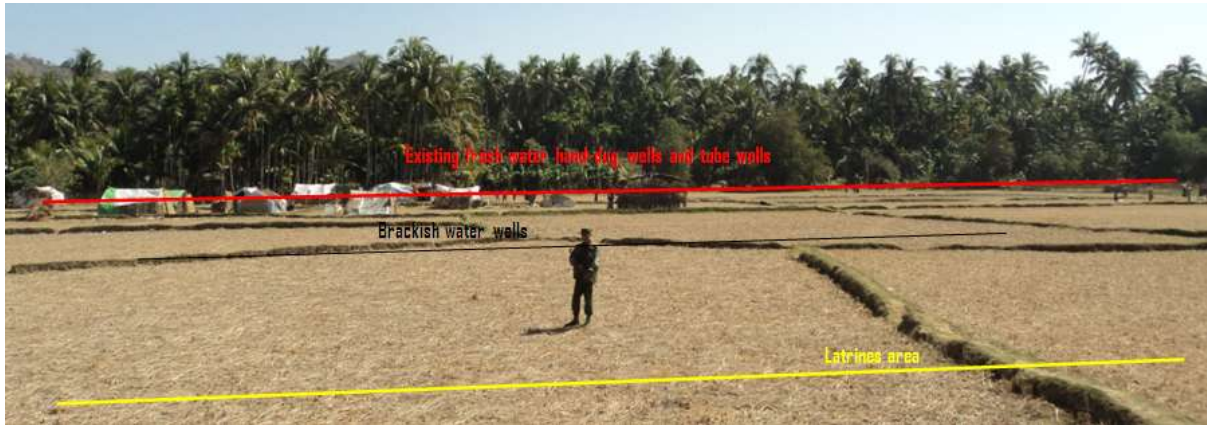
In Sit Tet Maw the environment is favourable for fresh water exploitation by shallow tube wells with hand pump as well as for basic drainage (Fig. 19).

Fig. 19: Proposed WASH scheme

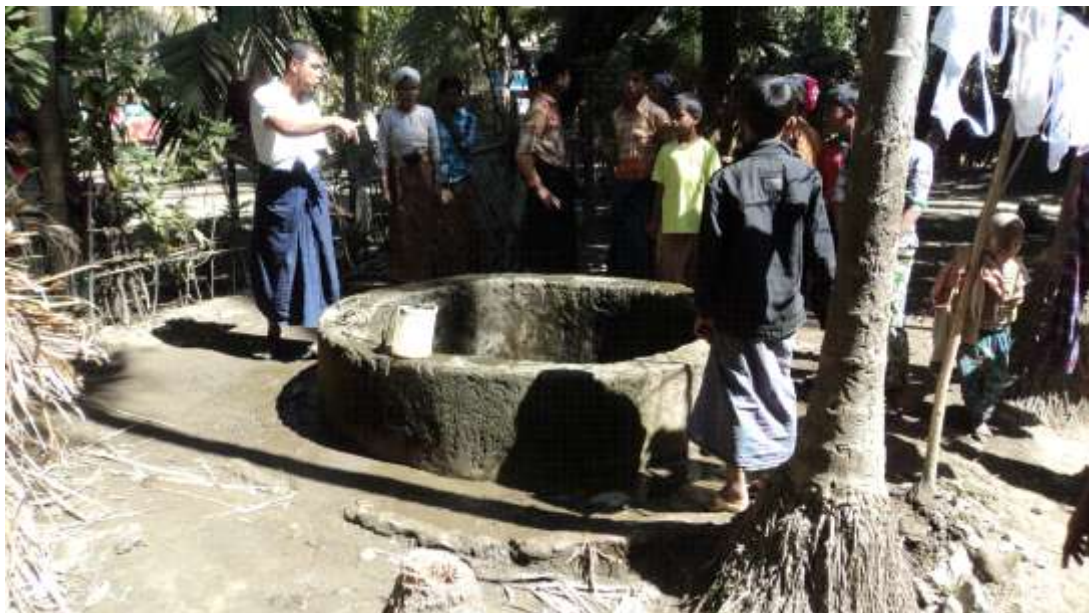
Fig. 20: Existing water well

Presently the IDPs are sharing the existing hand dug wells with the host community. In order to avoid frictions between users it is advisable to construct new wells as well as rehabilitate the existing ones (water table – 3 m). A detailed survey is needed for the site selection of new wells because the presence of several decommissioned latrines belonging to the host community. The IDPs dug some shallow wells (water table -1 m) in the paddy field and the water is utilized for laundry because its salinity. During the wet season these water points will be flooded.

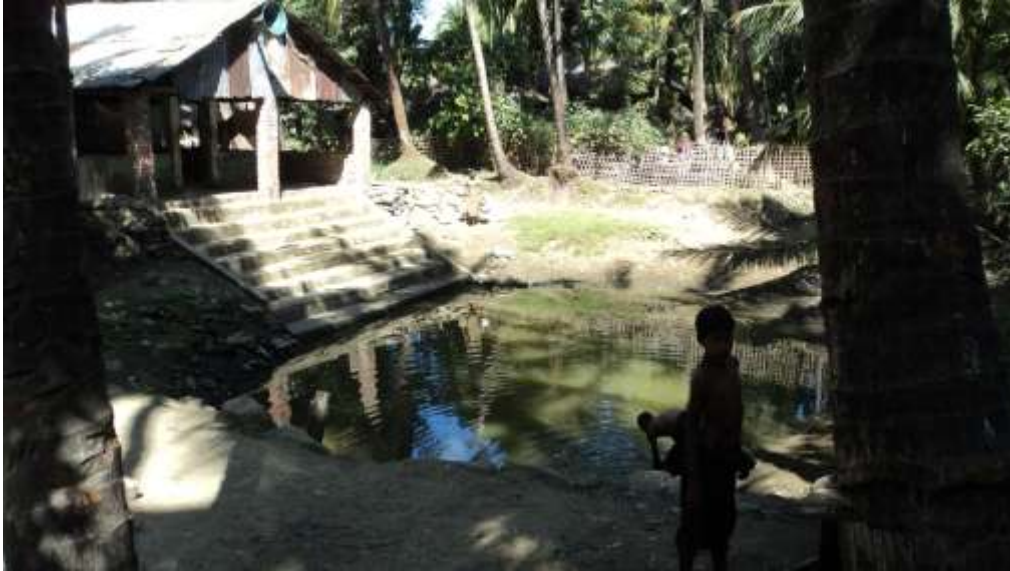
One small water pond is present in the mosque compound and its water (domestic purpose use) is shared between the host community and the IDPs. Its rehabilitation is advisable for domestic purpose and personal hygiene during the wet season.

Fig. 21: Water pond in the mosque compound

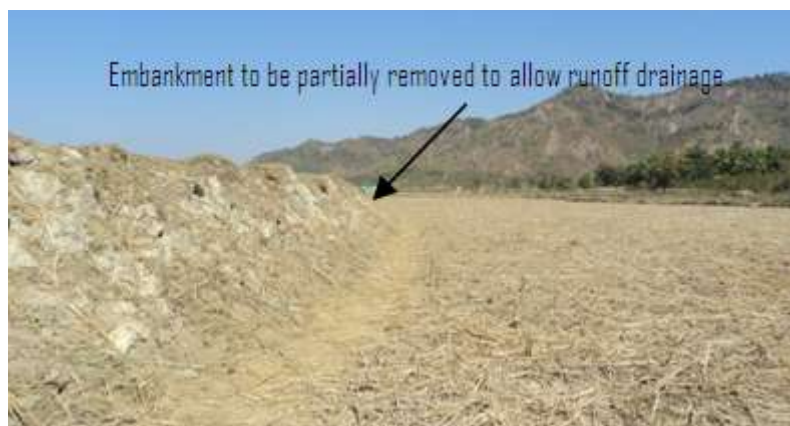
Fig. 22: Embankment in the West side of the paddy field

The topographic profile of the area facilitates the natural run off of the water to the sea. Presently, a large embankment is present to contain the rainy water within the paddy field: to reduce the risk of flooding it should be partially removed.

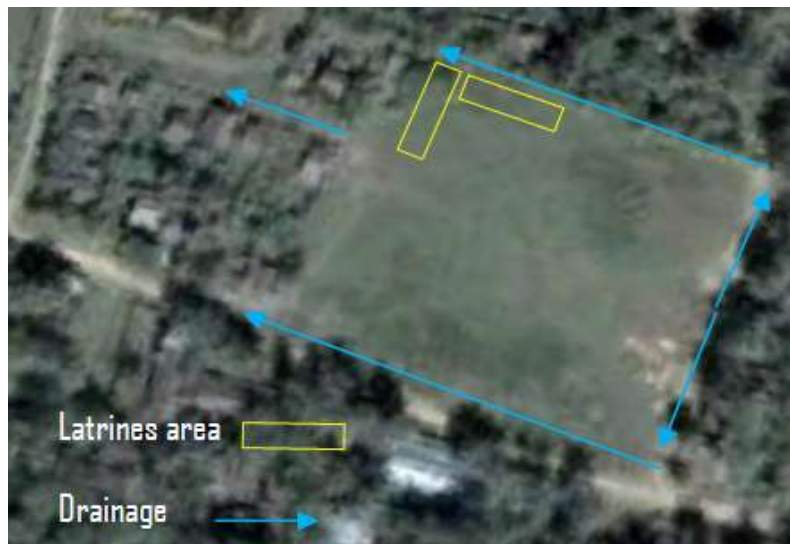
Fig. 23: Drainage scheme for Arakan camp

Arakan camp is sited in a football ward and the general slope of the area facilitates the drainage from the East side to the West side. Drainage ditches are already present and basic cleaning is the only activity needed to make them efficient during the wet season. Deepen them there is the risk to drain water from the surroundings, consequently it should be avoided. Water is piped from the town water supply. Latrines are filled up and they need to be decommissioned. Within the plot there is enough space for the construction of new latrines. Construction of septic tank latrines (brick walls or RC rings) is advisable.

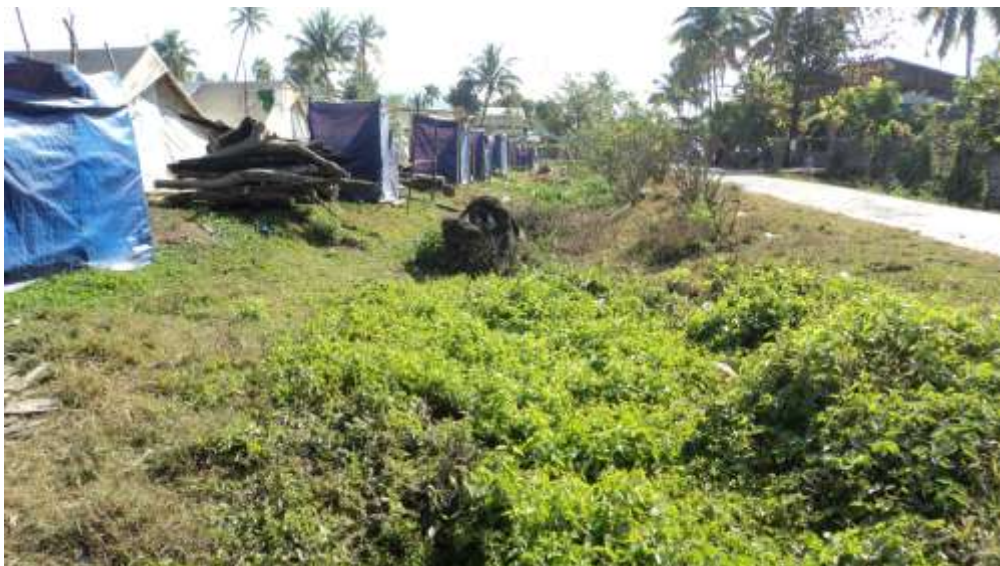
Fig. 24: Existing ditches surrounding the IPDs camp

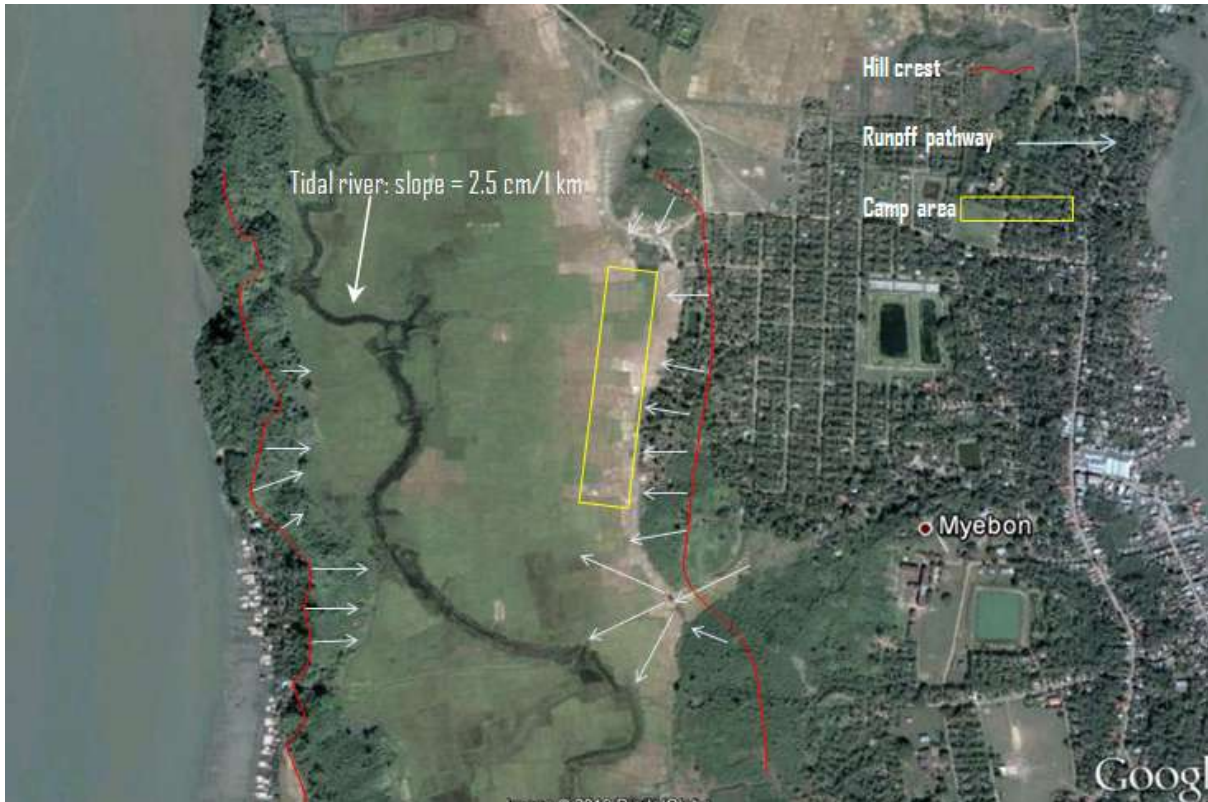
The area is located in the lower part of a valley surrounded by hills in the western and eastern sides, while the northern part shares its border with the sea. The southern part of the valley has similar morphological characteristics and it represents a large catchment area for water runoff flowing downstream where the camp is. A meandering river is the main water body present in the valley and it is influenced by the tidal cycle. During the wet season, the simultaneous combination of high river yields – due to the contribution of the upstream catchment area – and the high tide cycles, the low river bed slope and the run off from the hills behind the camp itself will turn the entire valley in a large pond. The only technical solution to preserve the camp area by floods is the elevation of the entire site by 1-1.2 m. This is not feasible because the large quantity of soil needed: a rough estimation quantified in 60,000 m³ the volume of the earth works (soil excavation in selected site not flood prone, dumping and compaction). Time, cost and logistic constrains are not favourable to this solution. Cash for labour cannot be considered a solution because excavation, transportation and compaction activities need heavy earth works machineries as lorry trucks, back hoes equipped with hydraulic hummer breakers, earth movers and compactors.

Fig. 25: Hydrological characteristics of the selected site

The site improvement for this camp is not feasible and alternative areas should be identify before the rainy season.

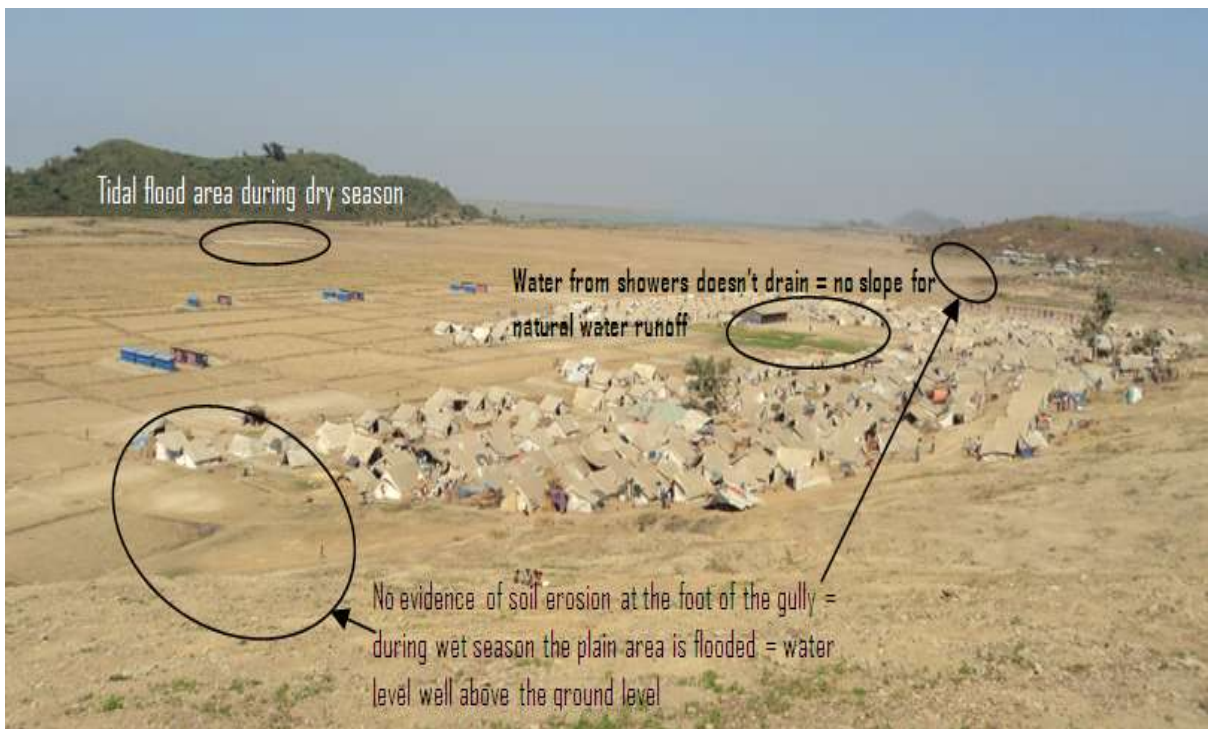
The proposed relocation site is the same area where the IDPs are sited at the moment. The topography, hydrology and geomorphology are not favourable for any efficient drainage work.

Fig. 25: Geomorphologic characteristics of the selected site
