Activation ID: EMSR130 Product N.: 07HINTHADA, v1, English

> Hinthada - Myanmar Flood - 01/08/2015
> Delineation Map - Monit01

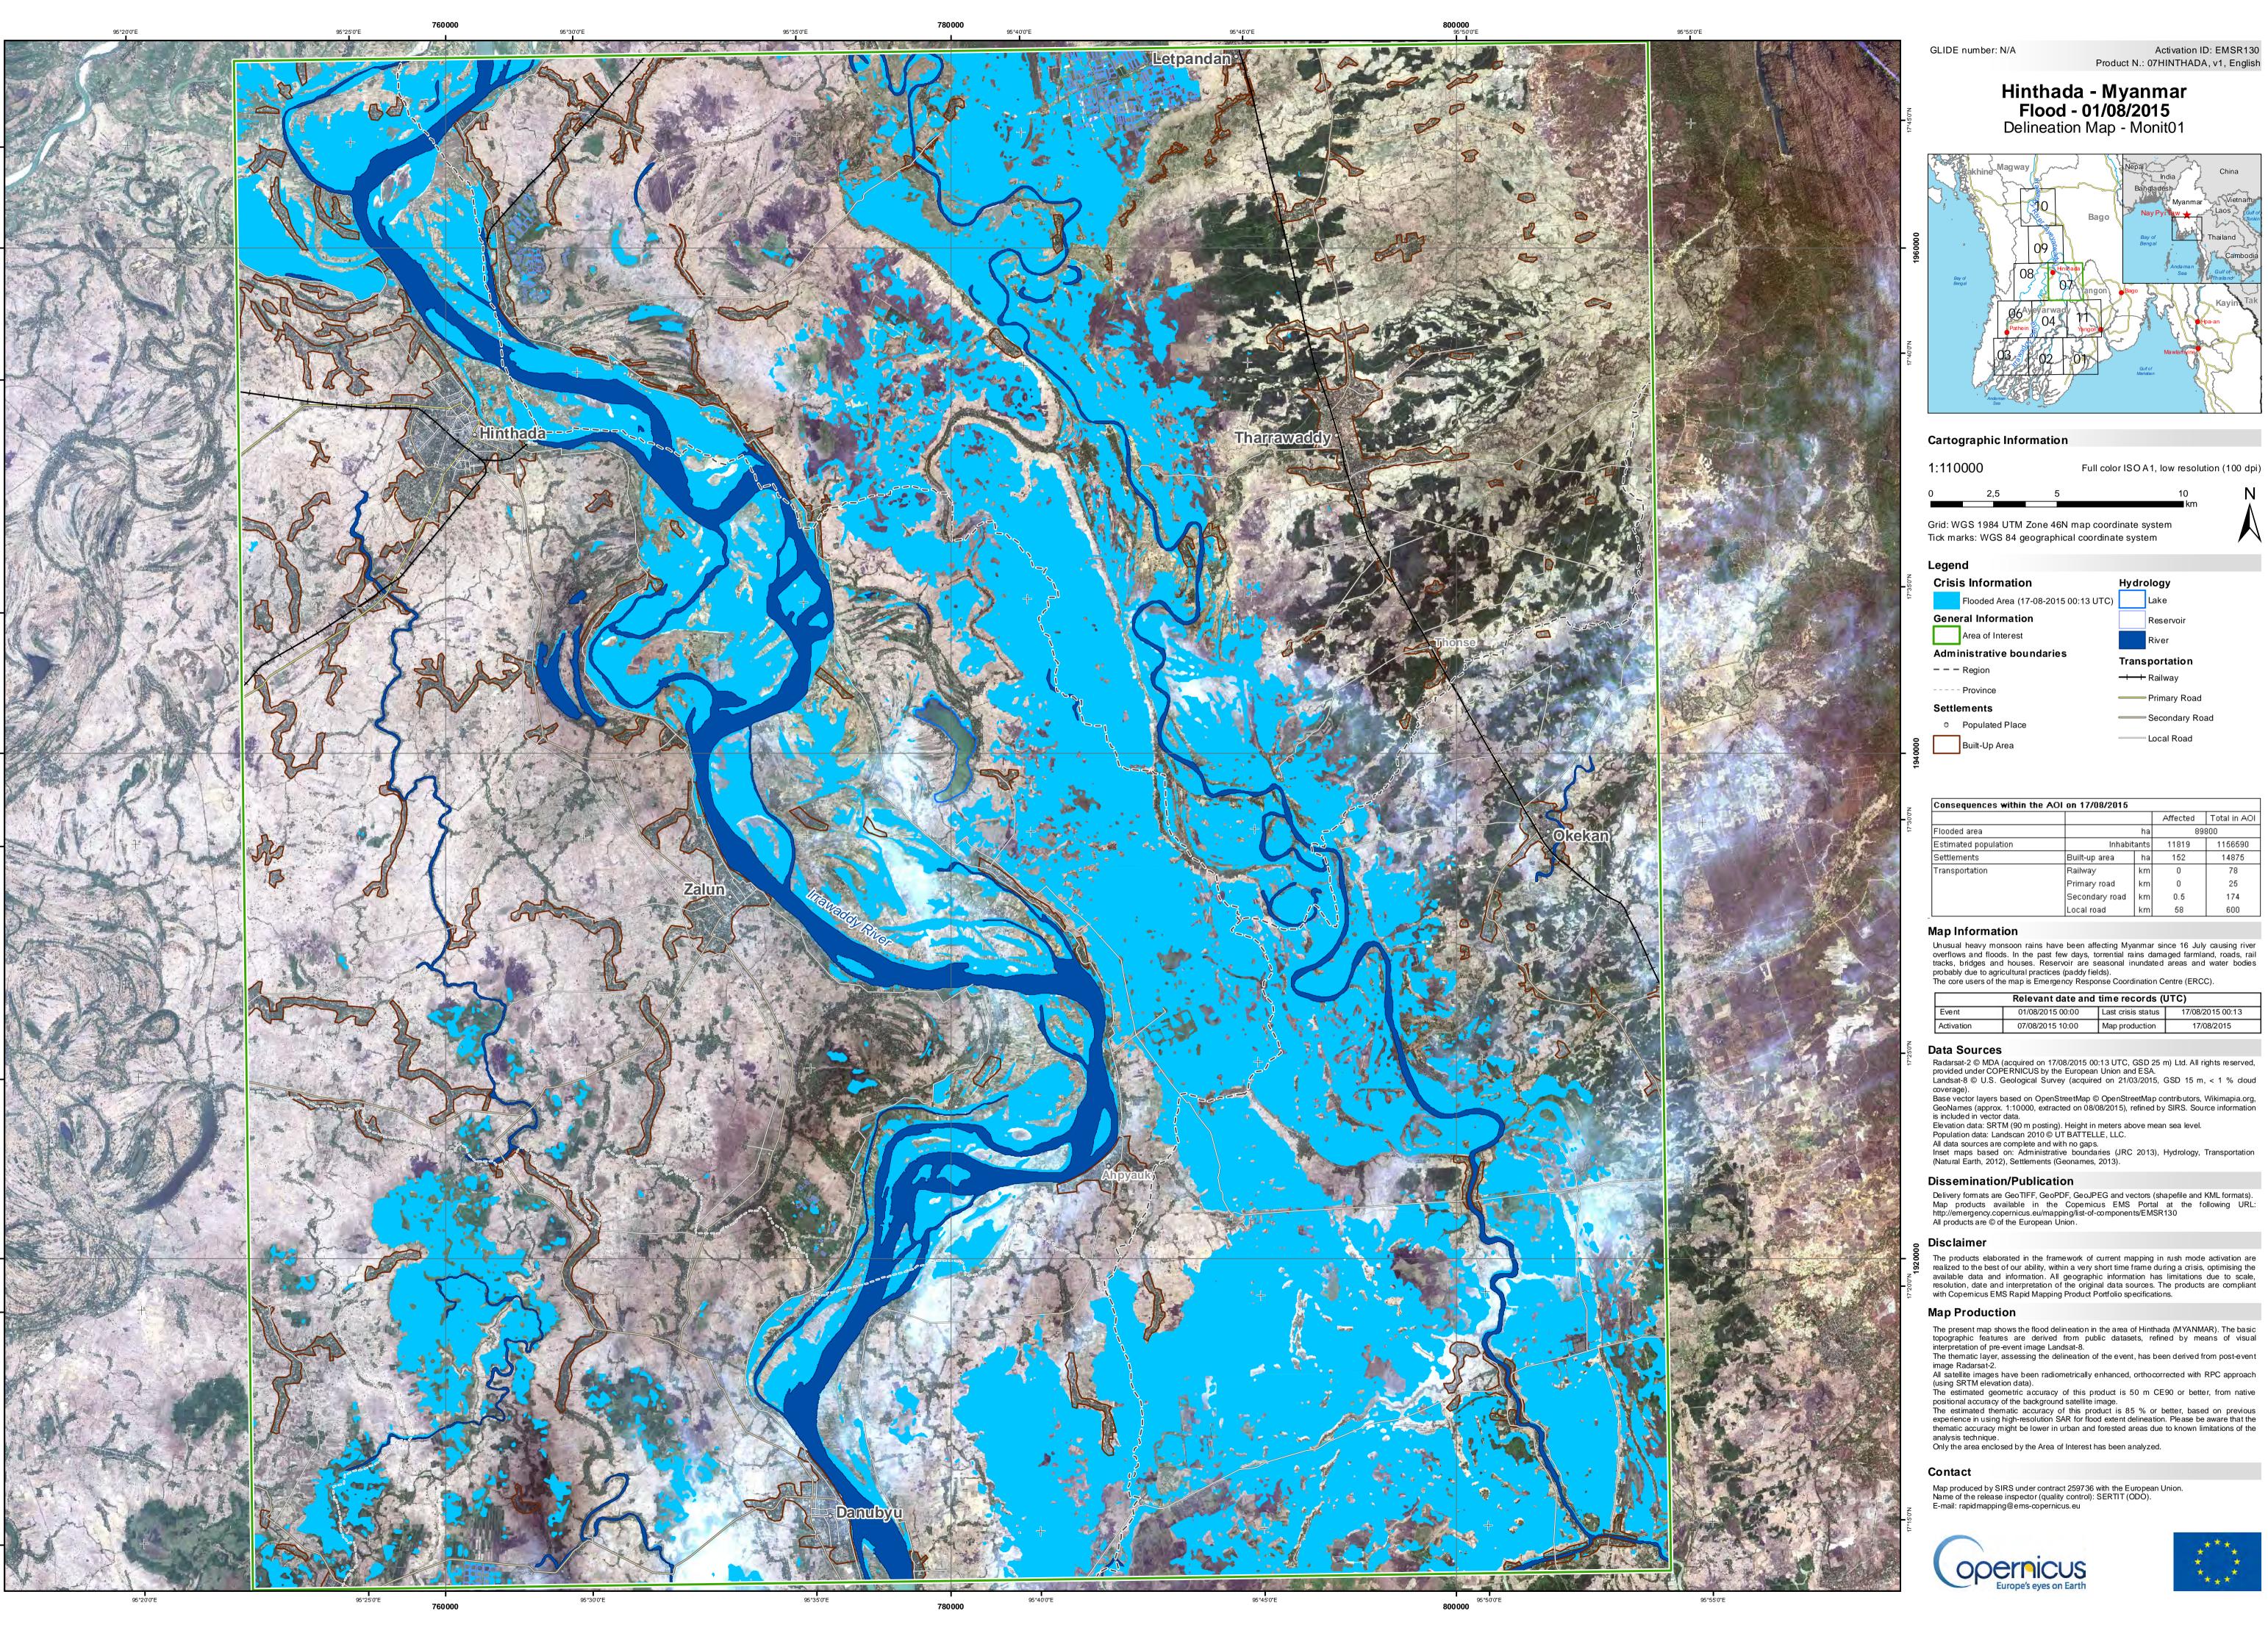
The present map shows the flood delineation in the area of Hinthada (MYANMAR). The basic topographic features are derived from public datasets, refined by means of visual interpretation of pre-event image Landsat-8.

The thematic layer, assessing the delineation of the event, has been derived from post-event image. Pedagget 2.

All satellite images have been radiometrically enhanced, orthocorrected with RPC approach (using SRTM elevation data). The estimated geometric accuracy of this product is 50 m CE90 or better, from native positional accuracy of the background satellite image.

The estimated thematic accuracy of this product is 85 % or better, based on previous experience in using high-resolution SAR for flood extent delineation. Please be aware that the thematic accuracy might be lower in urban and forested areas due to known limitations of the
