Activation ID: EMSR130 Product N.: 03LABUTTA, v1, English

Labutta - Myanmar Flood - 01/08/2015 Delineation Map

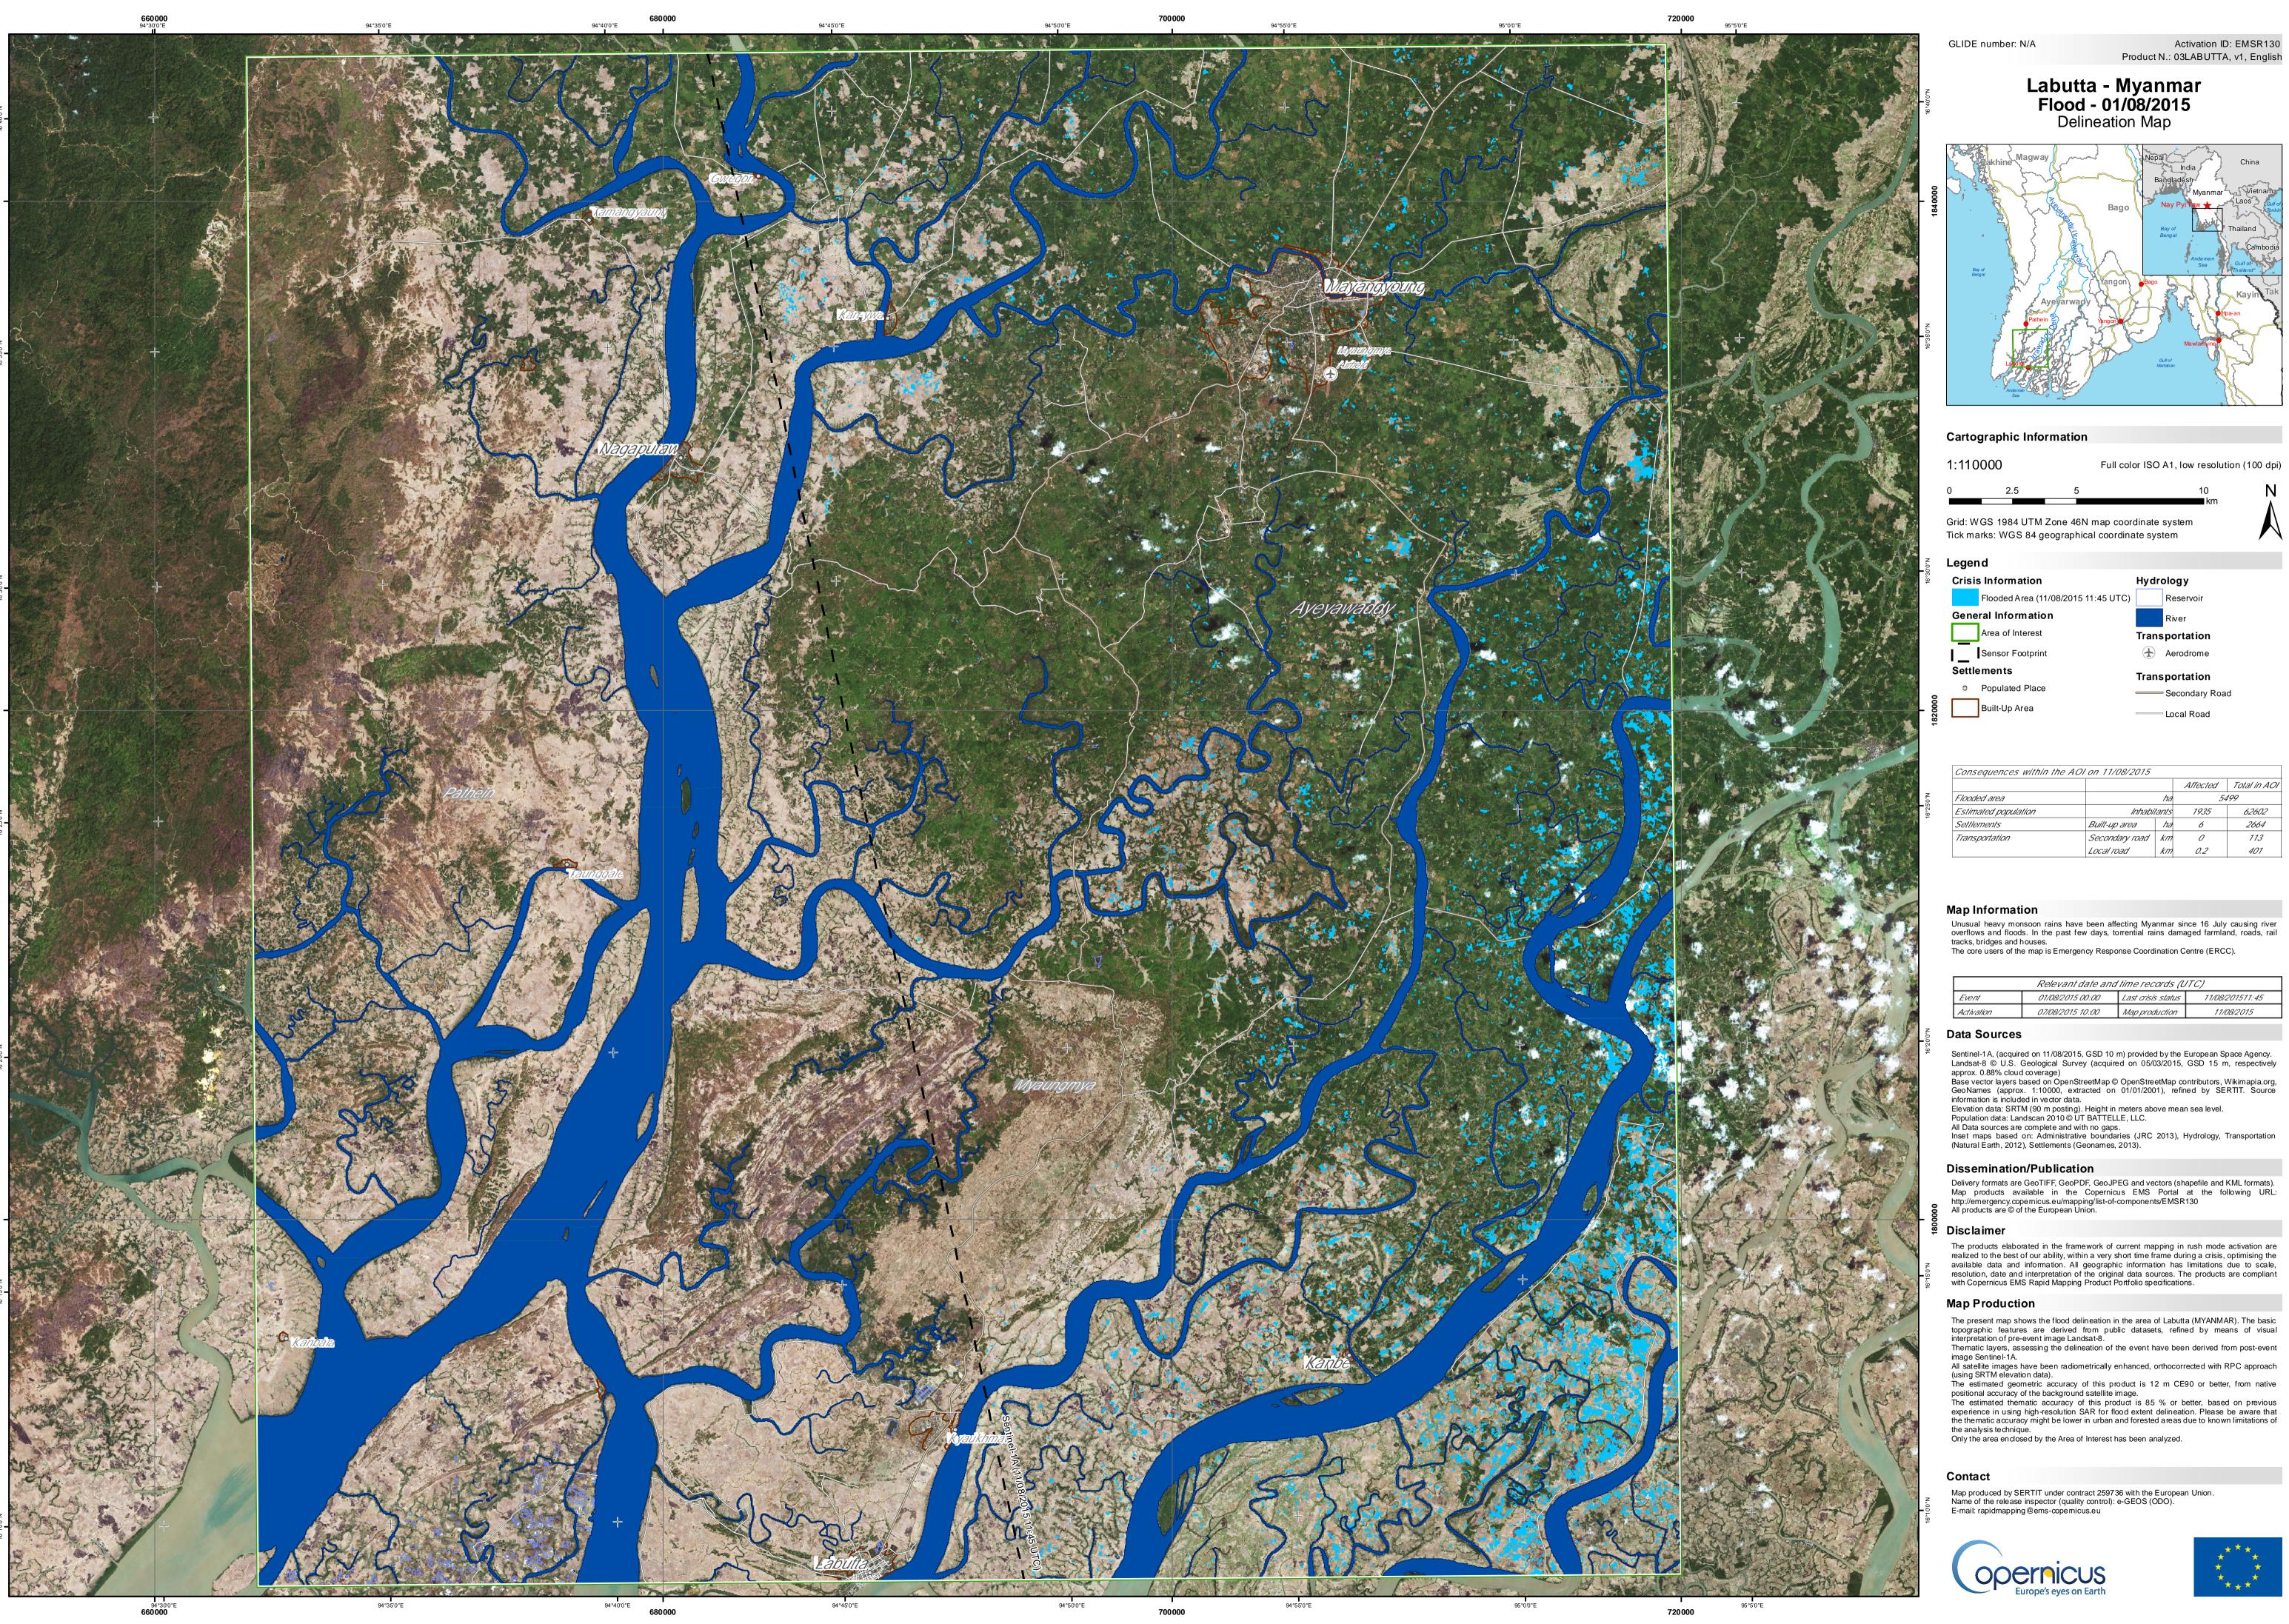
Affected	Total in AOI
Flooded area		ha	54	199
Estimated population	Inhabi	itants	1935	62602
Settlements	Built-up area	ha	6	2664
Transportation	Secondary road	km	0	113
	Local road	km	0.2	401

The present map shows the flood delineation in the area of Labutta (MYANMAR). The basic topographic features are derived from public datasets, refined by means of visual interpretation of pre-event image Landsat-8. The matic layers, assessing the delineation of the event have been derived from post-event

The estimated geometric accuracy of this product is 12 m CE90 or better, from native positional accuracy of the background satellite image. The estimated thematic accuracy of this product is 85 % or better, based on previous experience in using high-resolution SAR for flood extent delineation. Please be aware that the the matic accuracy might be lower in urban and forested areas due to known limitations of
