GLIDE number: N/A Activation ID: EMSR130

Product N.: 06PATHEIN, v1, English Pathein - Myanmar

Flood - 01/08/2015 Delineation Map - Monit01

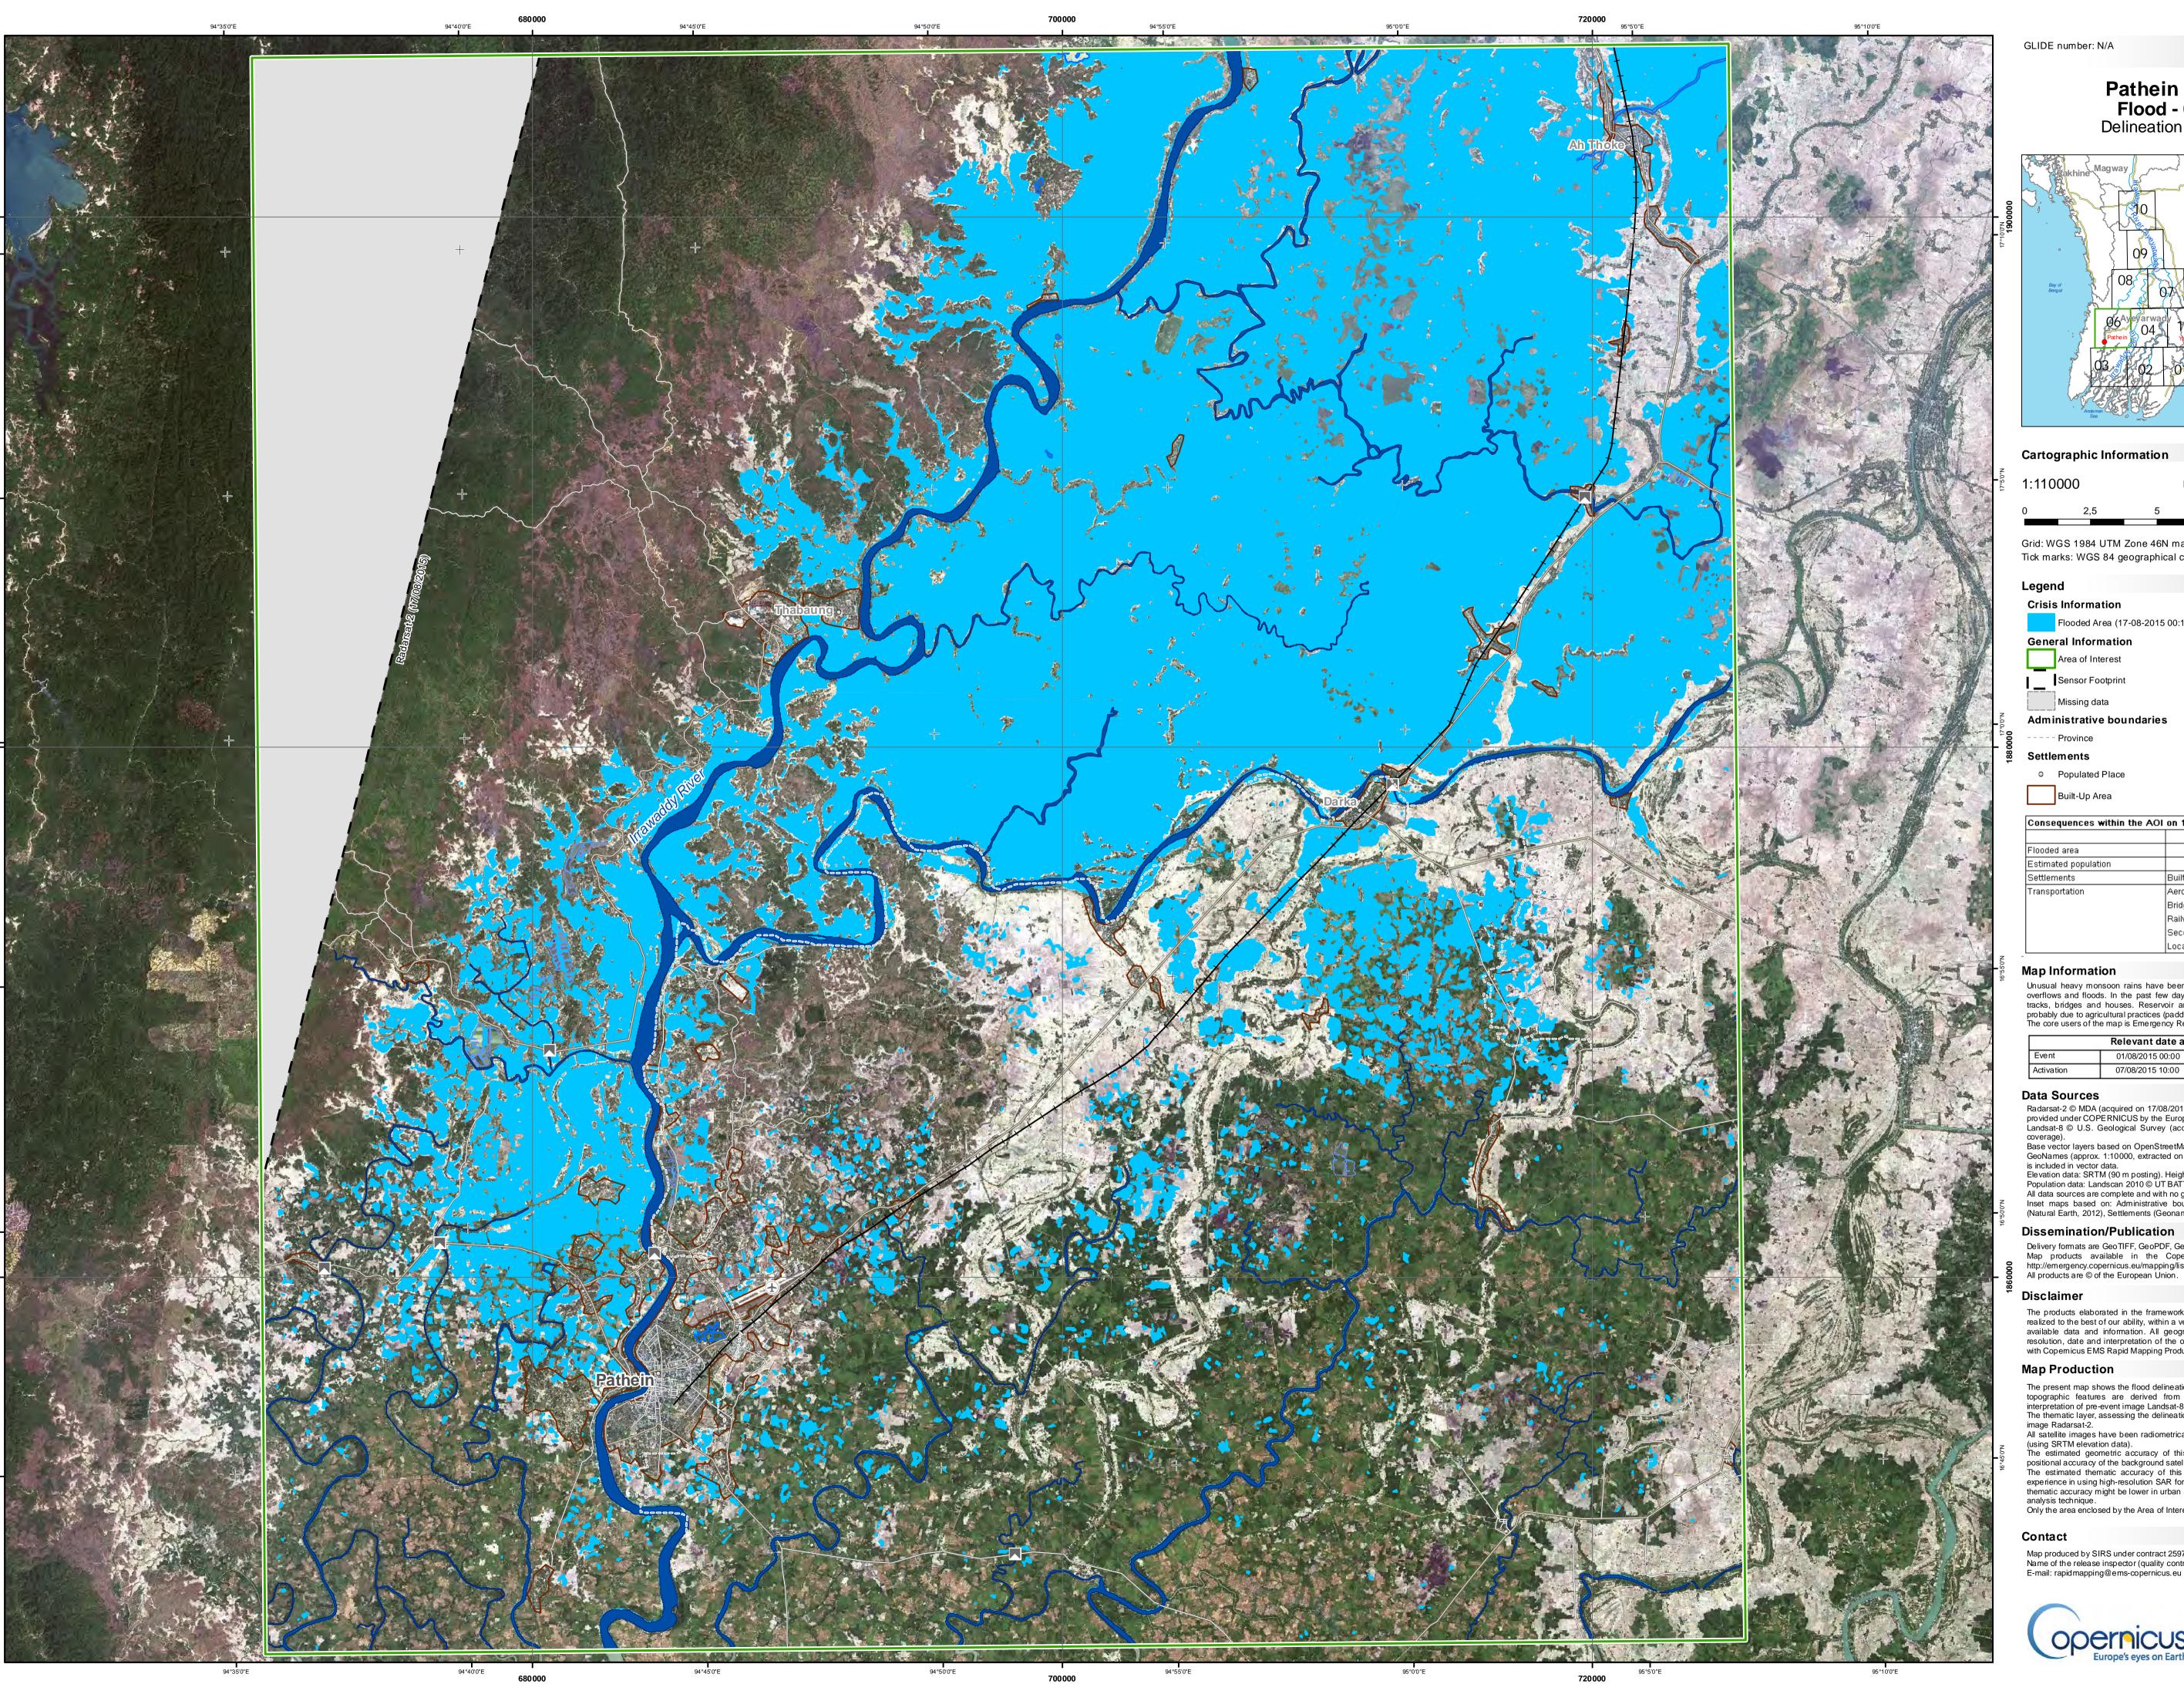
Map Production The present map shows the flood delineation in the area of Pathein (MYANMAR). The basic topographic features are derived from public datasets, refined by means of visual interpretation of pre-event image Landsat-8.

The thematic layer, assessing the delineation of the event, has been derived from post-event

image Radarsat-2. All satellite images have been radiometrically enhanced, orthocorrected with RPC approach (using SRTM elevation data).

The estimated geometric accuracy of this product is 50 m CE90 or better, from native positional accuracy of the background satellite image. The estimated thematic accuracy of this product is 85 % or better, based on previous

experience in using high-resolution SAR for flood extent delineation. Please be aware that the thematic accuracy might be lower in urban and forested areas due to known limitations of the Only the area enclosed by the Area of Interest has been analyzed.

Consequences within the AOI on 17/08/2015					
			Affected	Total in AOI	
Flooded area	ha		95838		
Estimated population	Inhabit	tants	25992	869884	
Settlements	Built-up area	ha	197	6593	
Transportation	Aerodrome	No.	0	1	
	Bridge	No.	0	7	
	Railway	km	17	67	
	Secondary road	km	11	186	
	Local road	km	3.1	309

Unusual heavy monsoon rains have been affecting Myanmar since 16 July causing river overflows and floods. In the past few days, torrential rains damaged farmland, roads, rail tracks, bridges and houses. Reservoir are seasonal inundated areas and water bodies probably due to agricultural practices (paddy fields).
