GLIDE number: N/A Activation ID: EMSR130
Product N.: 04PATHWE, v1, English

Pathwe - Myanmar Flood - 01/08/2015 Delineation Map

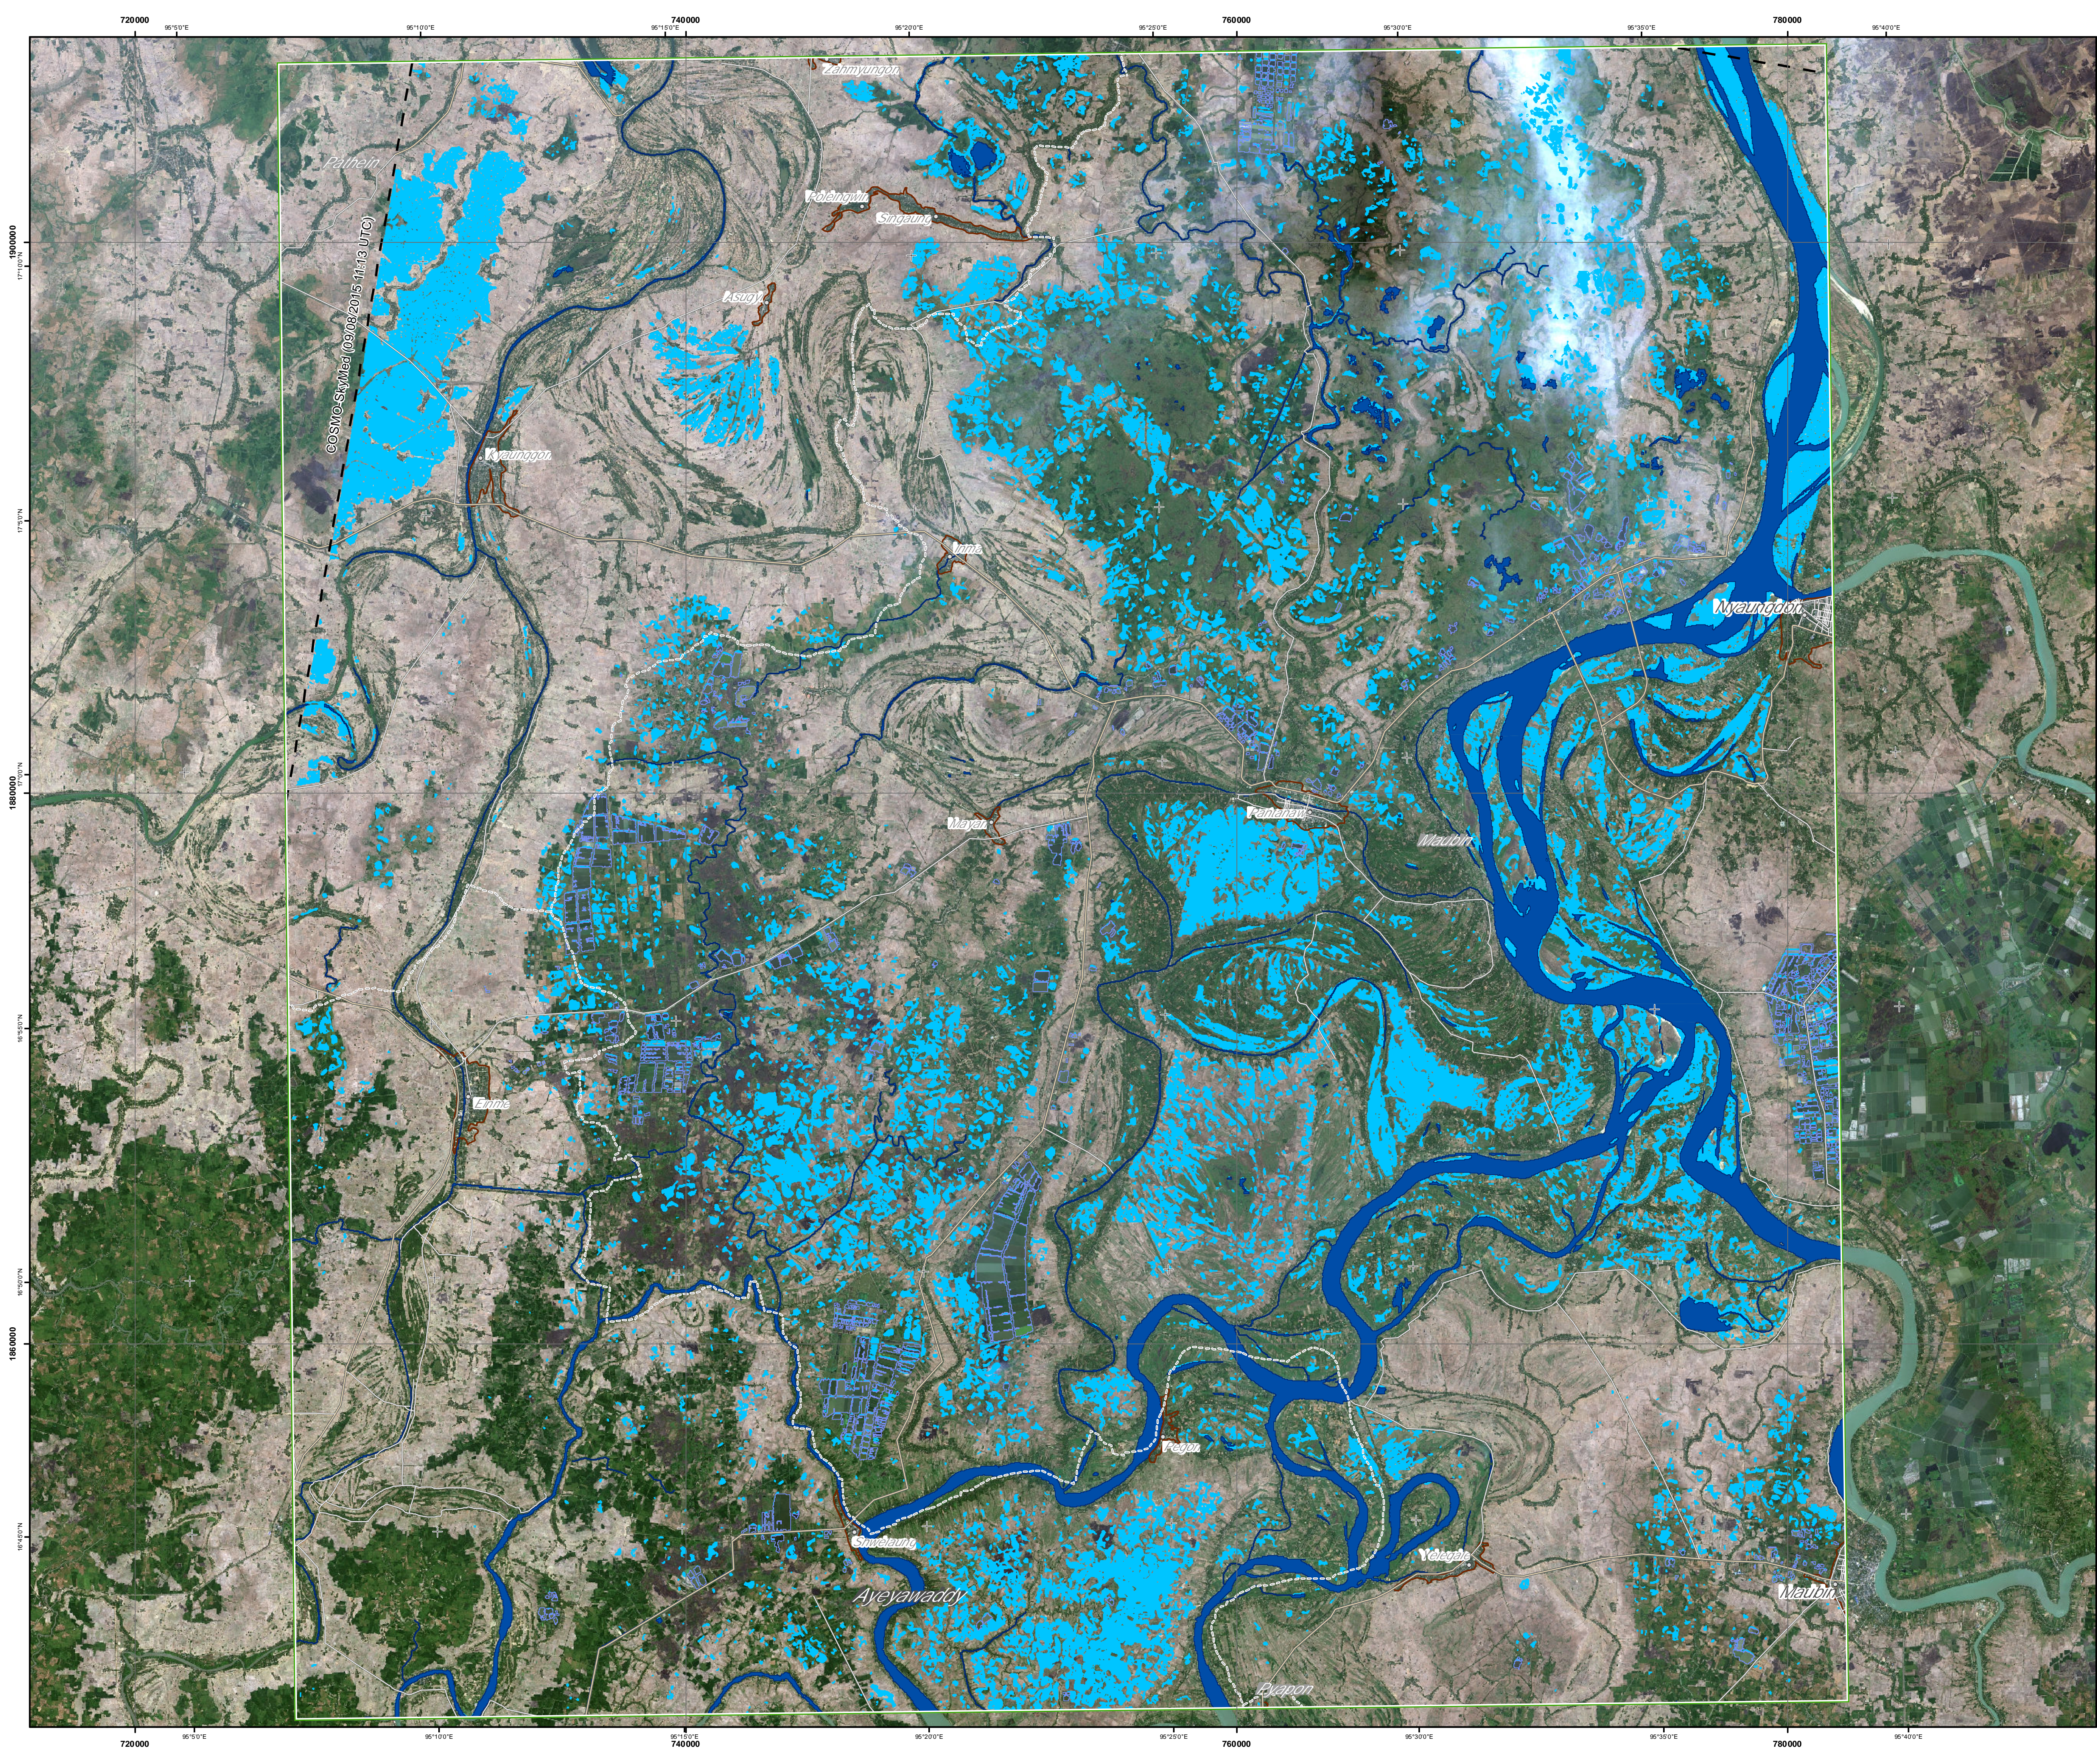
Consequences within the AOI on 09/08/2015			
		Affected	Total in AOI
Flooded area		ha	38006
Estimated population		Inhabitants	6365
Settlements	Built-up area	ha	6
Transportation	Secondary road	km	0
	Local road	km	8

The present map shows the flood delineation in the area of Pathwe (MYANMAR). The basic topographic features are derived from public datasets, refined by means of visual interpretation of pre-event image Landsat-8.
Thematic layers, assessing the delineation of the event have been derived from post-event image COSMO-SkyMed.
All satellite images have been radiometrically enhanced, orthorectified with RPC approach (using SRTM elevation data).
The estimated geometric accuracy of this product is 12 m CE90 or better, from native positional accuracy of the background satellite image.
The estimated thematic accuracy of this product is 85 % or better, based on previous experience in using high-resolution SAR for flood extent delineation. Please be aware that the thematic accuracy might be lower in urban and forested areas due to known limitations of the analysis technique.
Only the area enclosed by the Area of Interest has been analyzed.
