Pyay - MYANMAR Flood - 01/08/2015 Delineation Map - Monit01

Unusual heavy monsoon rains have been affecting Myanmar since 16 July causing river overflows and floods. In the past few days, torrential rains damaged farmland, roads, rail tracks, bridges and houses. The core users of the map is Emergency Response Coordination Centre (ERCC).

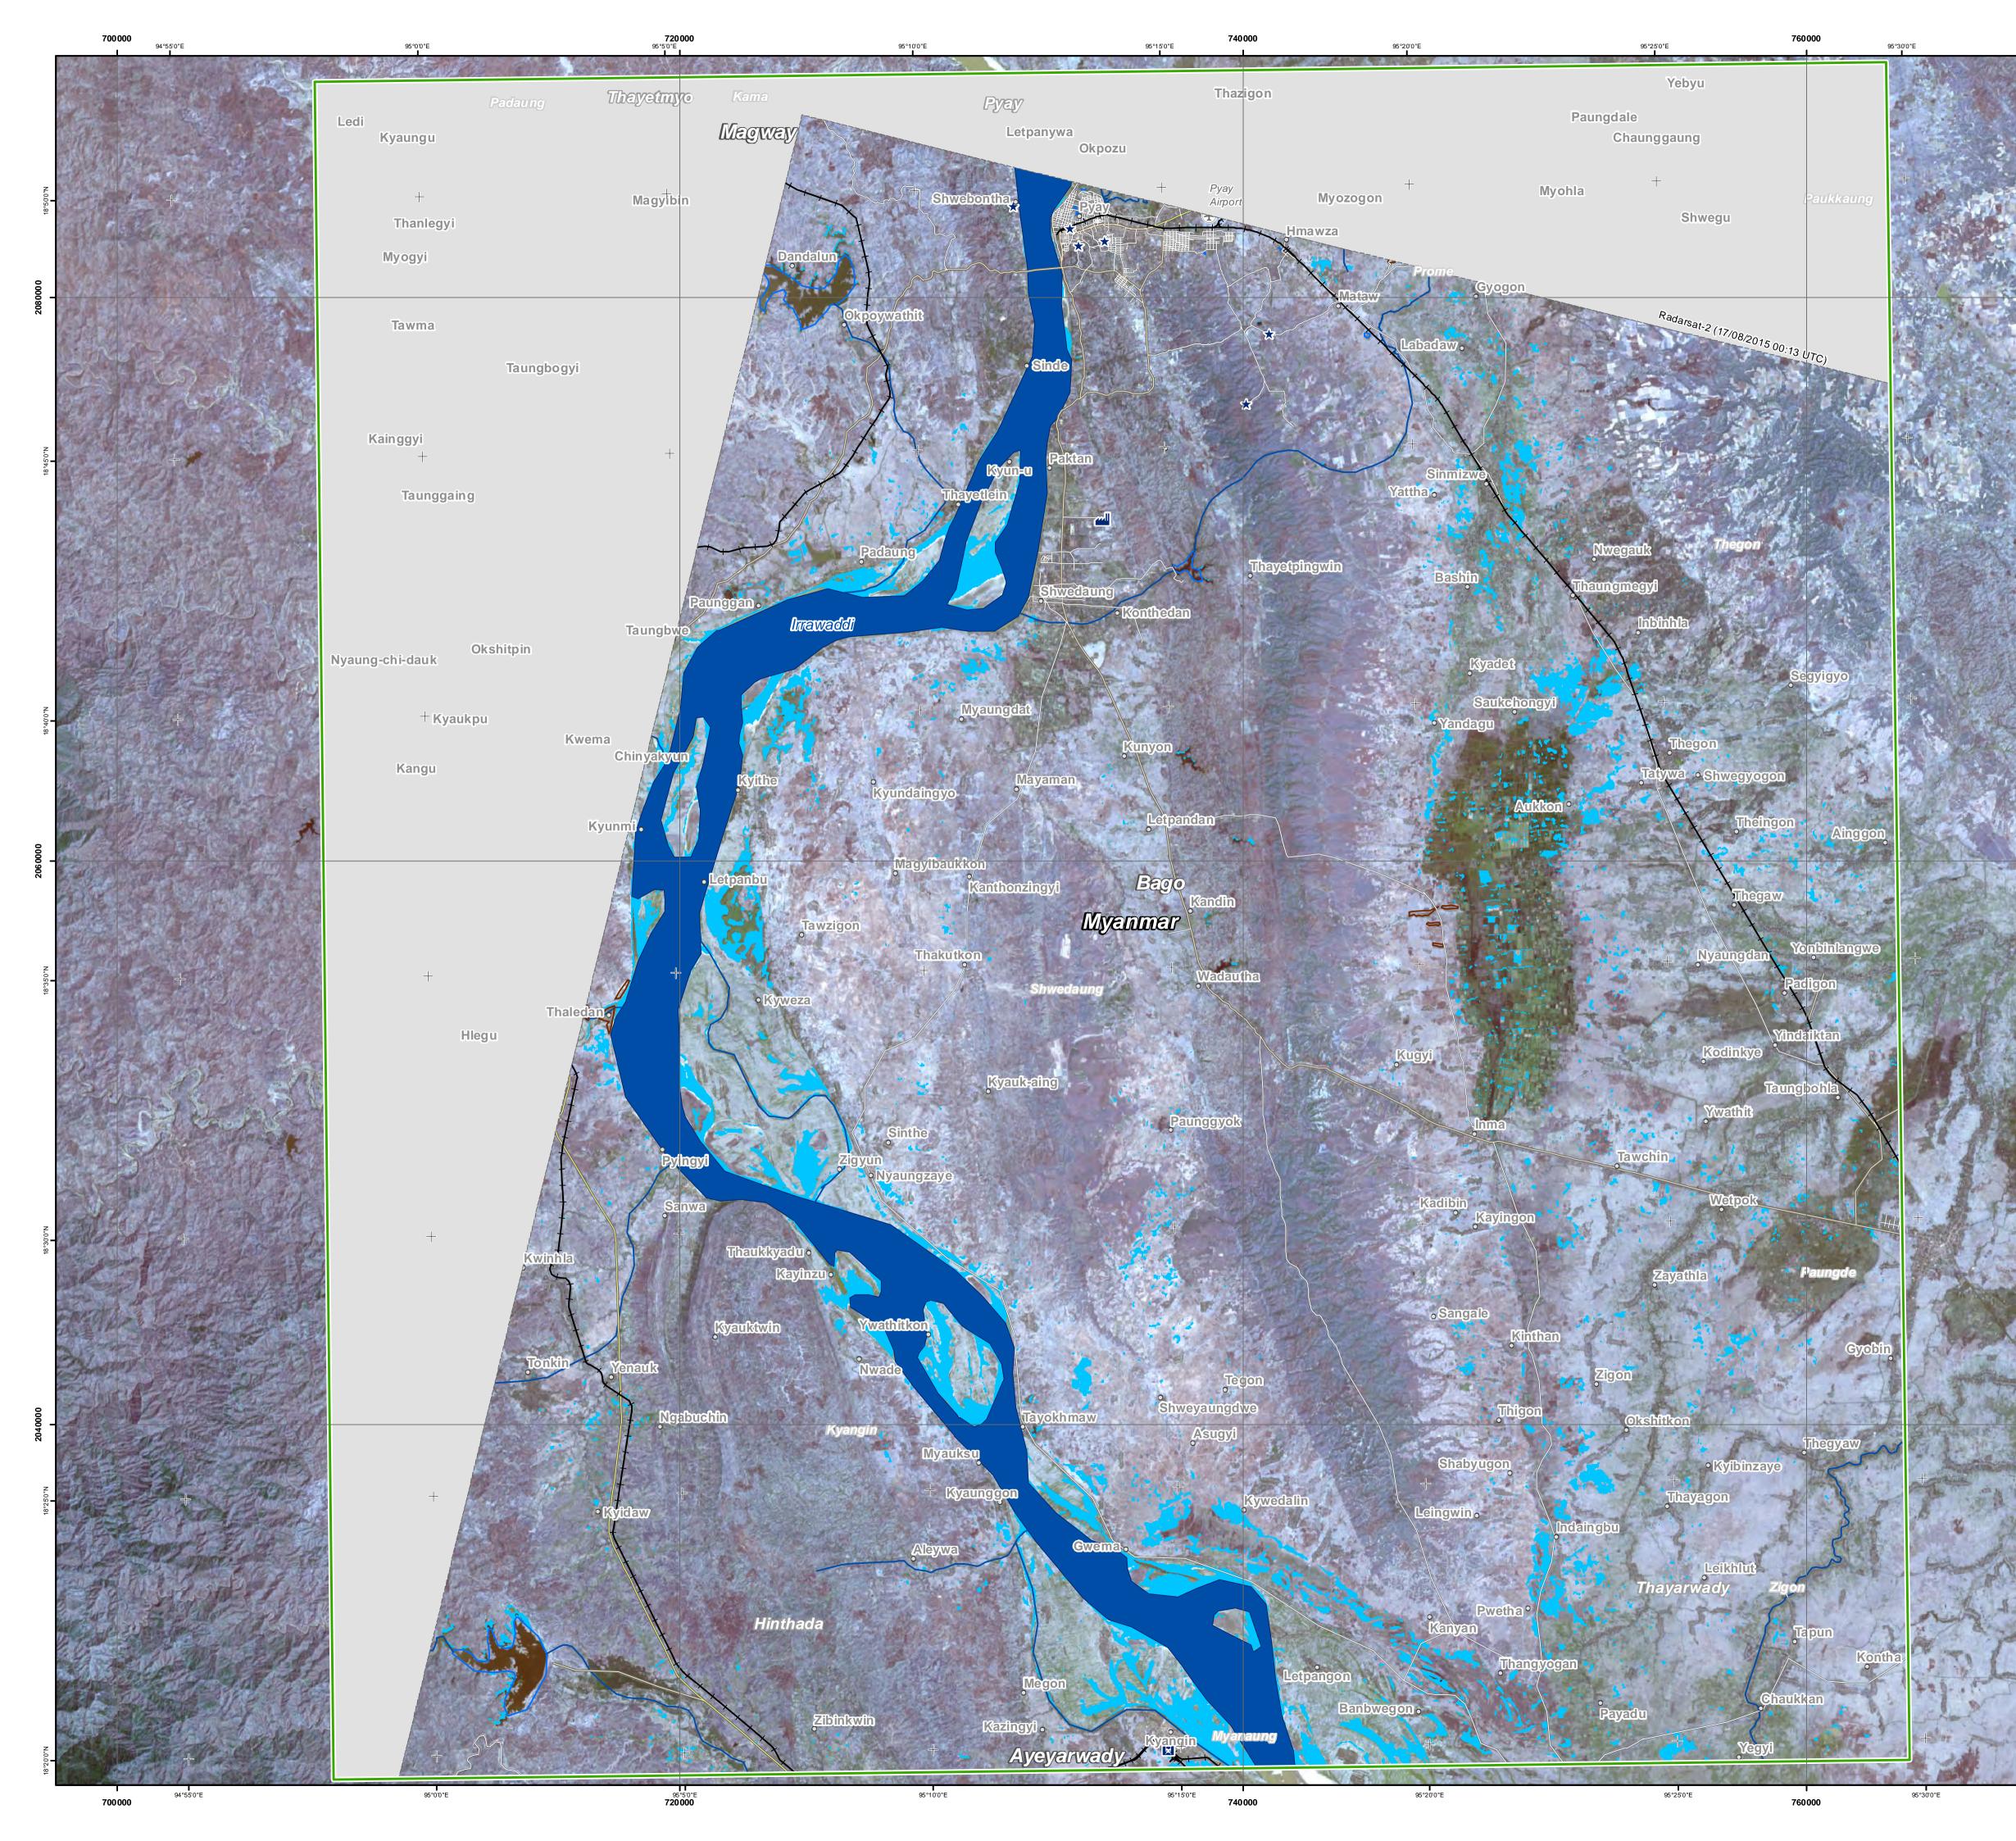
The present map shows the flood delineation in the area of Pyay (MYANMAR). The basic topographic features are derived from public datasets, refined by means of visual interpretation of pre-event image Landsat-8. The matic layers, assessing the delineation of the event have been derived from post-event image Radarsat-2. All satellite images have been radiometrically enhanced, orthocorrected with RPC approach (using SRTM elevation data). The estimated geometric accuracy of this product is 50 m CE90 or better, from native positional accuracy of the background satellite image. The estimated thematic accuracy of this product is 85 % or better, based on previous experience in using high-resolution SAR for flood extent delineation. Please be aware that the thematic accuracy might be lower in urban and forested areas due to known limitations of the analysis technique. the analysis technique.

Only the area enclosed by the Area of Interest has been analyzed.
