Compendium of WASH in Schools Facilities in Emergencies

DRAFT
UNICEF
2012

Compendium of WASH in Schools facilities

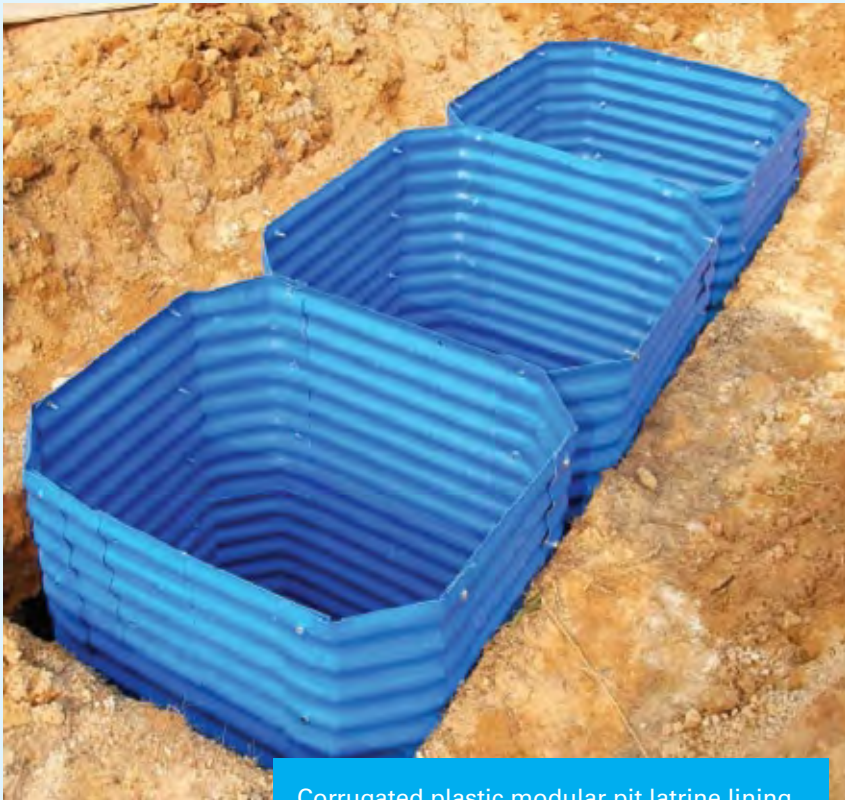
Corrugated plastic modular pit latrine lining (Evenproducts, United Kingdom)

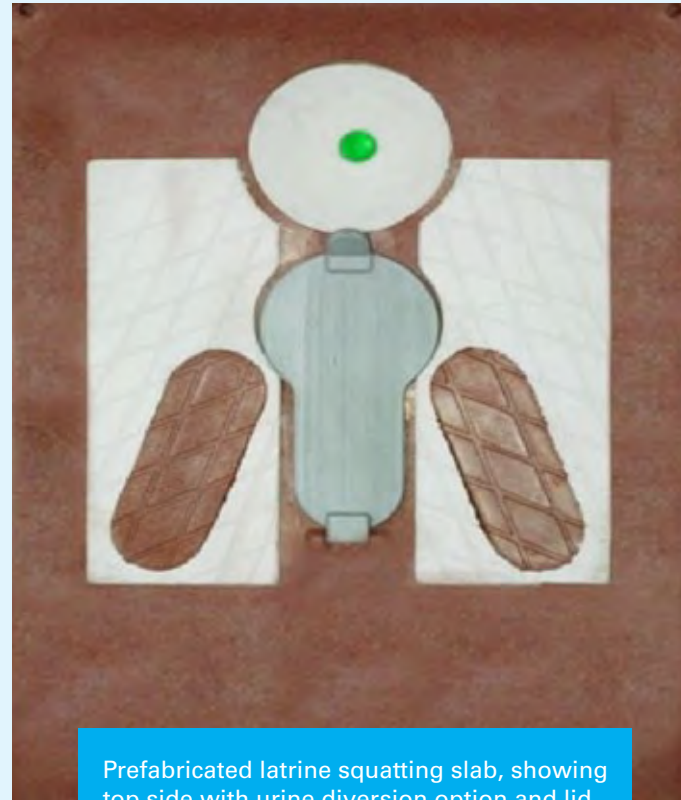
Prefabricated latrine squatting slab, showing top side with urine diversion option and lid for covering squat hole (Nag Magic, India)

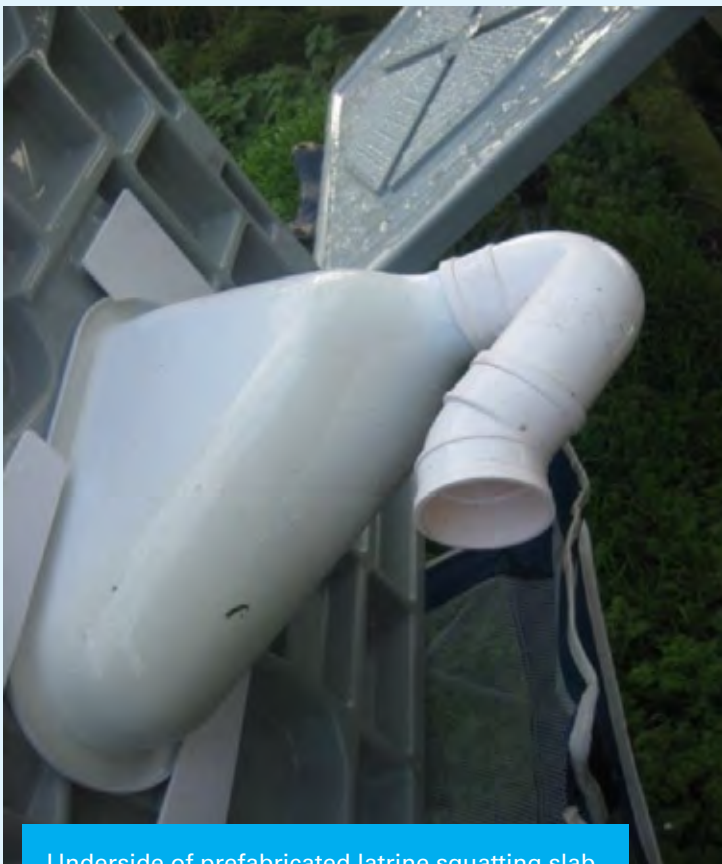
Underside of prefabricated latrine squatting slab, showing u-bend trap (AirCell Structures, UK)

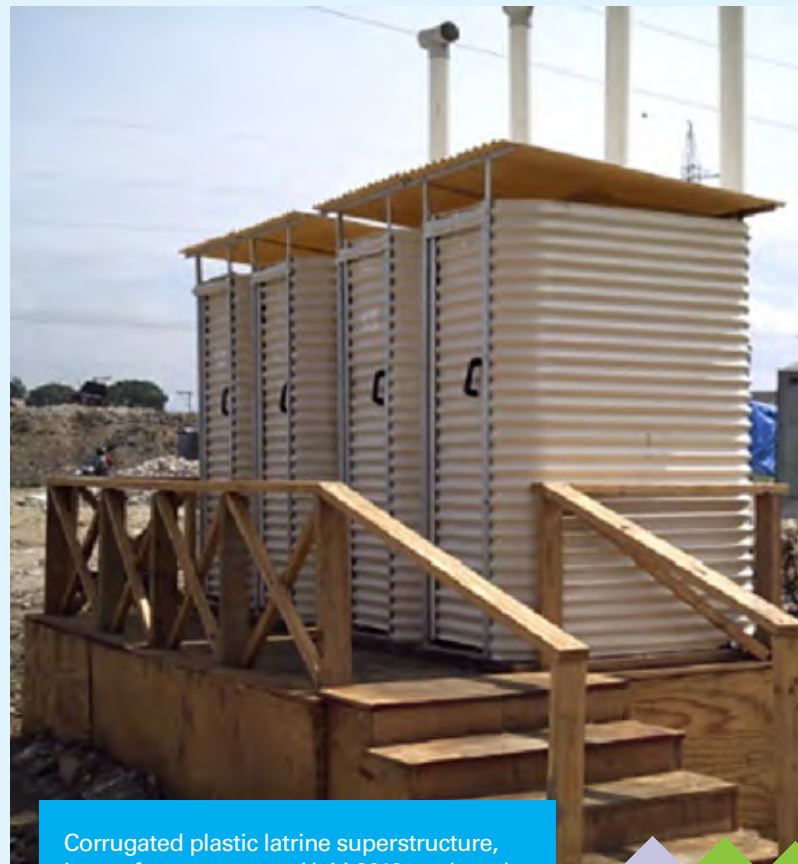
Corrugated plastic latrine superstructure, in use for response to Haiti 2010 earthquake (Evenproducts, United Kingdom)

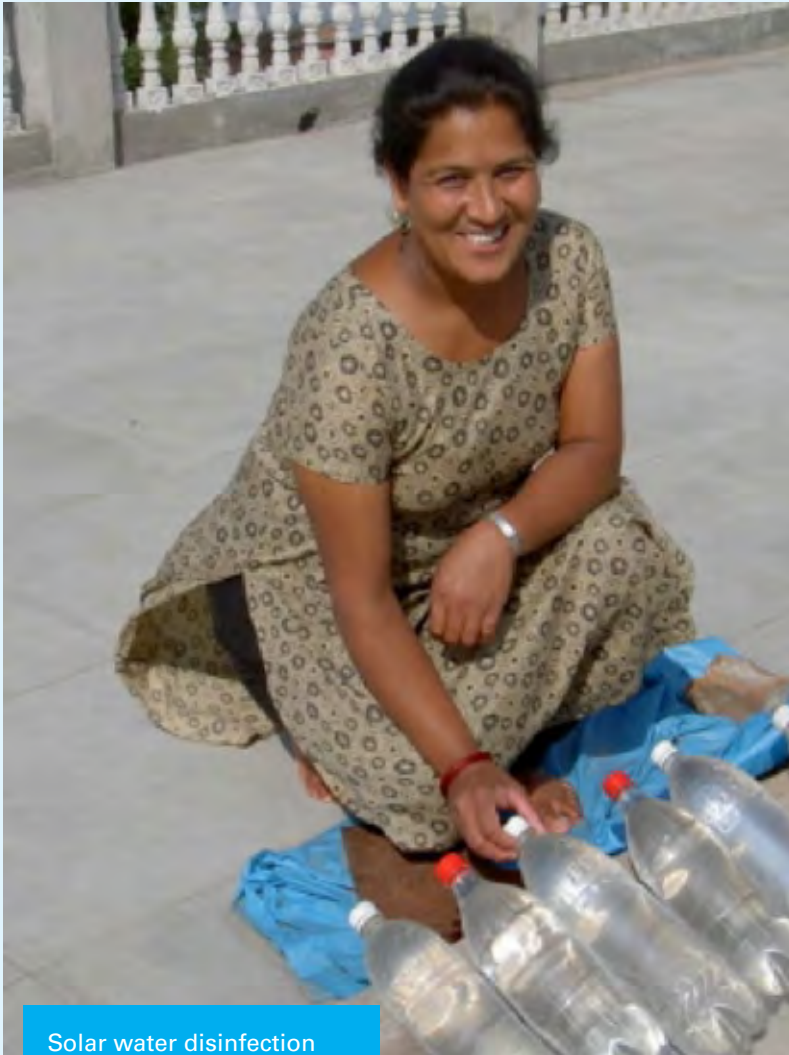
Solar water disinfection using recycled bottles

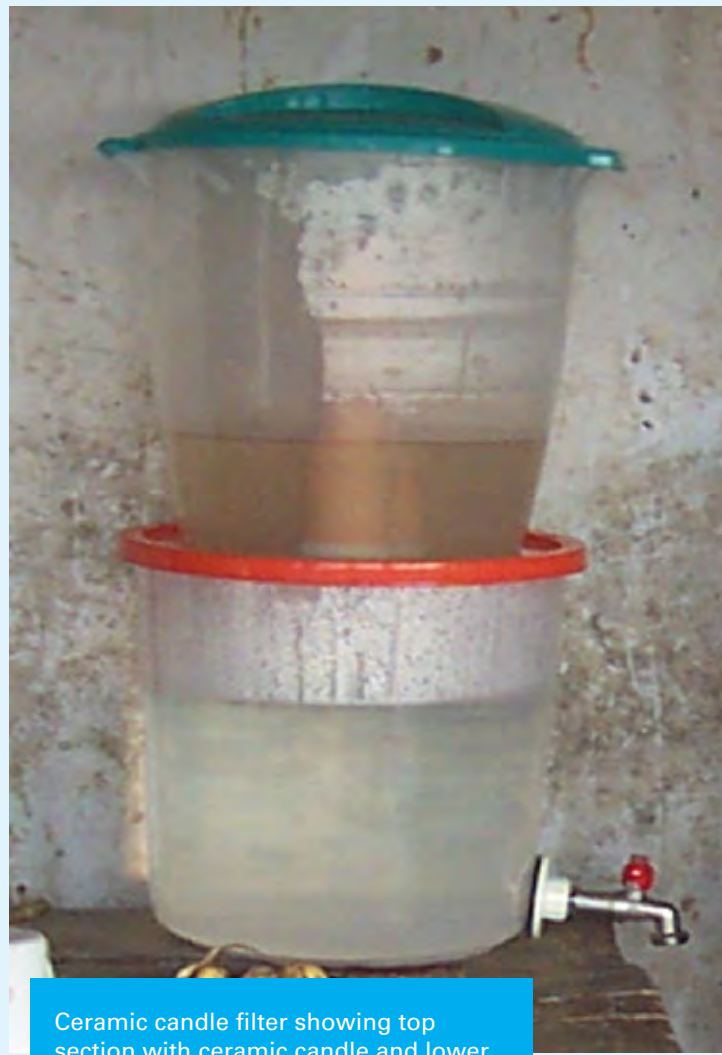
Ceramic candle filter showing top section with ceramic candle and lower section with storage and outlet tap

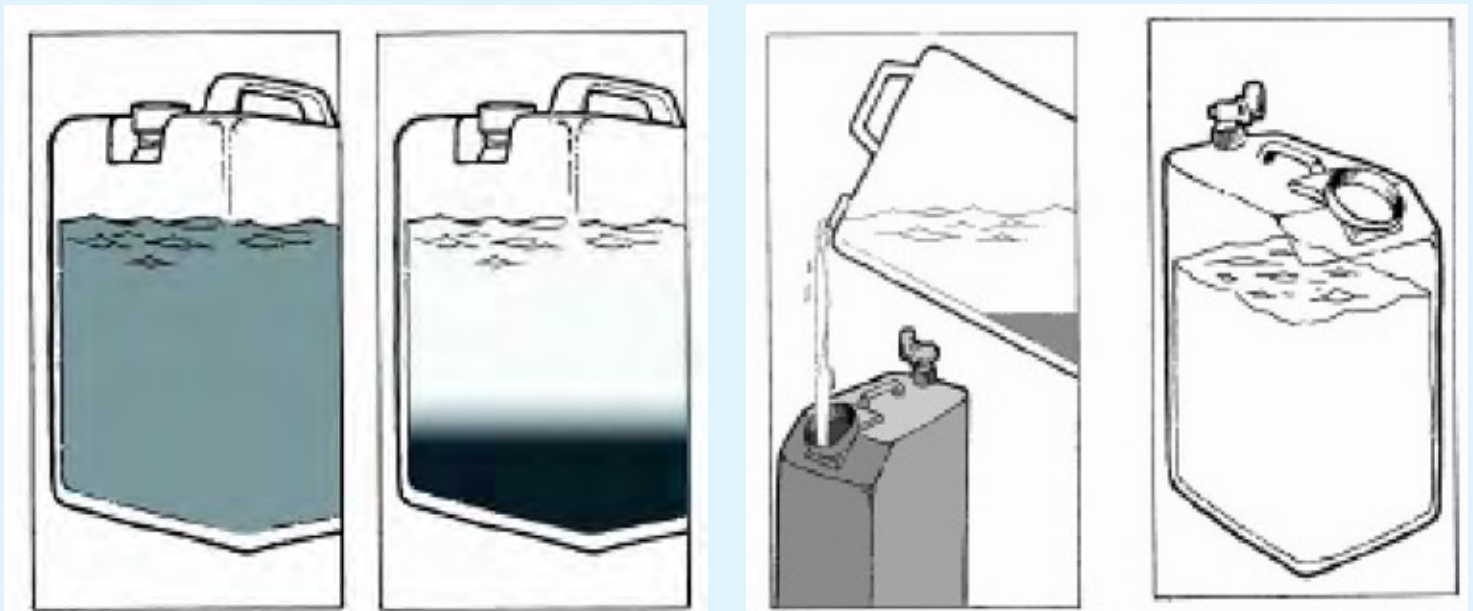
Stages of plain sedimentation using one water container for settling and a second for storage of clear water prior to chemical treatment with chlorine

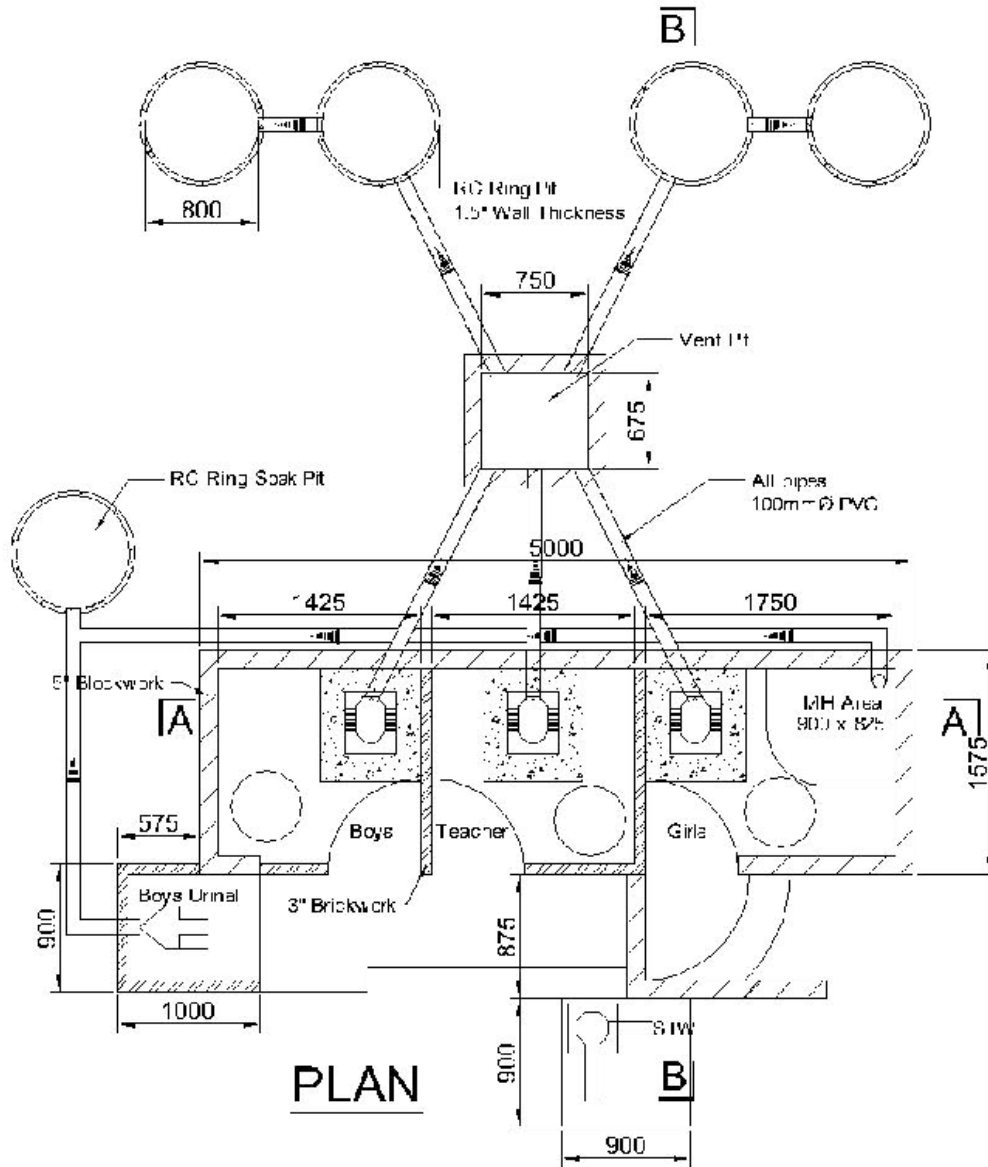
Drawing Title		
Bangladesh Community Latrine for Children Option 3: Plan & Drainage		
Drawing Reference		Sheet Number
Ex-Ban(Pre)-Dwg-RevPR1		1 of 2
Scale	Sheet Size	Date
1:50	A4	June 2011

PLAN

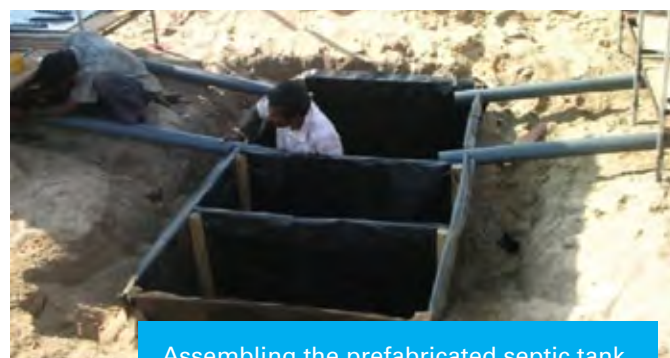
Assembling the prefabricated septic tank

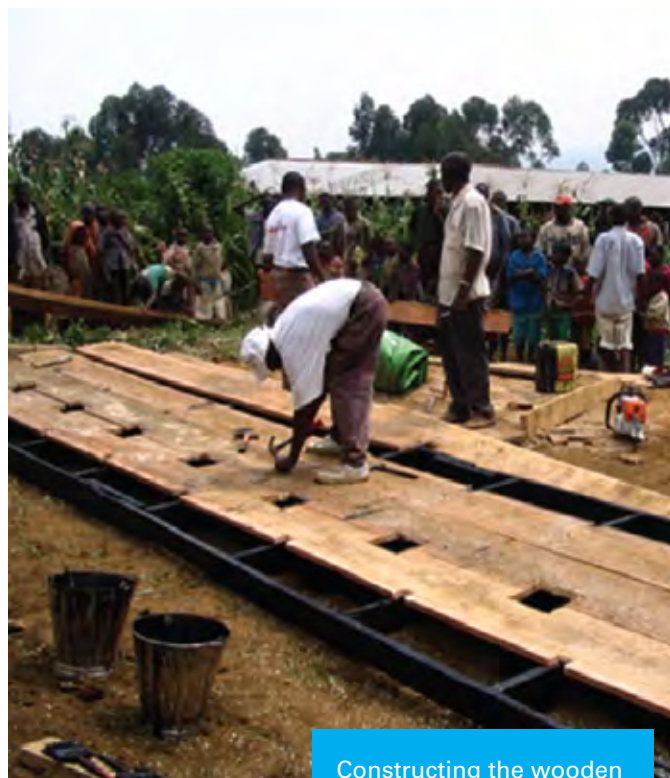
Constructing the wooden floor for a latrine block

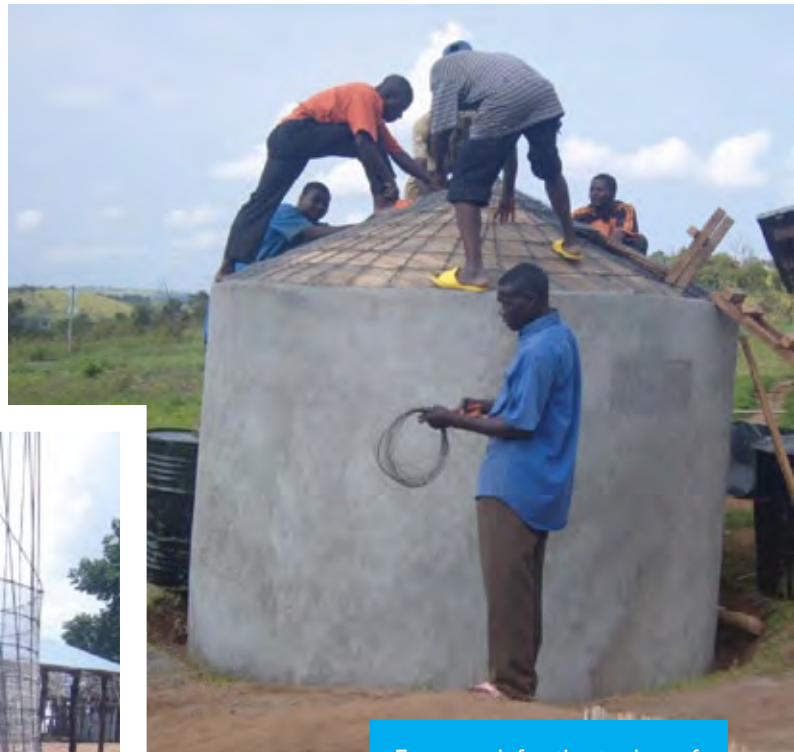
Formwork for the tank roof

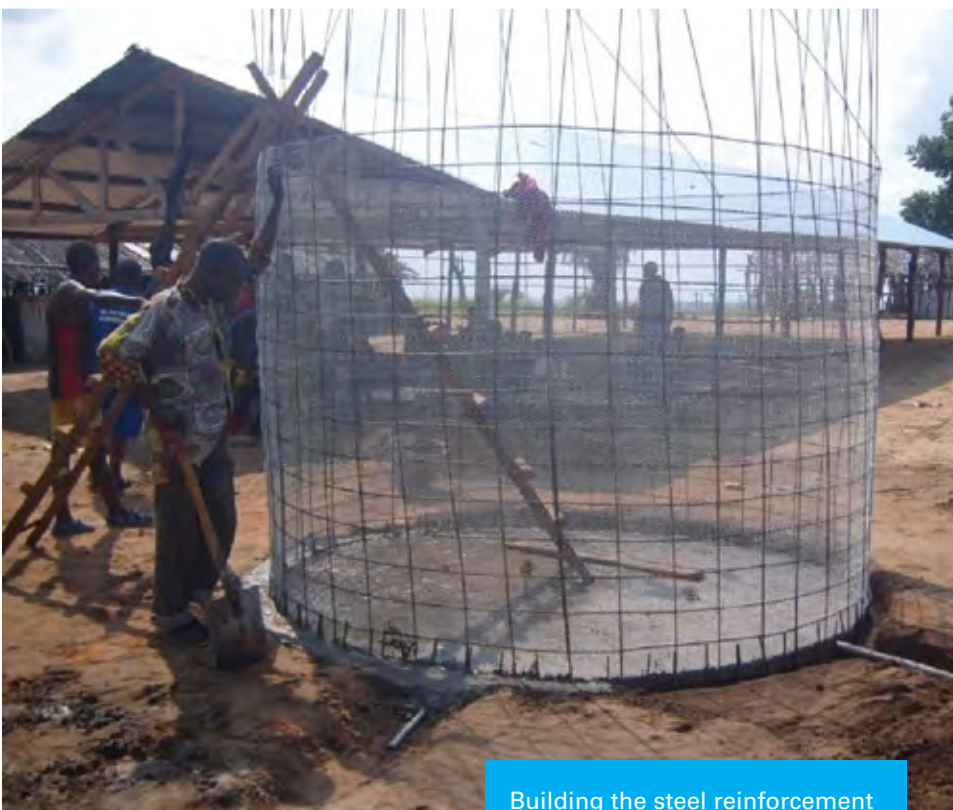
Building the steel reinforcement for a ferrocement tank

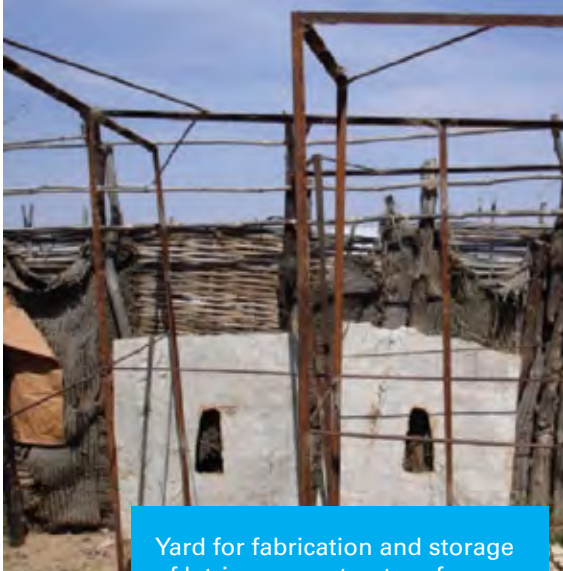
Yard for fabrication and storage of latrine superstructure frames and concrete latrine slabs

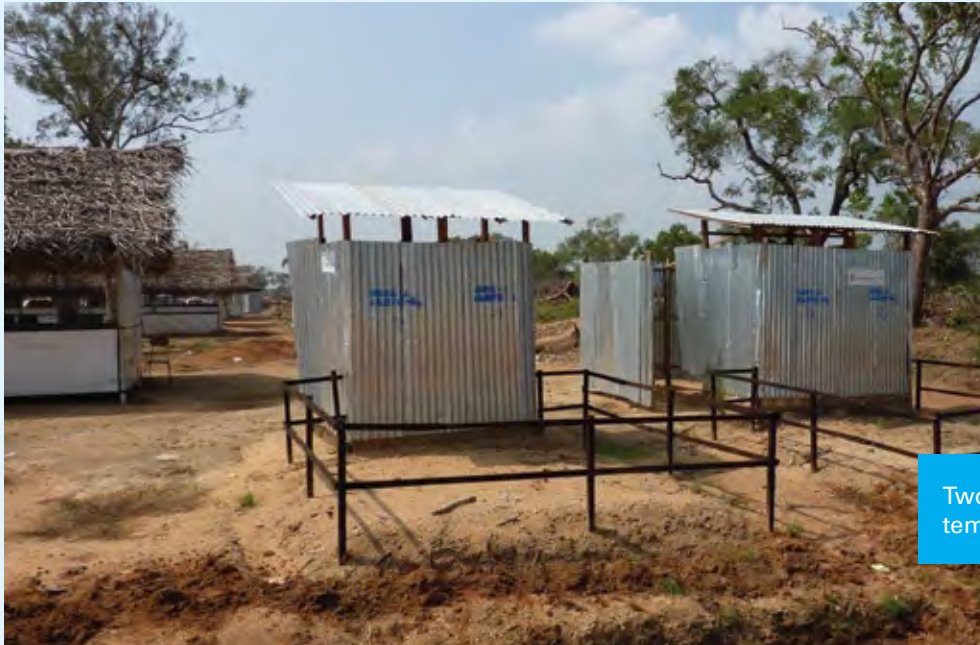
Two twin-pit latrines at a temporary learning space

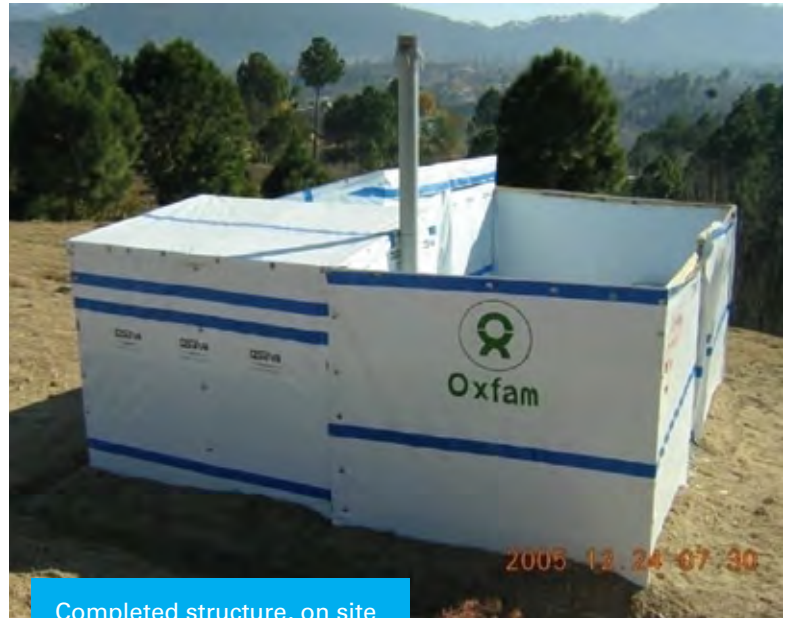
Completed structure, on site

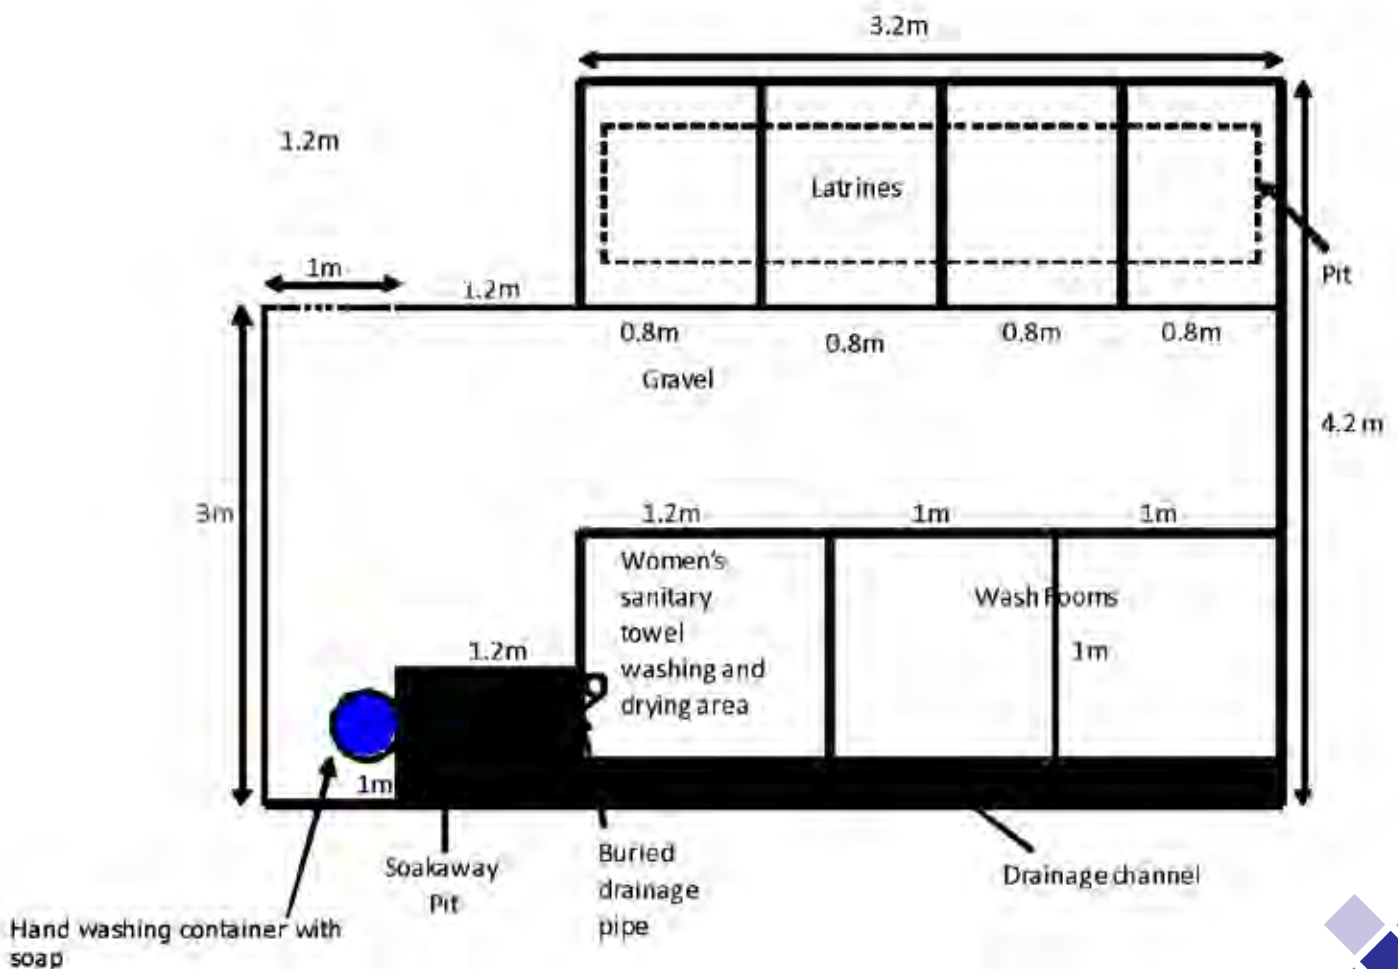
Floor plan of women's hygiene block, featuring enclosed washing areas and a high level of privacy

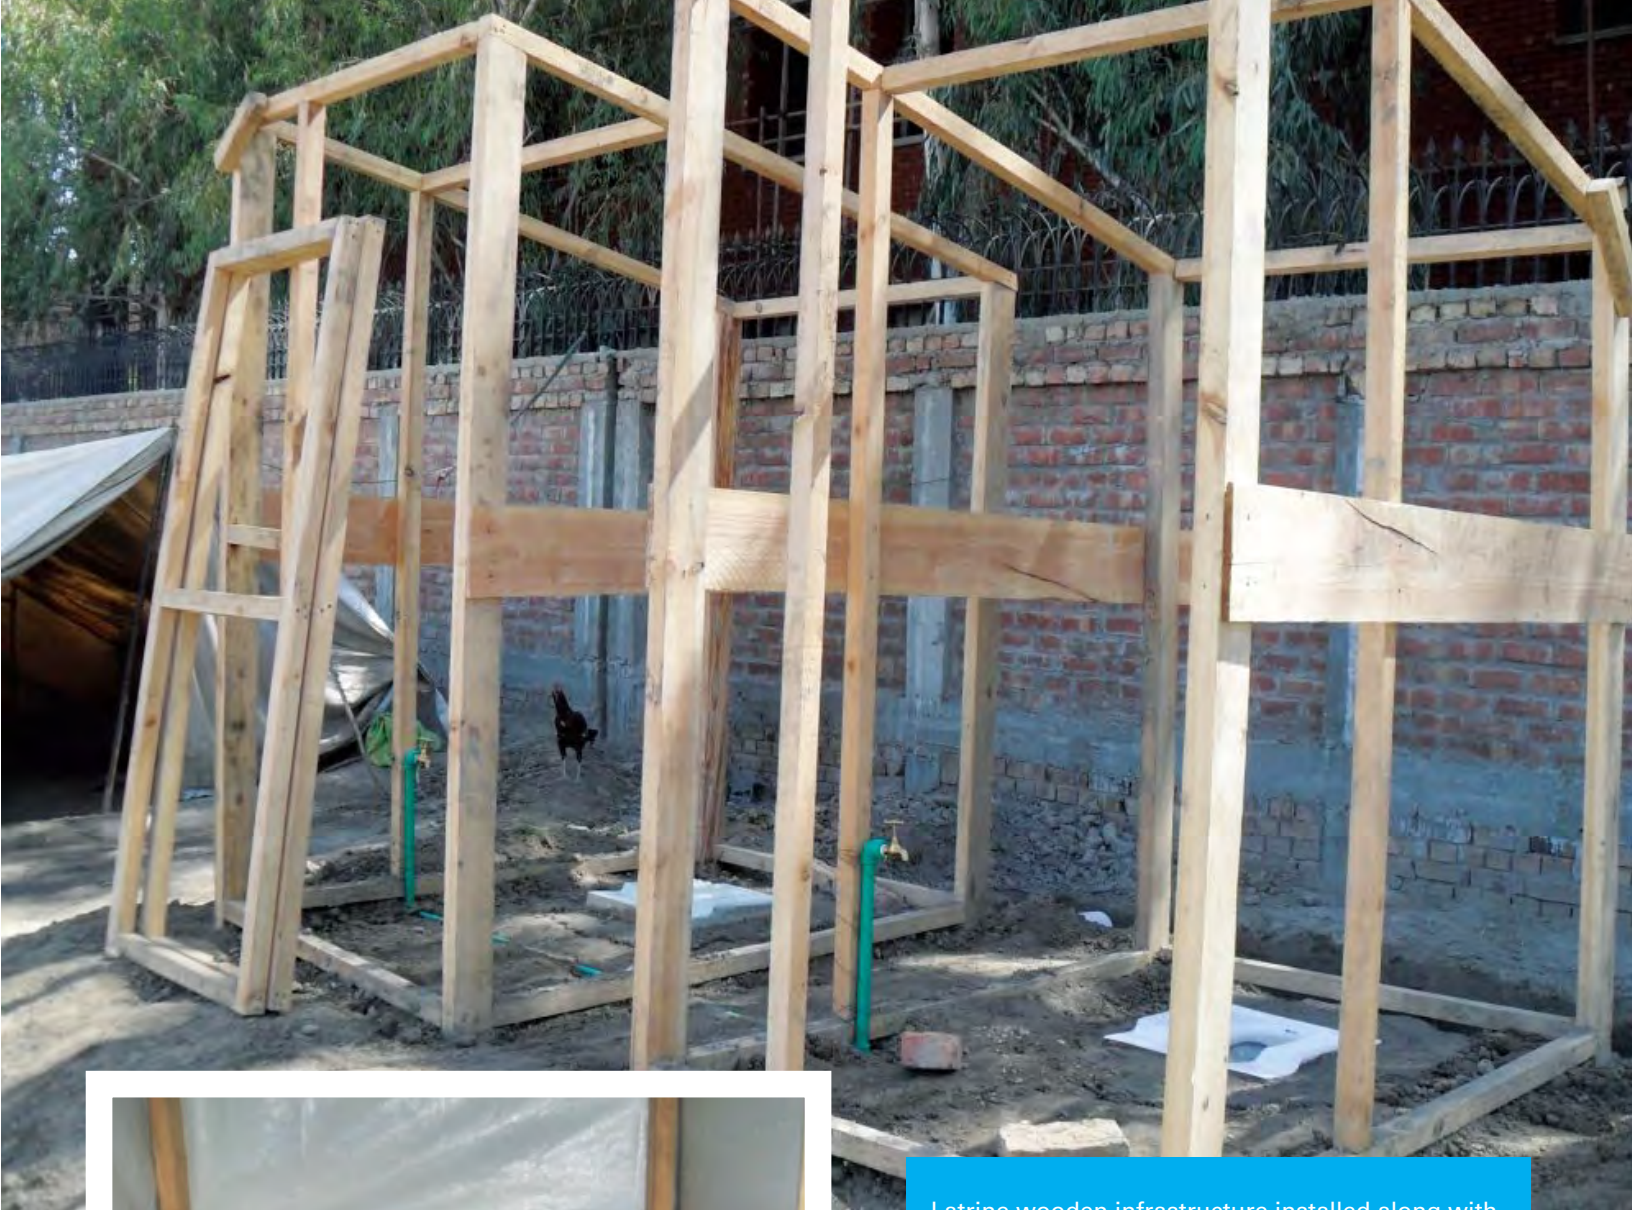
Latrine wooden infrastructure installed along with pour flush pans (above) and completed latrine with plastic sheeting walls (left)

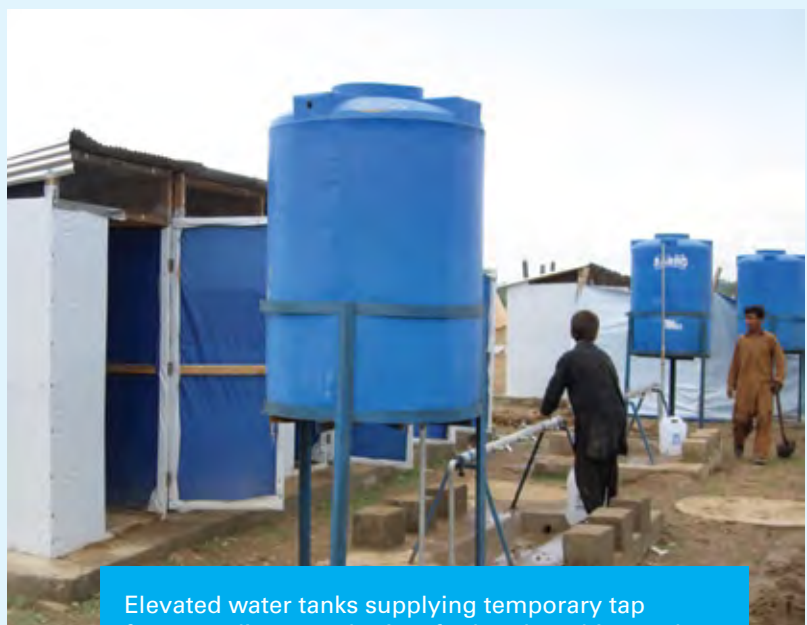
Elevated water tanks supplying temporary tap frames, adjacent to latrine, for hand washing and anal cleansing

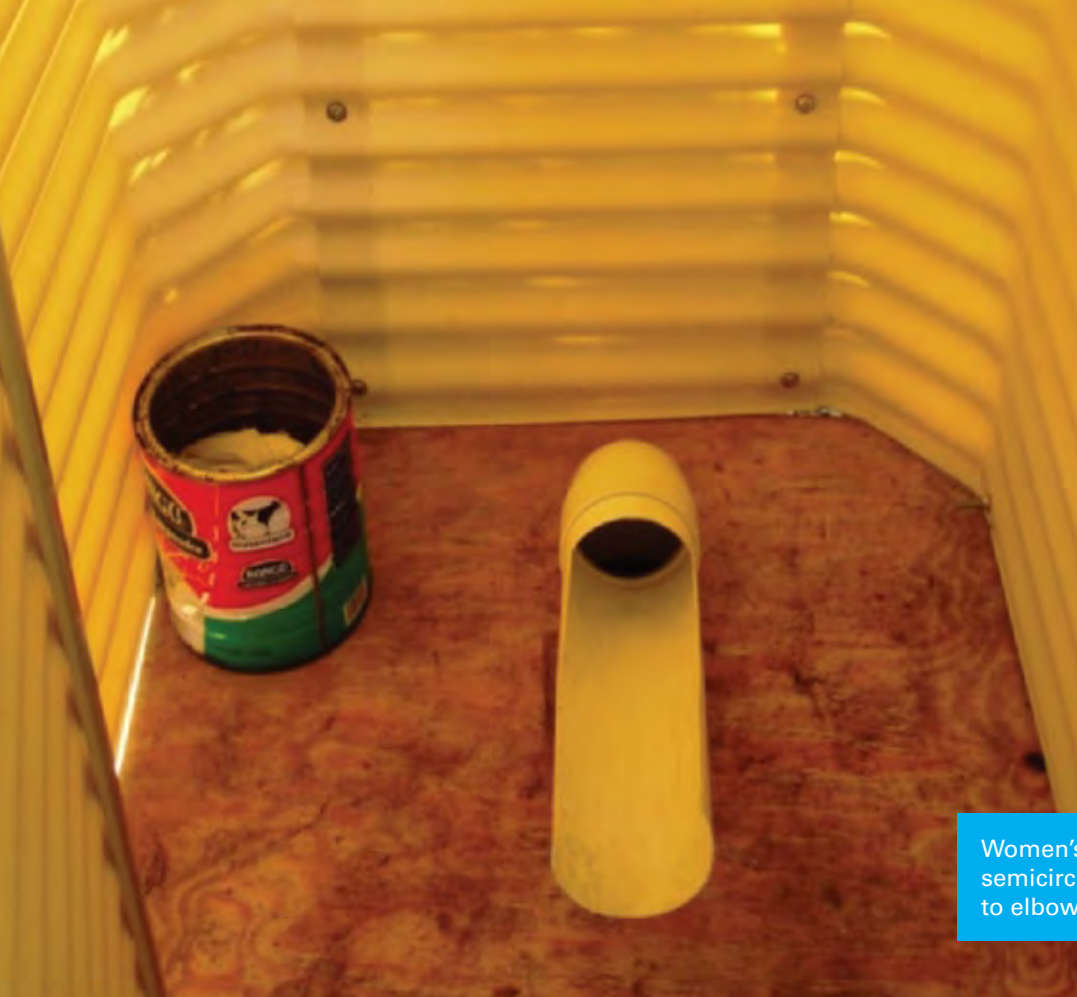
Women's urinal made from semicircle of pipe connected to elbow

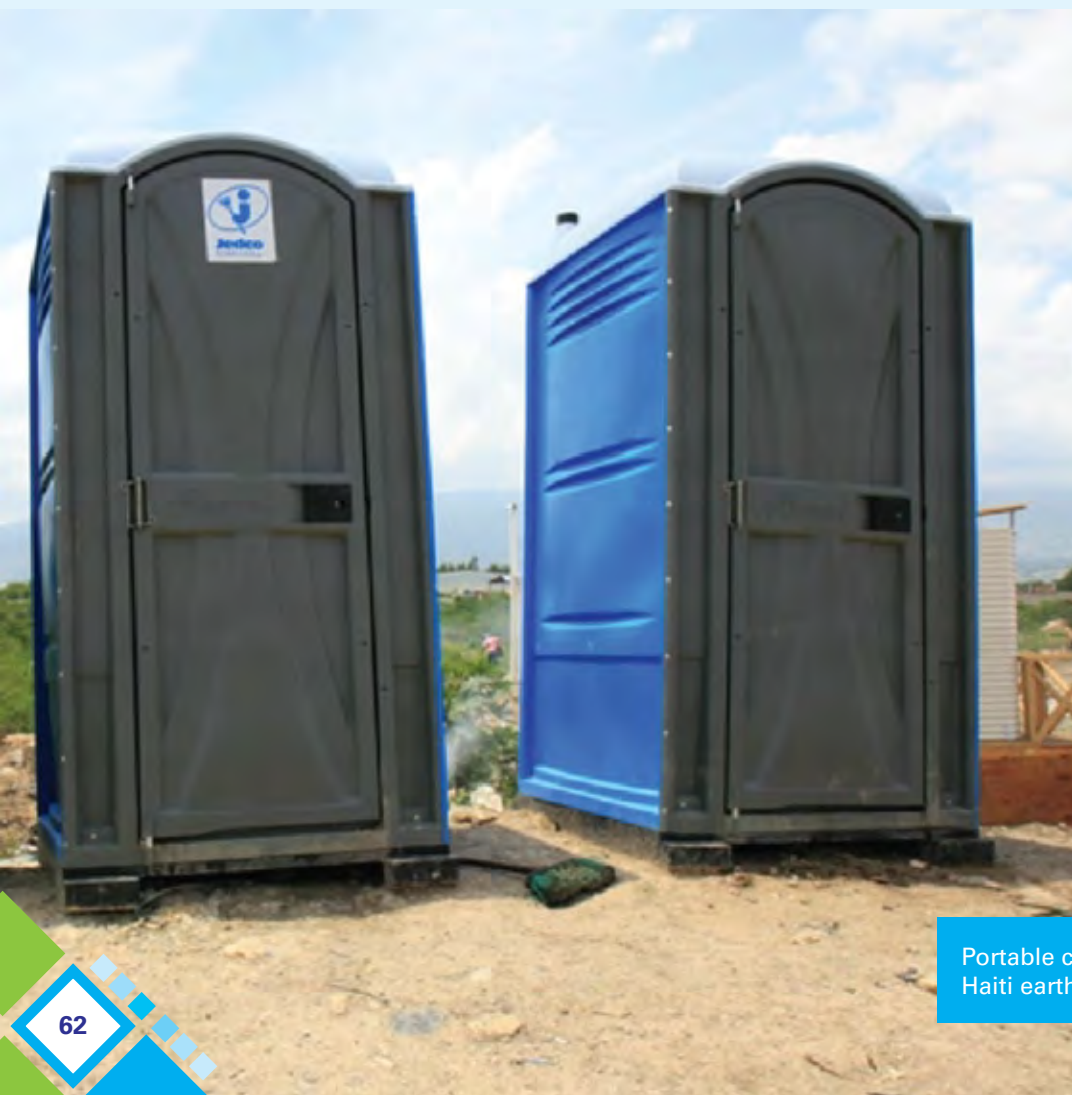
Portable chemical latrines used in Haiti earthquake response, 2010

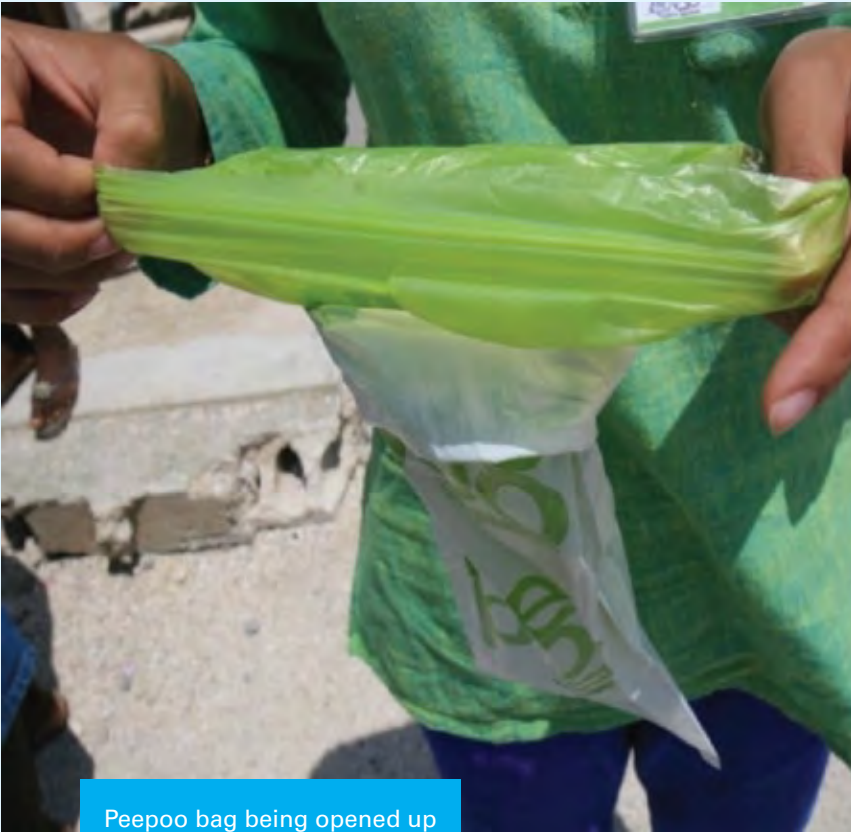
Peepoo bag being opened up

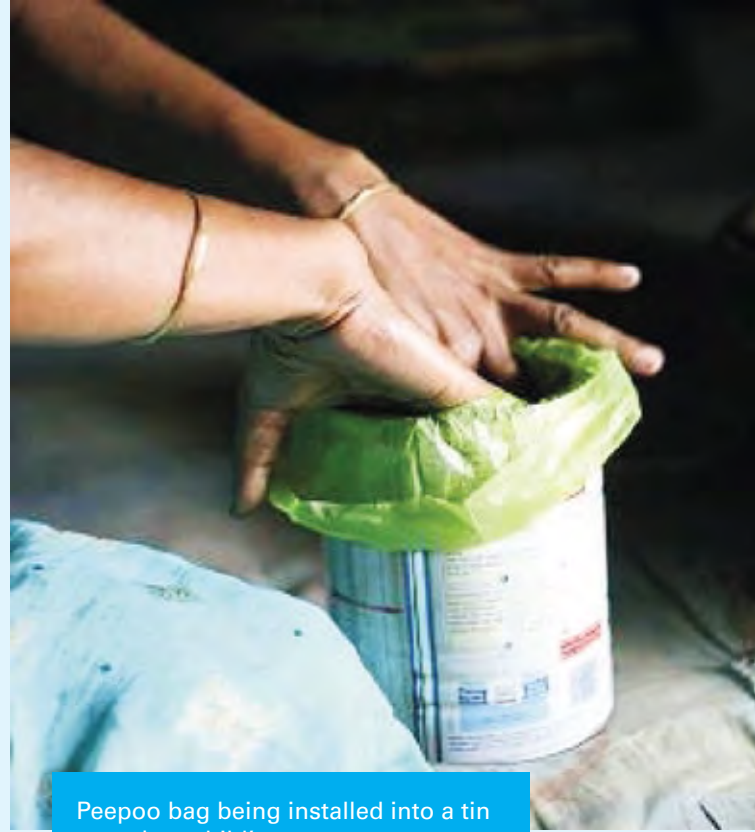
Peepoo bag being installed into a tin to make a child's potty

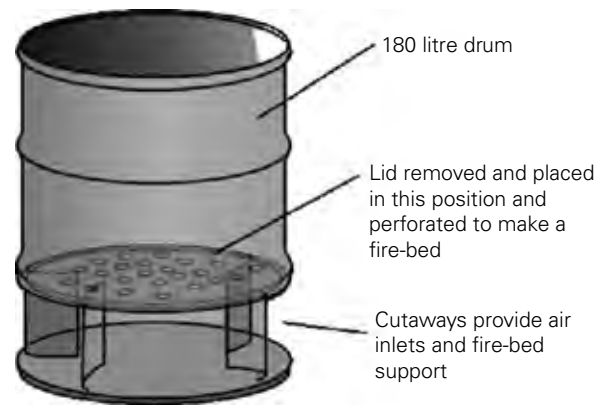
Design for menstrual hygiene management incinerator

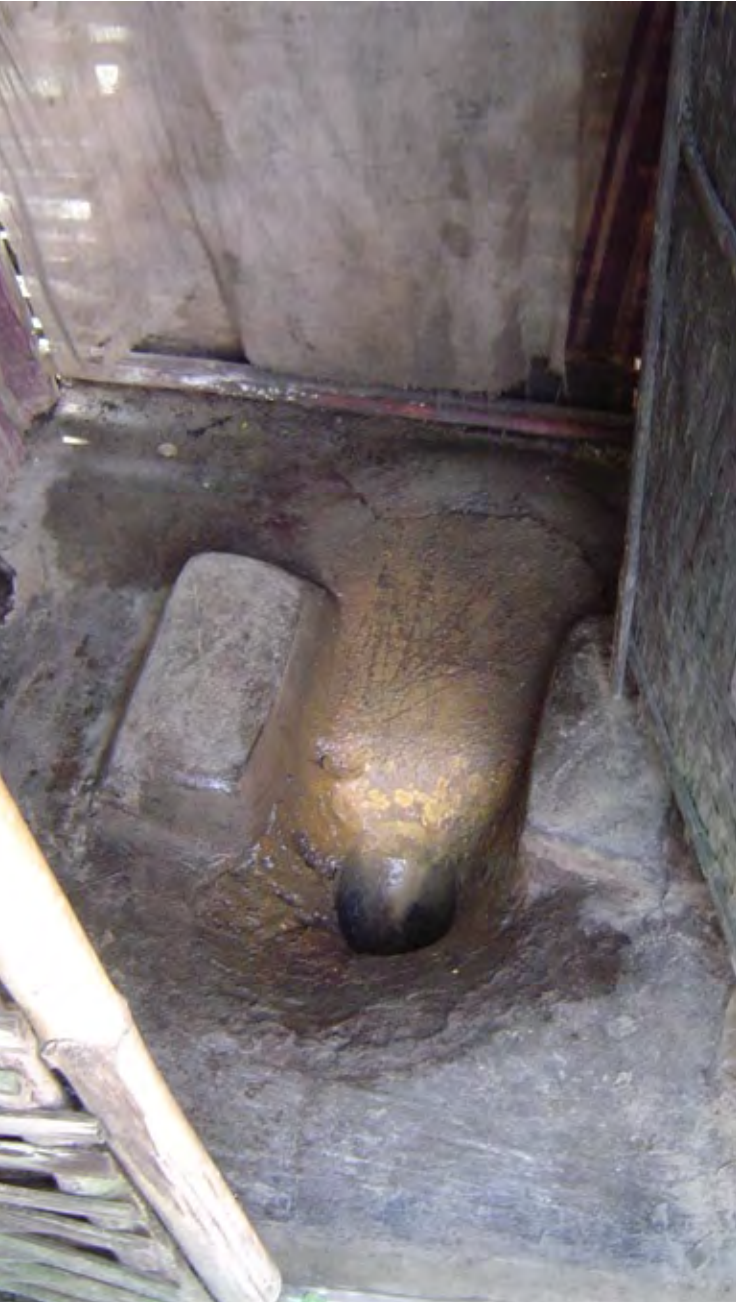
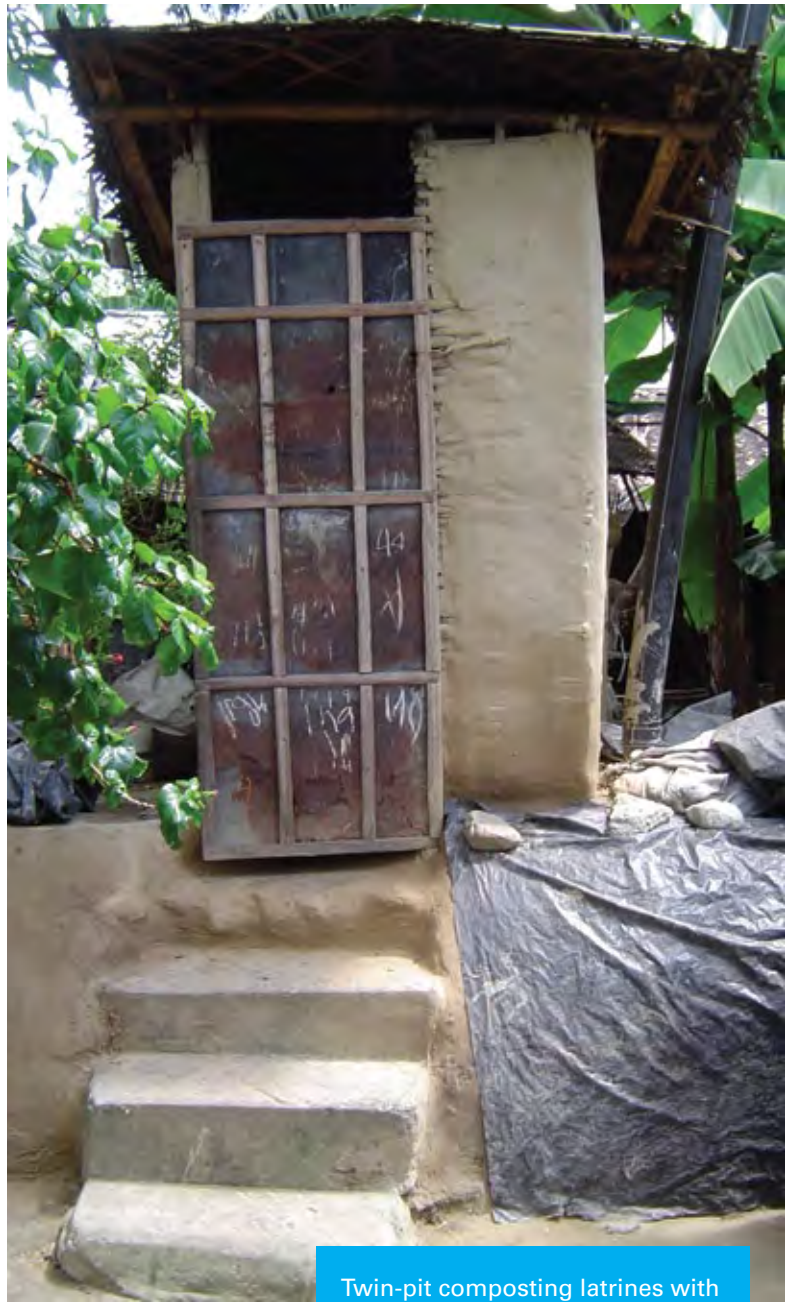
Twin-pit composting latrines with brick and cement pit lining

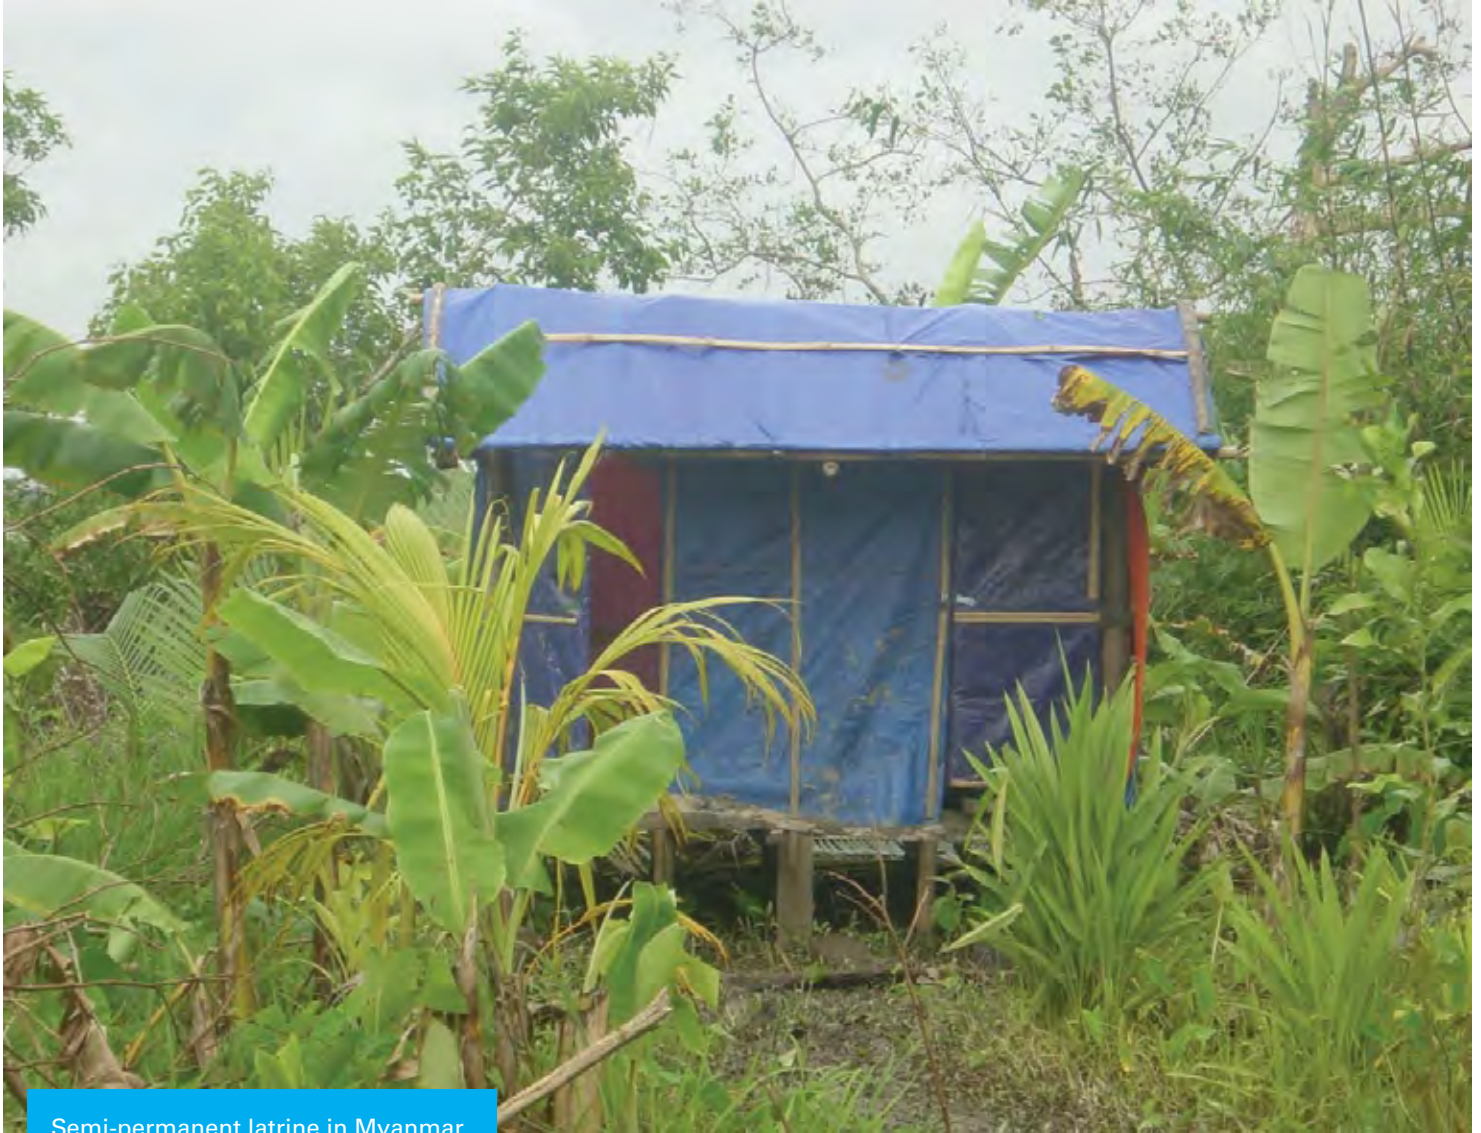
Semi-permanent latrine in Myanmar

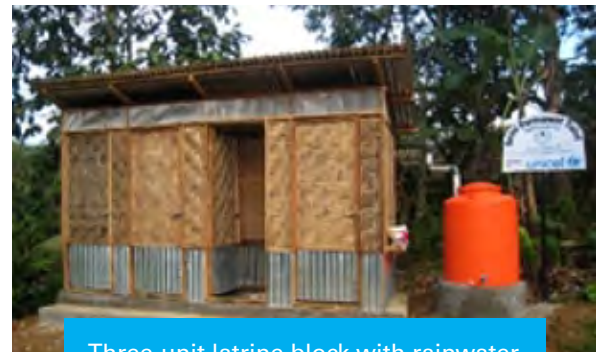
Three-unit latrine block with rainwater harvesting system
