Compendium of WASH in Schools Facilities in Emergencies

DRAFT
UNICEF
2012

Compendium of WASH in Schools facilities

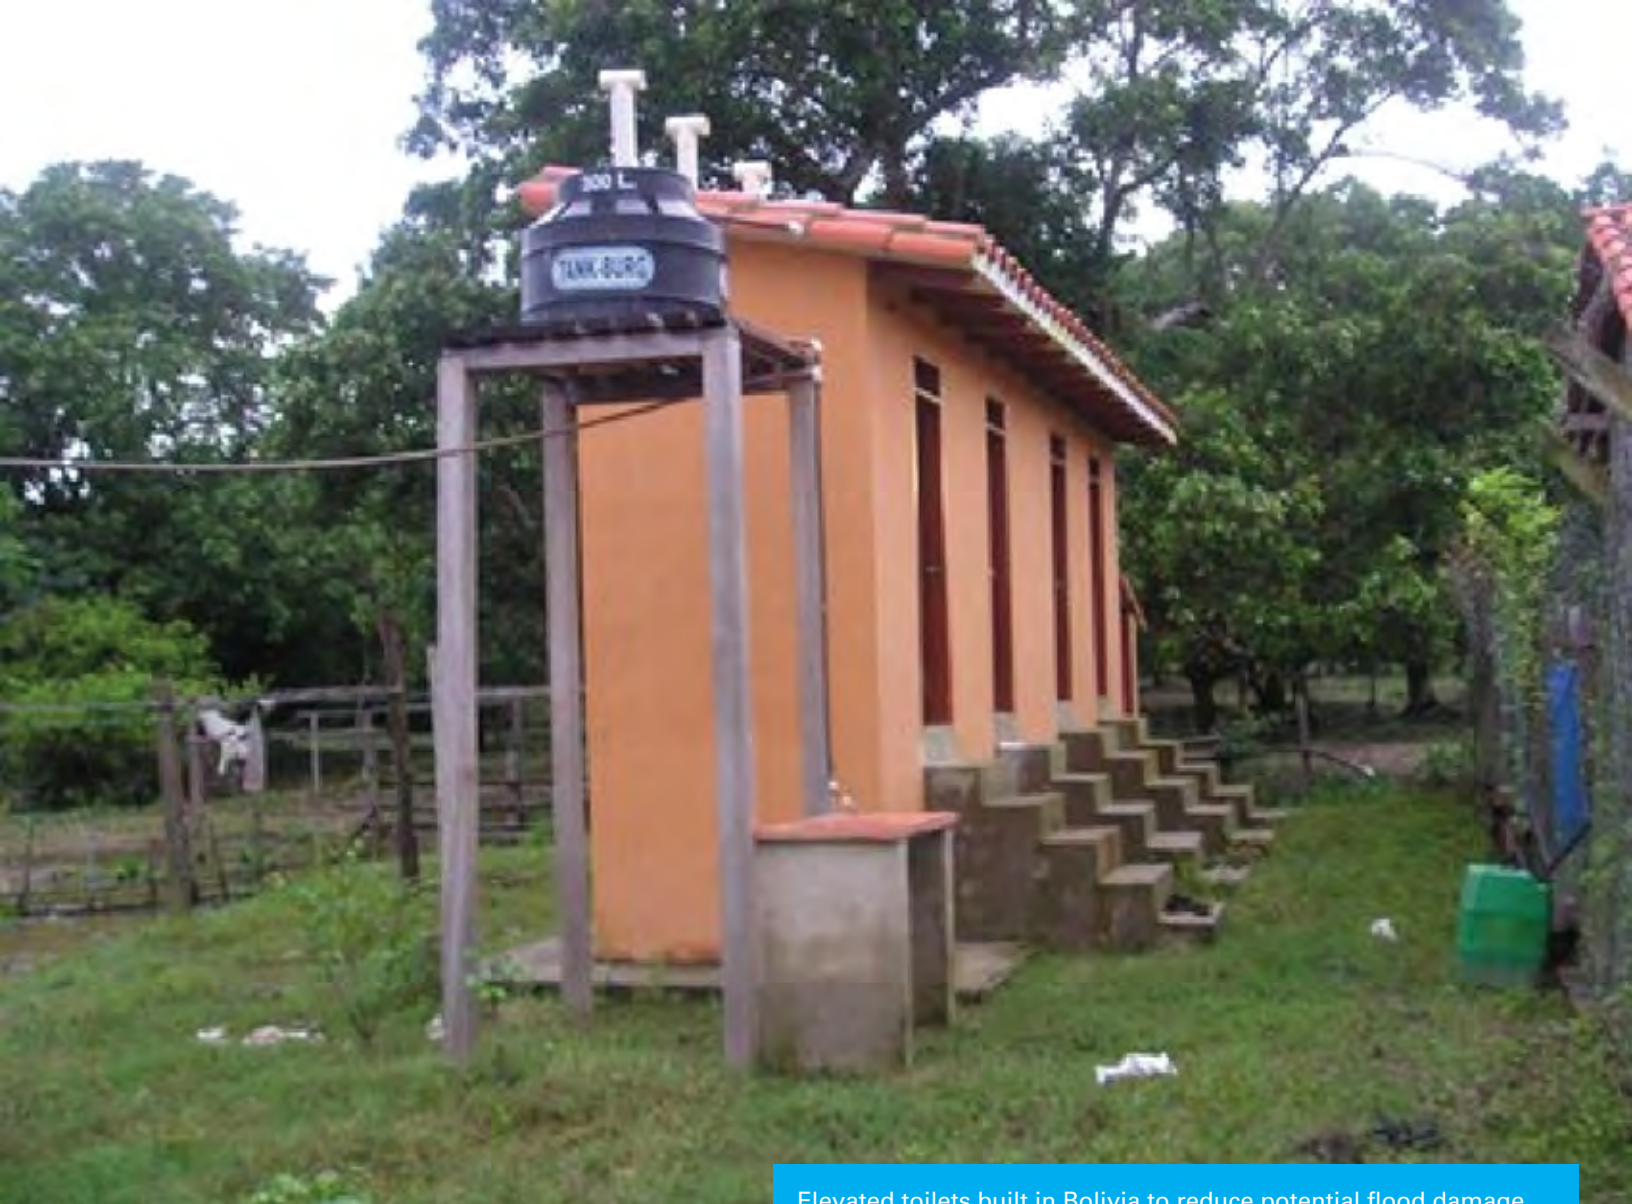
Elevated toilets built in Bolivia to reduce potential flood damage
