Pathein - Myanmar Flood - 01/08/2015 Delineation Map

Unusual heavy monsoon rains have been affecting Myanmar since 16 July causing river overflows and floods. In the past few days, torrential rains damaged farmland, roads, rail tracks, bridges and houses. The core users of the map is Emergency Response Coordination Centre (ERCC).

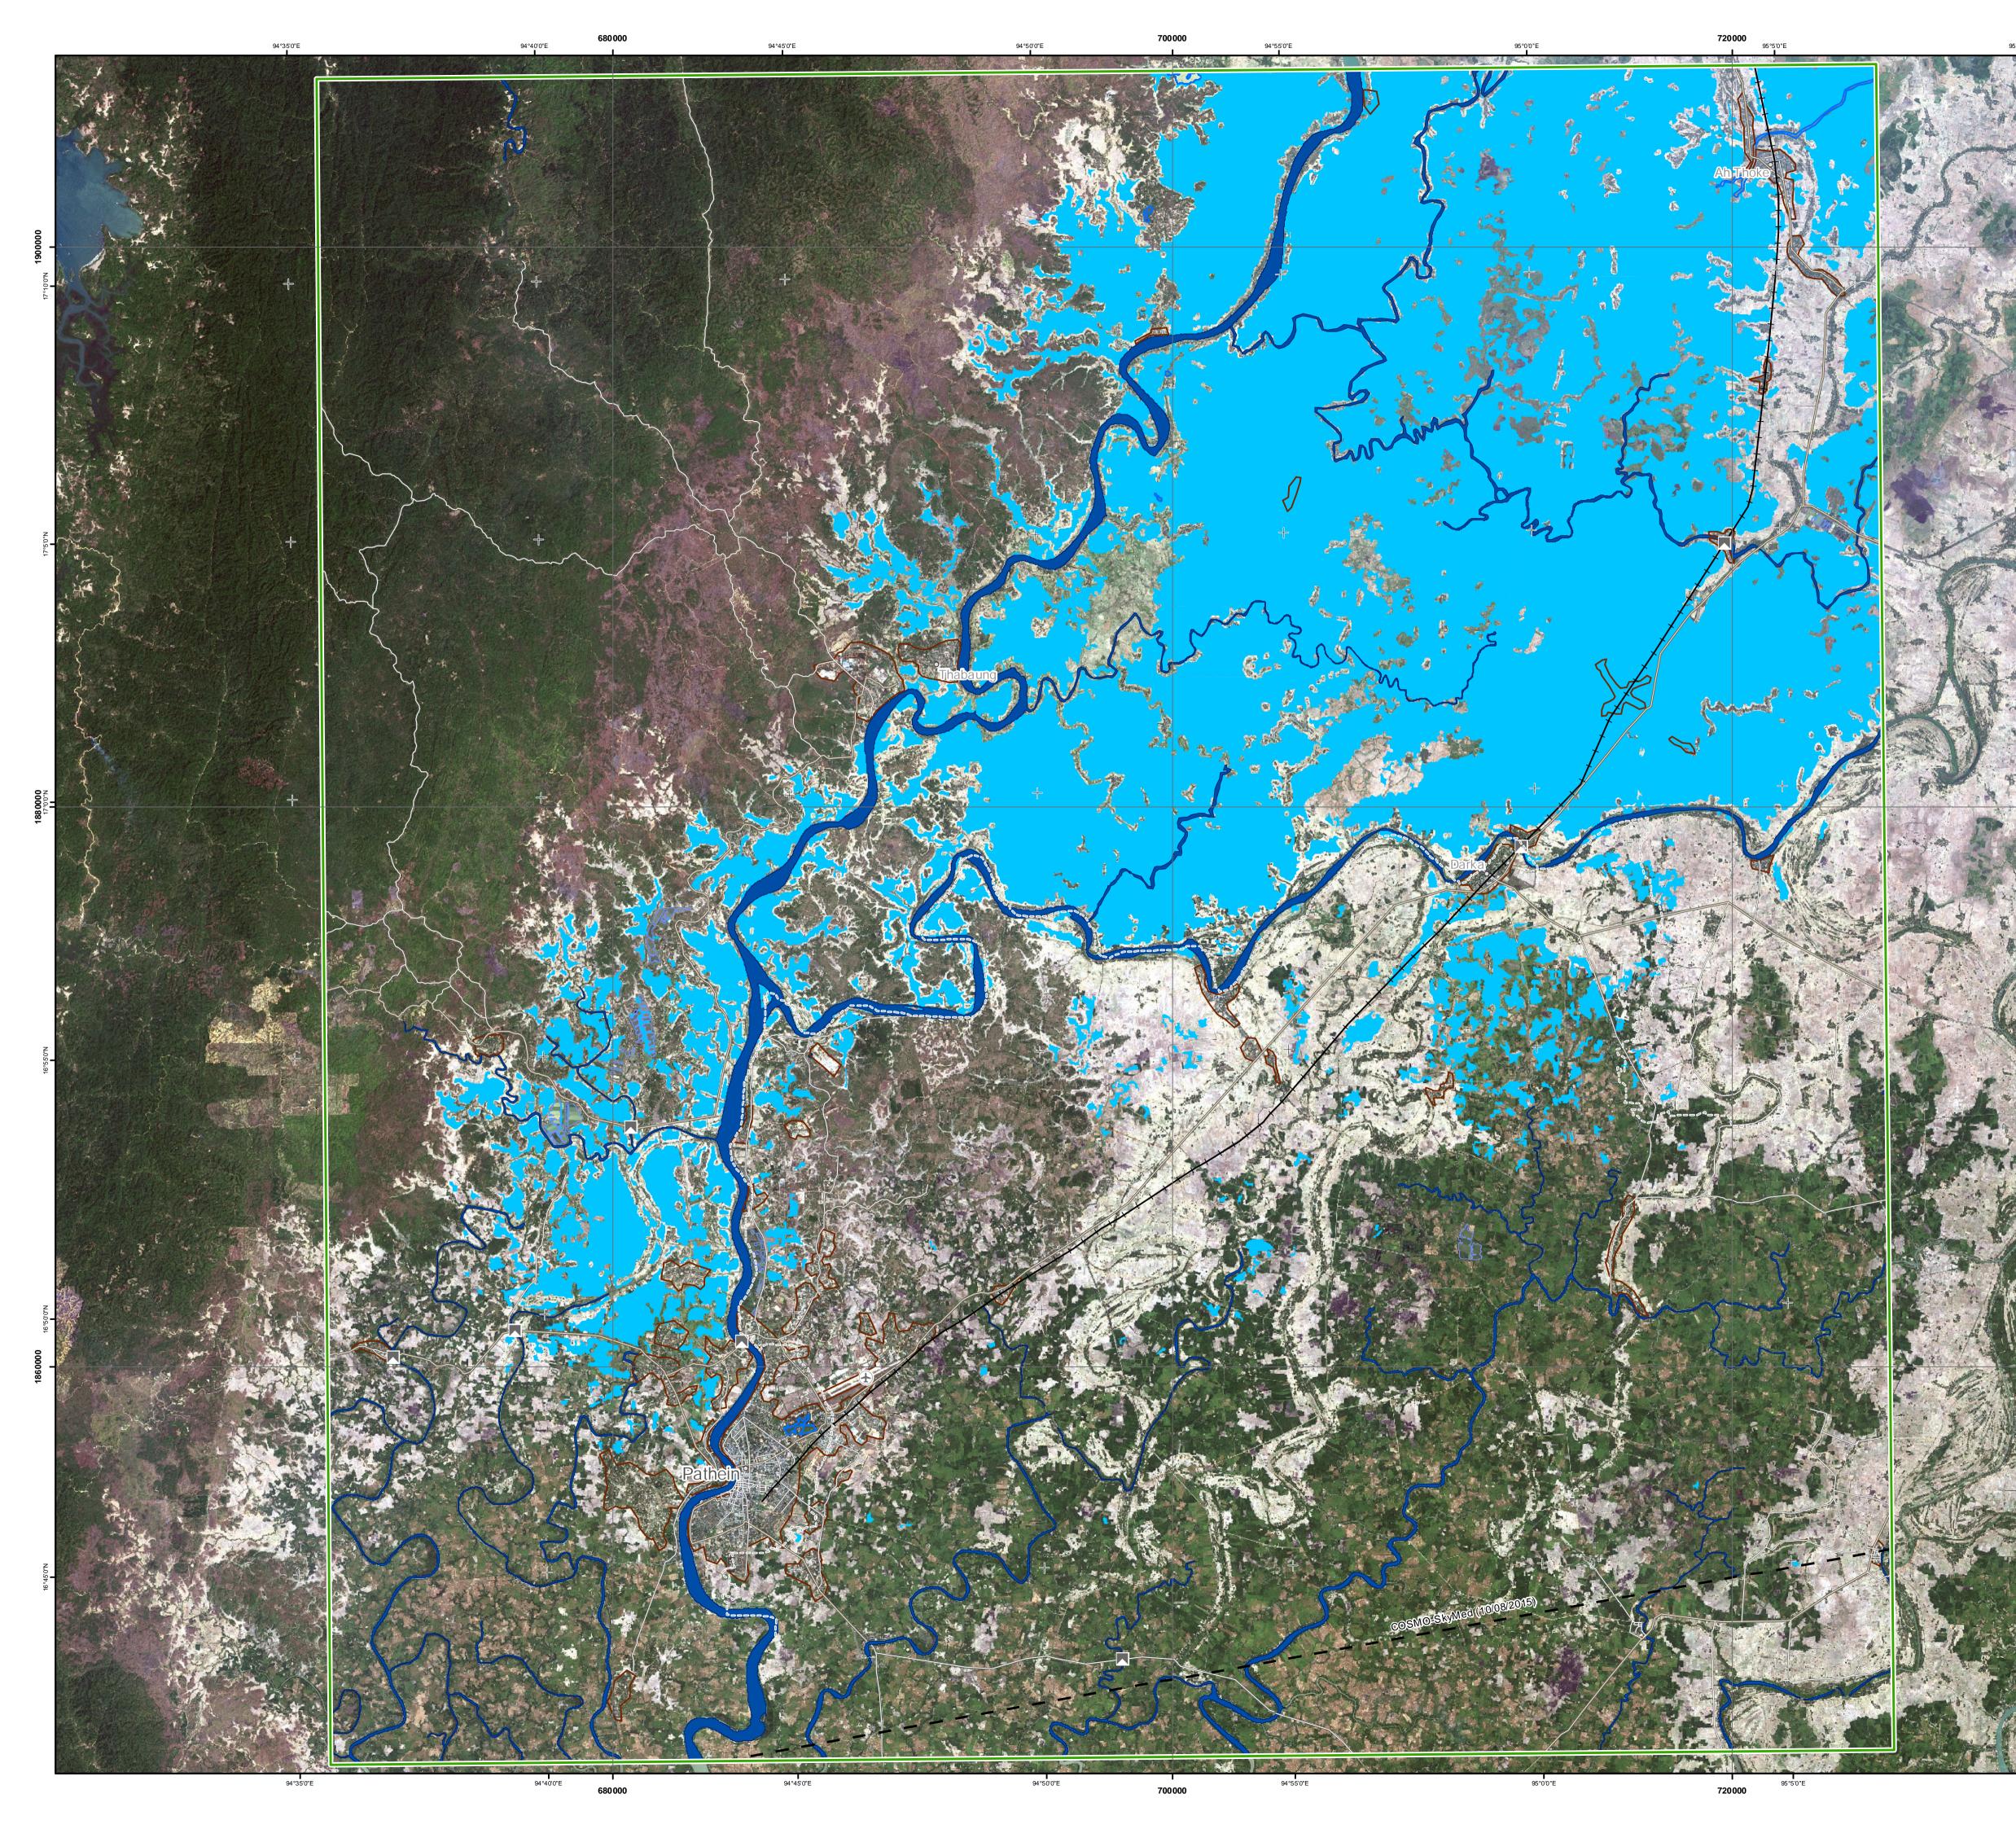
The present map shows the flood delineation in the area of Pathein (MYANMAR). The basic topographic features are derived from public datasets, refined by means of visual interpretation of pre-event image Landsat-8. The thematic layer, assessing the delineation of the event, has been derived from post-event

image COSMO-SkyMed. All satellite images have been radiometrically enhanced, orthocorrected with RPC approach (using SRTM elevation data). The estimated geometric accuracy of this product is 100 m CE90 or better, from native

positional accuracy of the background satellite image. The estimated thematic accuracy of this product is 85 % or better, based on previous experience in using high-resolution SAR for flood extent delineation. Please be aware that the thematic accuracy might be lower in urban and forested areas due to known limitations of the analysis technique. Only the area enclosed by the Area of Interest has been analyzed.

_	Local Road				
Consequences within the AOI on 10/08/2015						
			Affected	Total in AOI		
Flooded area		ha	76857			
Estimated population	Inhab	Inhabitants		869884		
Settlements	Built-up area	ha	211	6593		
Transportation	Aerodrome	No.	0	1		
	Bridge	No.	0	7		
	Railway	km	13	67		
	Secondary road	km	9.2	186		
	Local road	km	0.6	309
