GLIDE number: N/A      Activation ID: EMSR130  
Product N.: 04PATHWE, v1, English

**Pathwe - Myanmar**  
**Flood - 01/08/2015**  
Delineation Map - Monit01

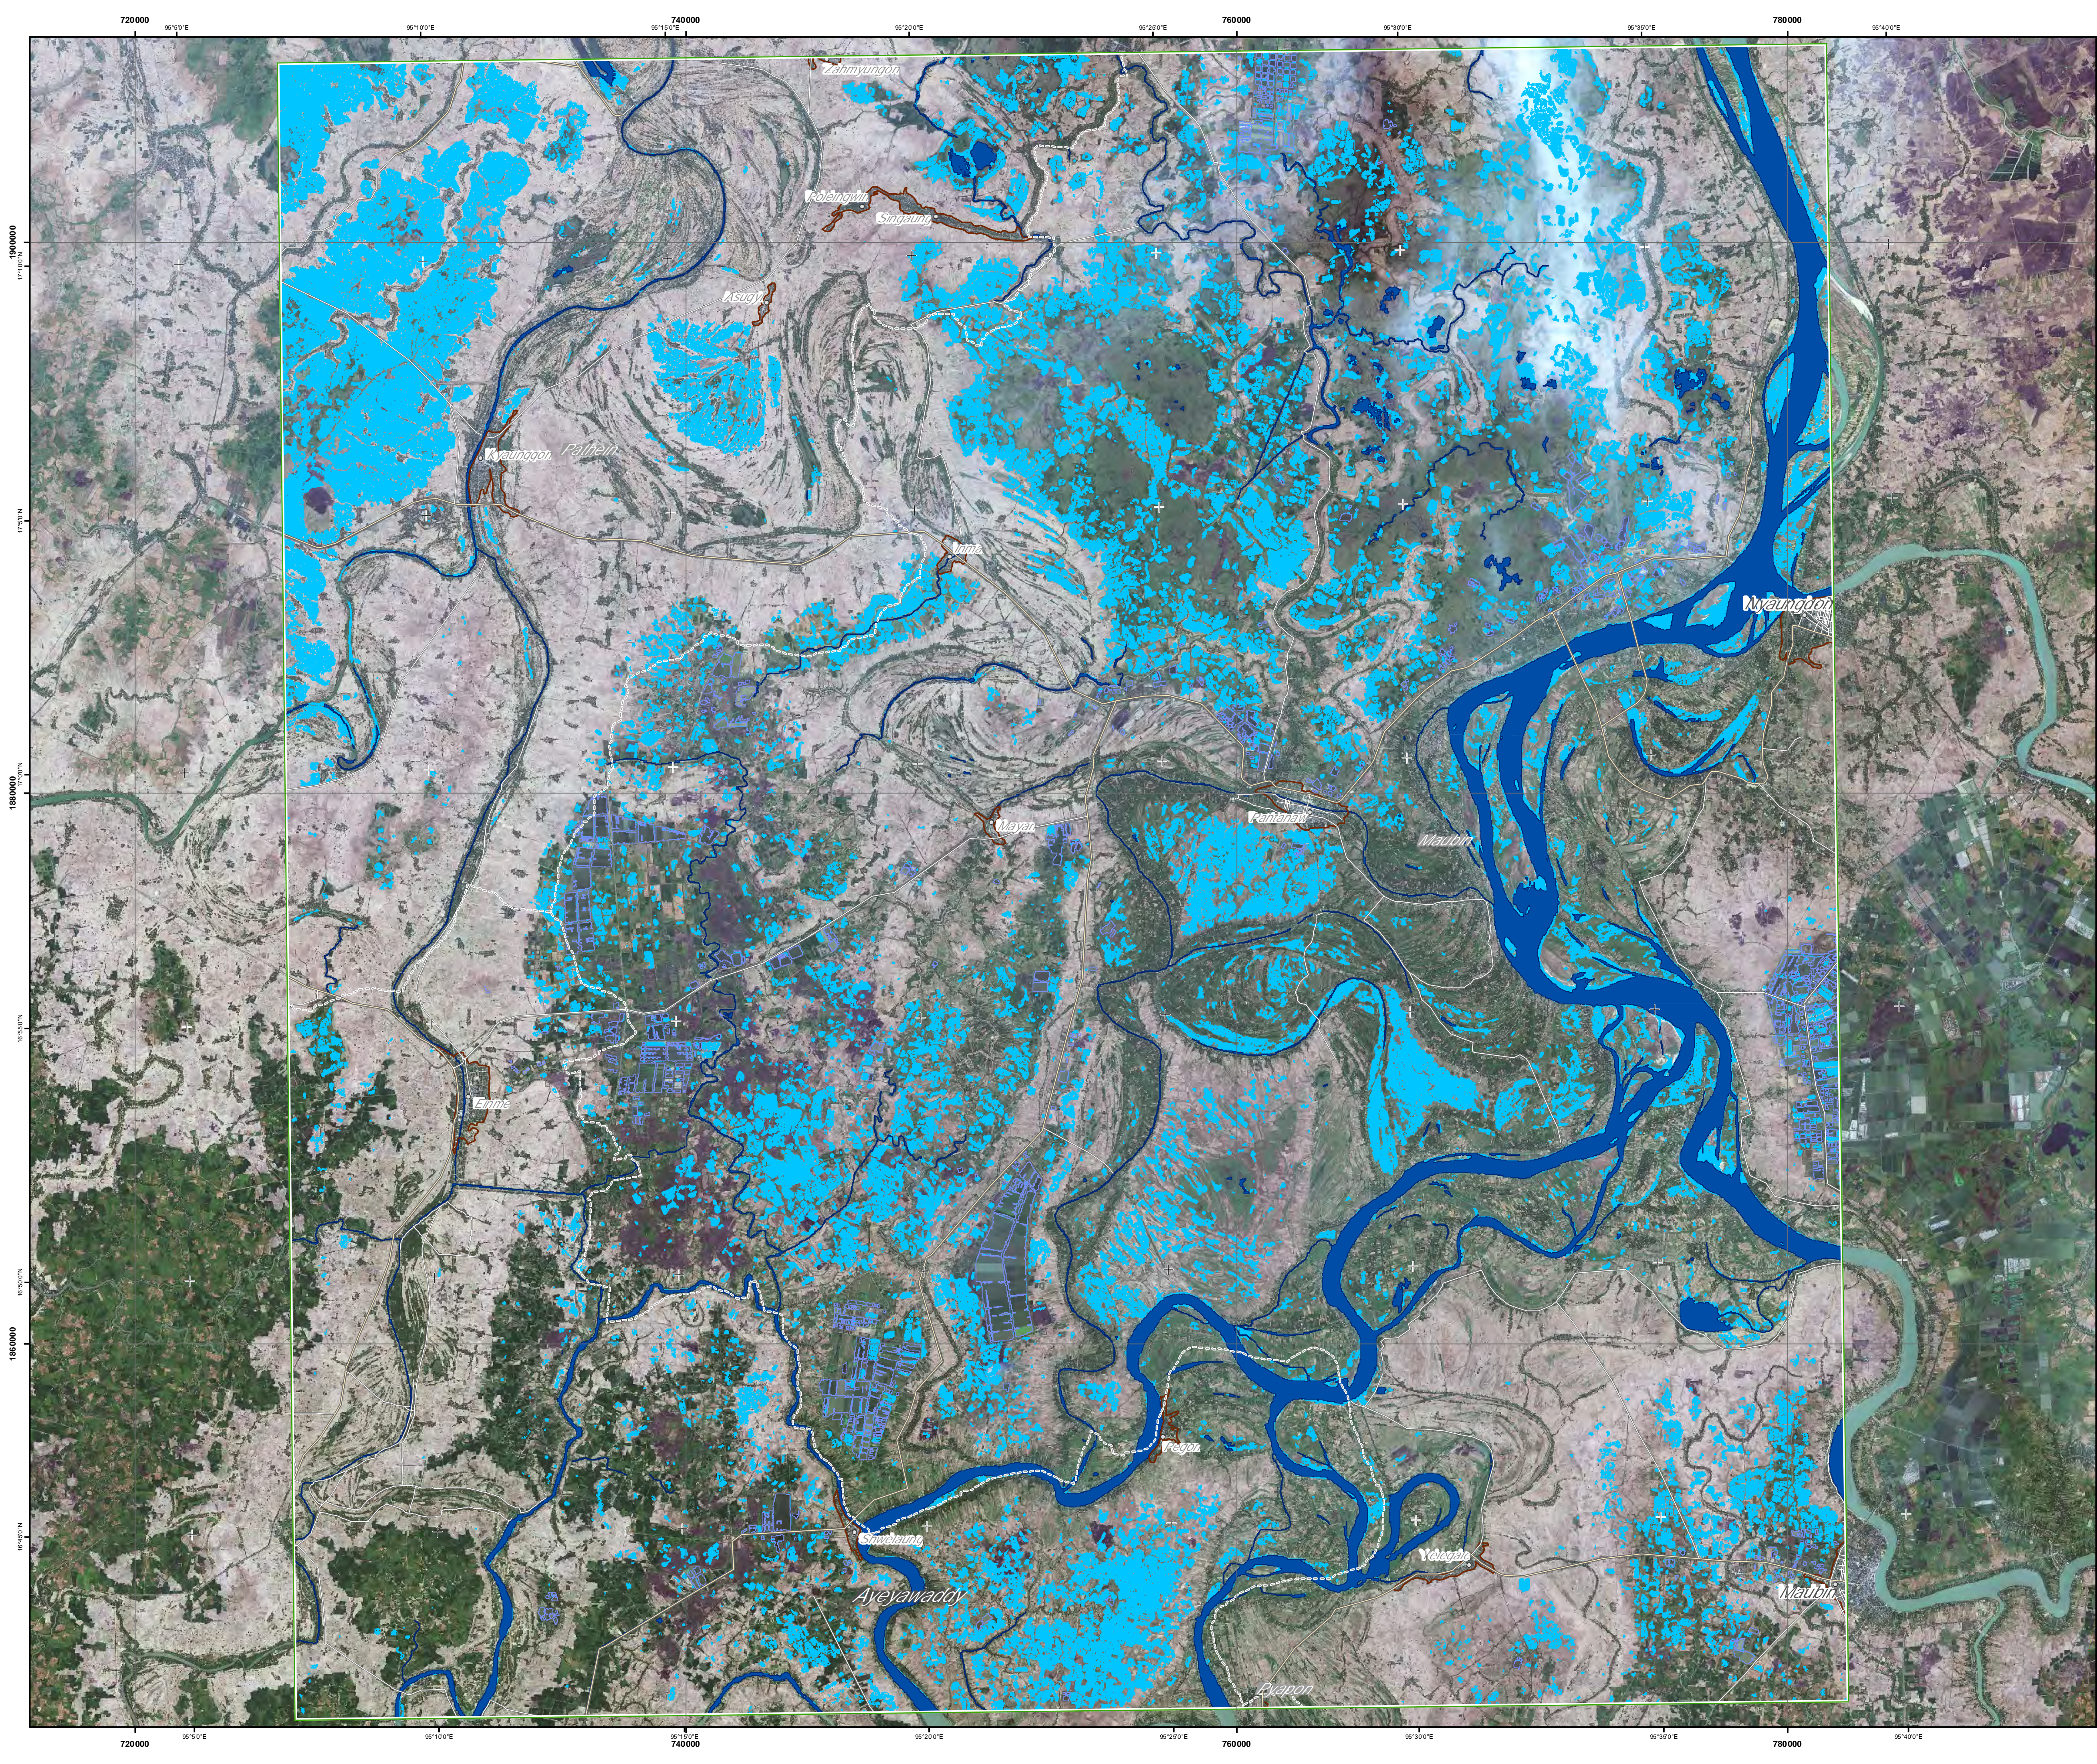
Consequences within the AOI on 17/08/2015			
Flooded area		ha	47047
Estimated population		Inhabitants	63040
Settlements	Built-up area	ha	2
Transportation	Secondary road	km	1
	Local road	km	6

The present map shows the flood delineation in the area of Pathwe (MYANMAR). The basic topographic features are derived from public datasets, refined by means of visual interpretation of pre-event image Landsat-8.  
Thematic layers, assessing the delineation of the event have been derived from post-event image RadarSat-2.  
All satellite images have been radiometrically enhanced, orthorectified with RPC approach (using SRTM elevation data).  
The estimated geometric accuracy of this product is 50 m CE90 or better, from native positional accuracy of the background satellite image.  
The estimated thematic accuracy of this product is 85 % or better, based on previous experience in using high-resolution SAR for flood extent delineation. Please be aware that the thematic accuracy might be lower in urban and forested areas due to known limitations of the analysis technique.  
Only the area enclosed by the Area of Interest has been analyzed.
