overflows and floods. In the past few days, torrential rains damaged farmland, roads, rail tracks, bridges and houses. The core users of the map is Emergency Response Coordination Centre (ERCC).

The present map shows the flood delineation in the area of Pyay (MYANMAR). The basic topographic features are derived from public datasets, refined by means of visual interpretation of pre-event image Landsat-8. Thematic layers, assessing the delineation of the event have been derived from post-event image Sentinel-1A. All satellite images have been radiometrically enhanced, orthocorrected with RPC approach (using SRTM elevation data).

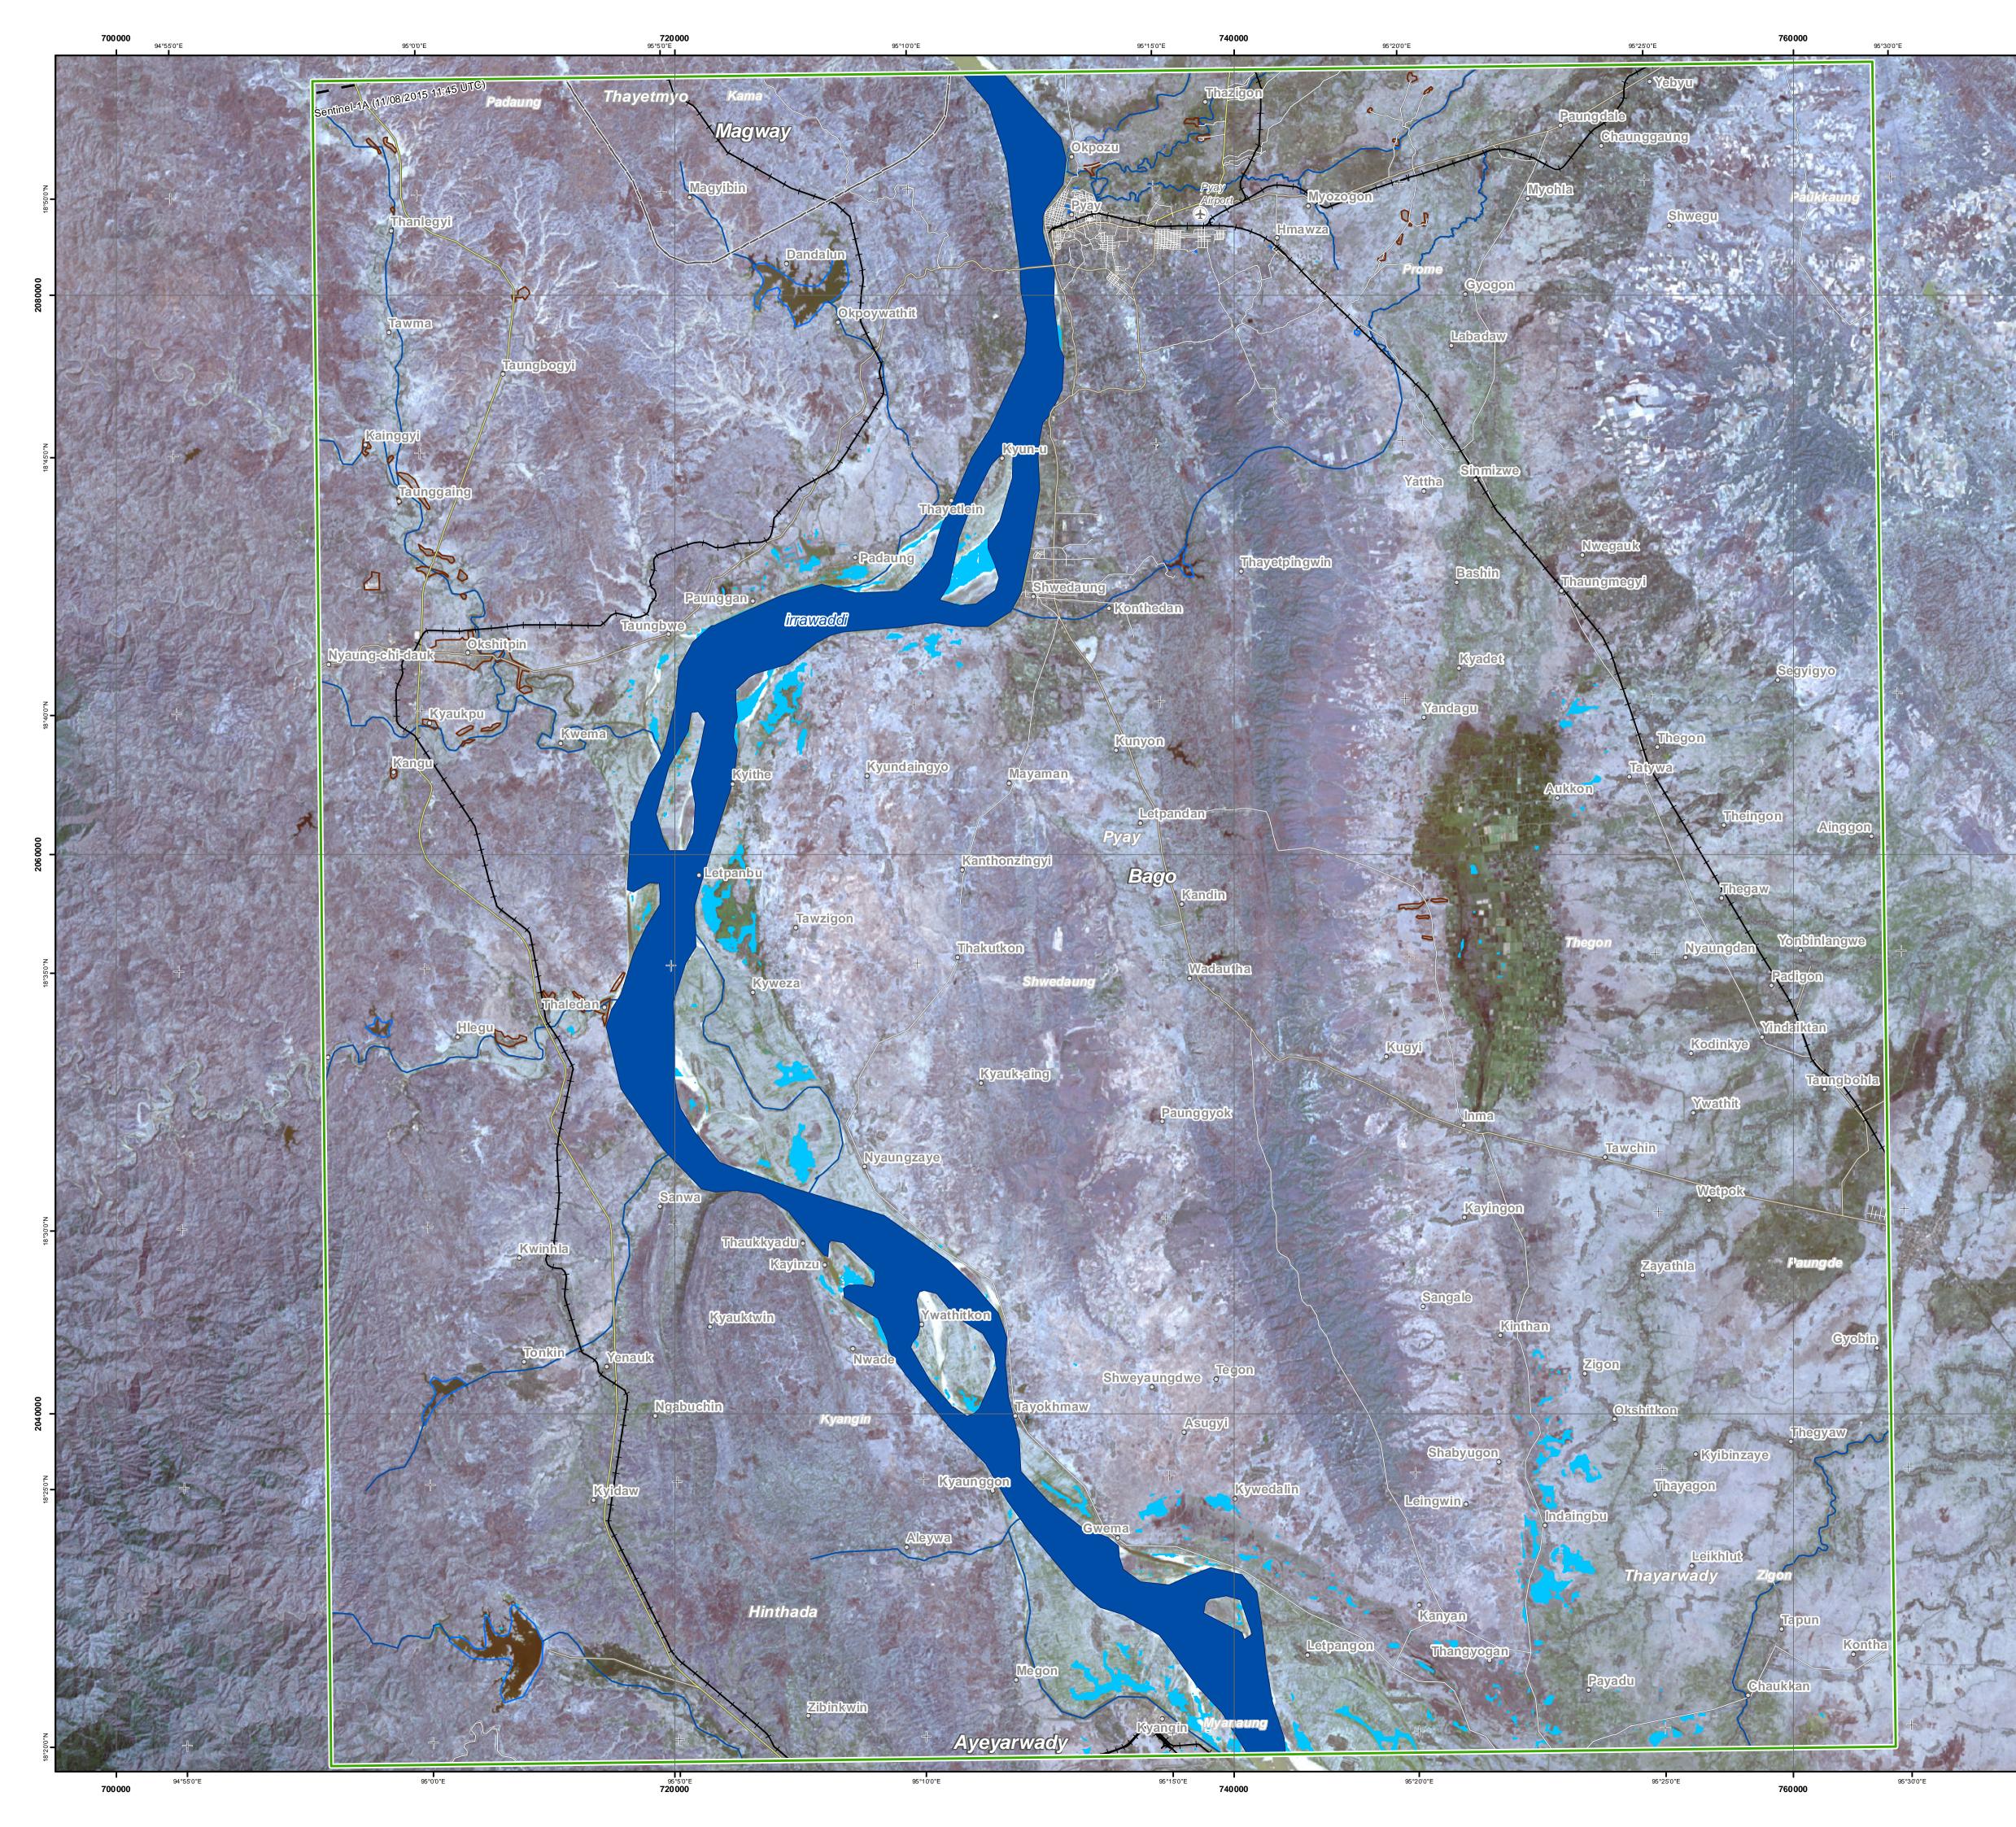
Consequences within the AOI on 11/08/2015					
			Affected	Total in AOI	
Flooded area	ha		2531		
Estimated population	Inhabi	tants	73642	858144	
Settlements	Built-up area	ha	0	590	
Transportation	Primary roads	km	0	75,9	
	Secondary roads	km	0	146,3	
	Local roads	km	0	415,3	
	Railways	km	0,8	167,8

The estimated geometric accuracy of this product is 10 m CE90 or better, from native positional accuracy of the background satellite image. The estimated thematic accuracy of this product is 85 % or better, based on previous experience in using high-resolution SAR for flood extent delineation. Please be aware that the thematic accuracy might be lower in urban and forested areas due to known limitations of the analysis technique.
