Activation ID: EMSR130 Product N.: 11YANGONWEST, v1, English

Yangon West - Myanmar Flood - 01/08/2015 Delineation Map - Monit02

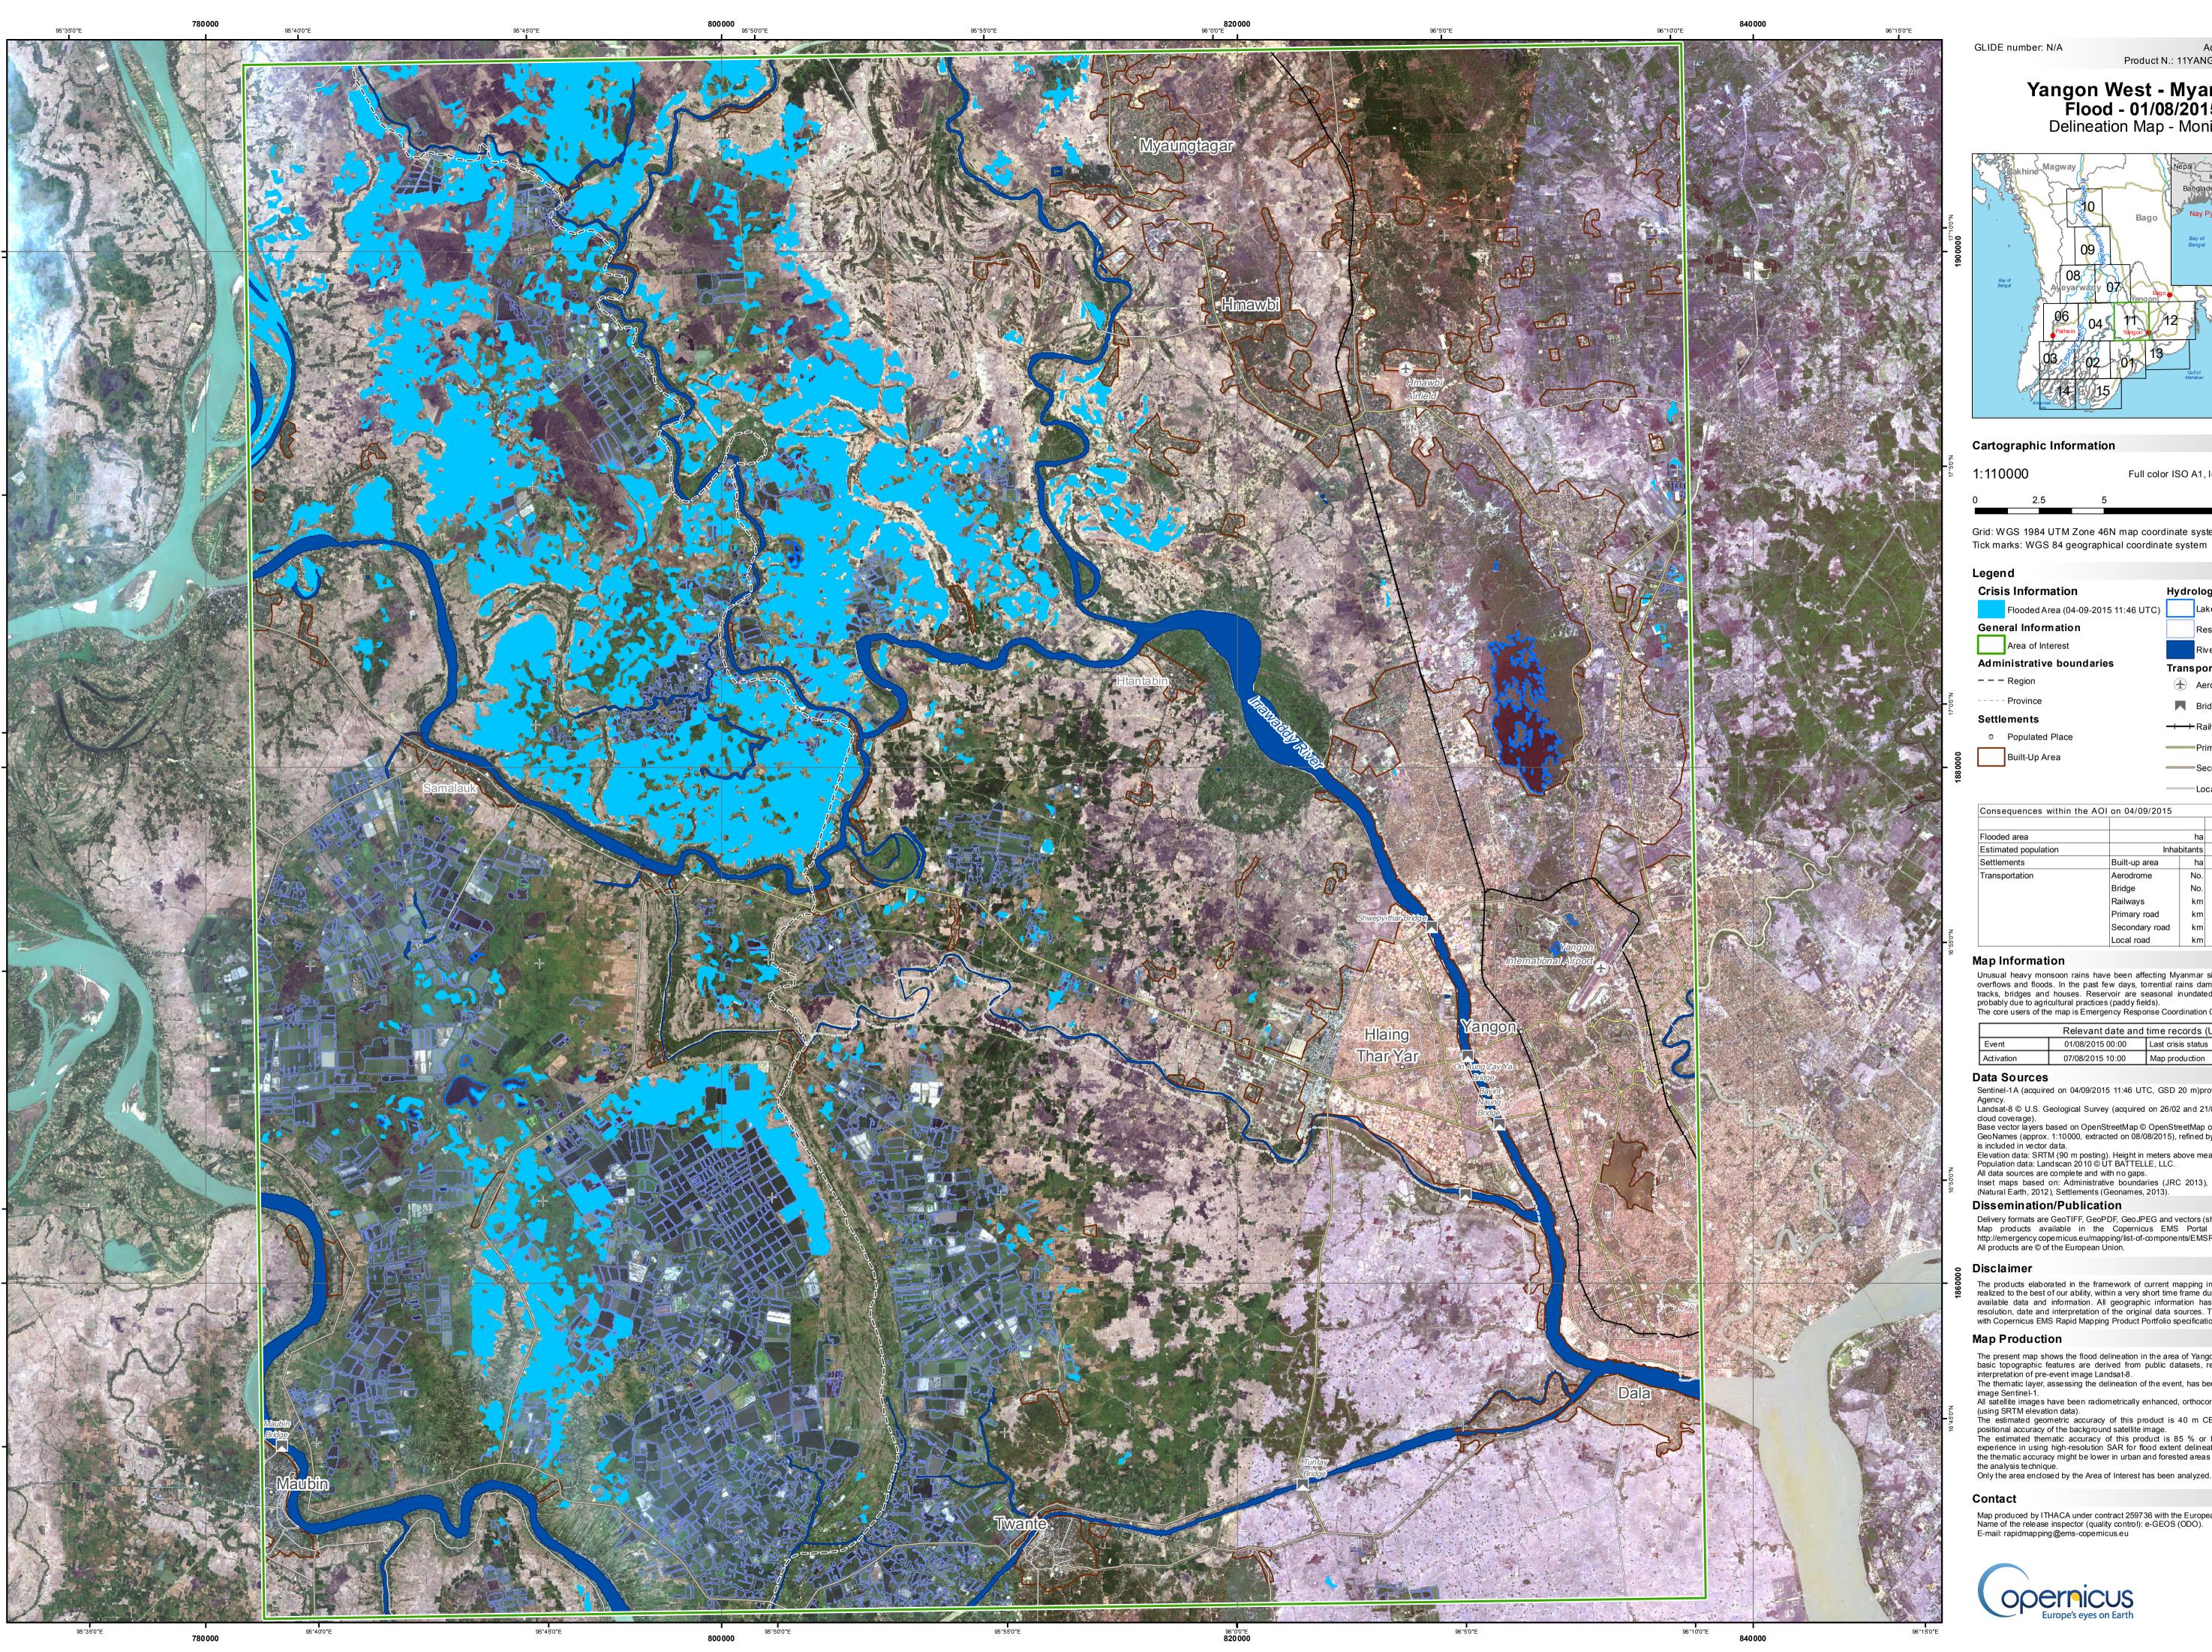
The present map shows the flood delineation in the area of Yangon West (MYANMAR). The basic topographic features are derived from public datasets, refined by means of visual interpretation of pre-event image Landsat-8.

The thematic layer, assessing the delineation of the event, has been derived from post-event image Sentinel-1. All satellite images have been radiometrically enhanced, orthocorrected with RPC approach

(using SRTM elevation data). The estimated geometric accuracy of this product is 40 m CE90 or better, from native positional accuracy of the background satellite image. The estimated thematic accuracy of this product is 85 % or better, based on previous experience in using high-resolution SAR for flood extent delineation. Please be aware that

the the matic accuracy might be lower in urban and forested areas due to known limitations of the analysis technique. Only the area enclosed by the Area of Interest has been analyzed.

Consequences within the AC	I on 04/09/2015			
			Affected	Total in AOI
Flooded area	ha		31183	
Estimated population	Inhabitants		42554	3749921
Settlements	Built-up area	ha	0	40136
Transportation	Aerodrome	No.	0	2
	Bridge	No.	0	6
	Railways	km	0	74
	Primary road	km	0.03	198
	Secondary road	km	0.33	241
	Local road	km	0.48	209
