Activation ID: EMSR130 Product N.: 08YEGYI, v2, English

Yegyi - MYANMAR Flood - 01/08/2015 Delineation Map

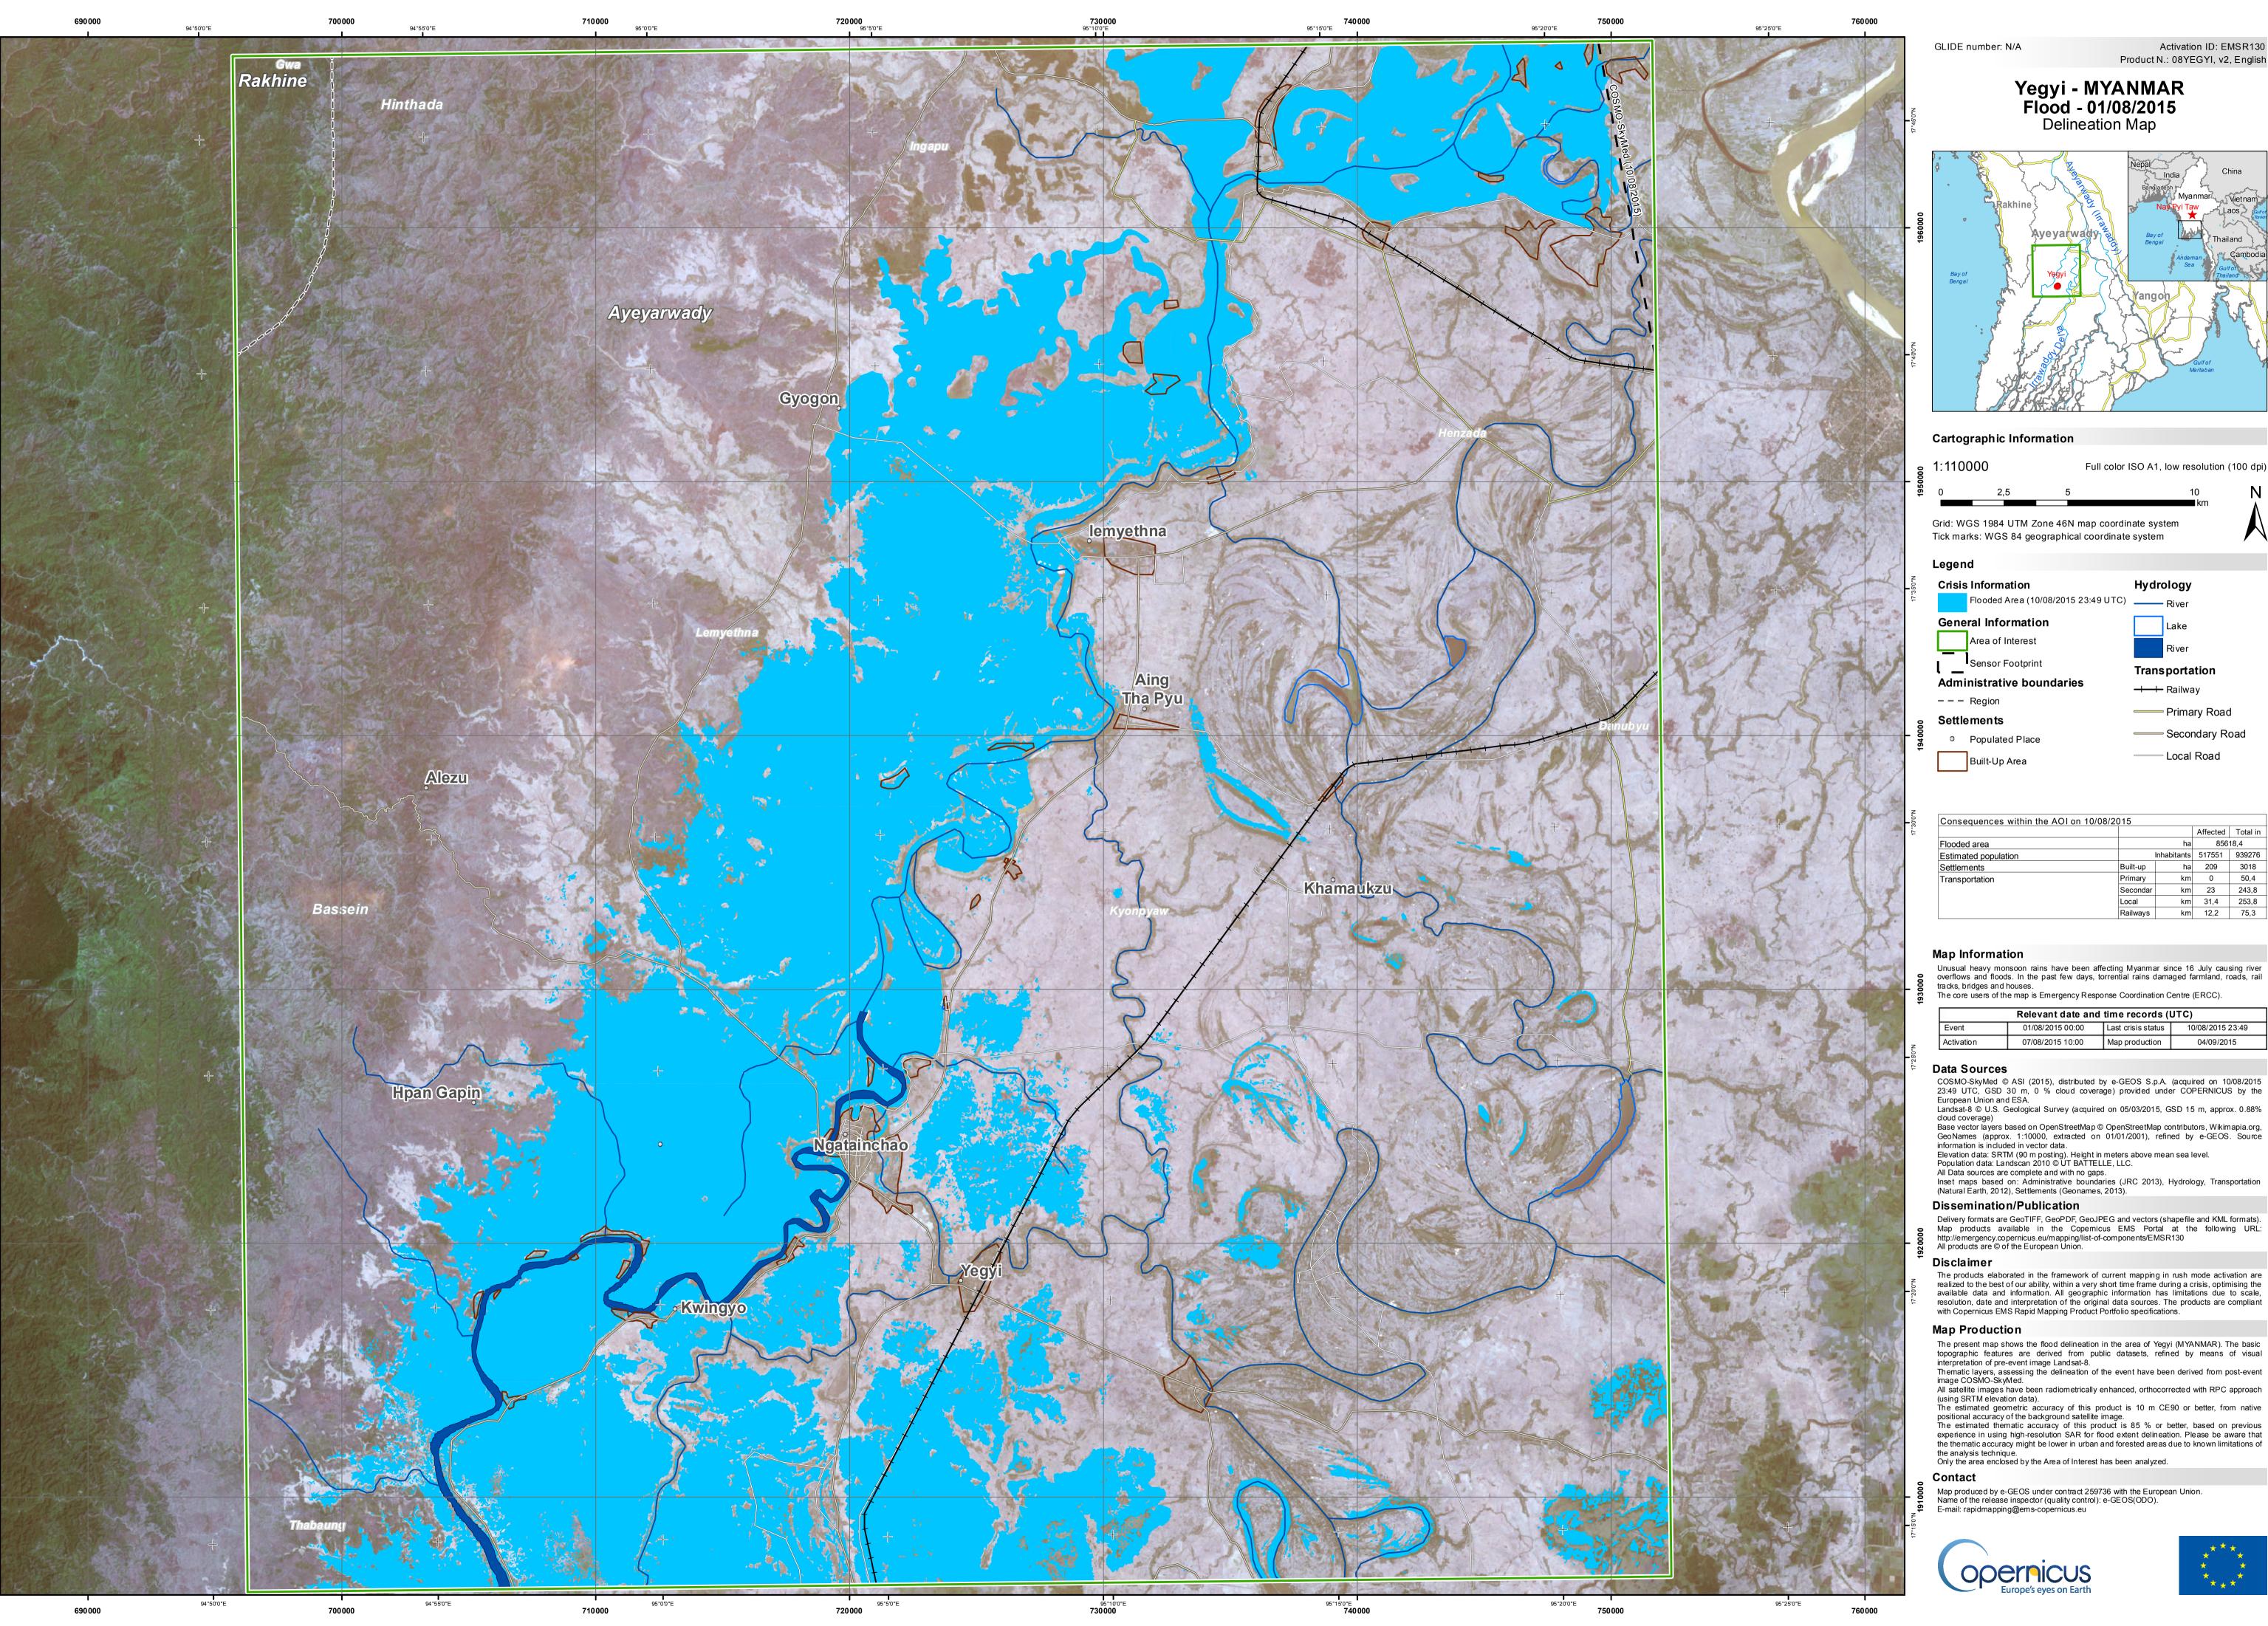
Hydrology Flooded Area (10/08/2015 23:49 UTC) General Information Area of Interest

Consequences within the AOI on 10/08/2015 Estimated population km 0 50,4 km 23 243,8 km 31,4 253,8 km 12,2 75,3

The present map shows the flood delineation in the area of Yegyi (MYANMAR). The basic topographic features are derived from public datasets, refined by means of visual interpretation of pre-event image Landsat-8.

image COSMO-SkyMed. All satellite images have been radiometrically enhanced, orthocorrected with RPC approach

(using SRTM elevation data). The estimated geometric accuracy of this product is 10 m CE90 or better, from native

positional accuracy of the background satellite image. The estimated thematic accuracy of this product is 85 % or better, based on previous experience in using high-resolution SAR for flood extent delineation. Please be aware that the the matic accuracy might be lower in urban and forested areas due to known limitations of

the analysis technique.
Only the area enclosed by the Area of Interest has been analyzed.
