# 2015年缅甸洪涝灾害遥感监测产品

2015 Myanmar Flood Remote Sensing Mapping-Flooded Area in Rakhine,Bago,Ayeyarwady&Magway on August 9th

图件编号 Map ID: FL-2015-008-025

灾后: 2015年8月9日 Post-disaster: 9 August 2015

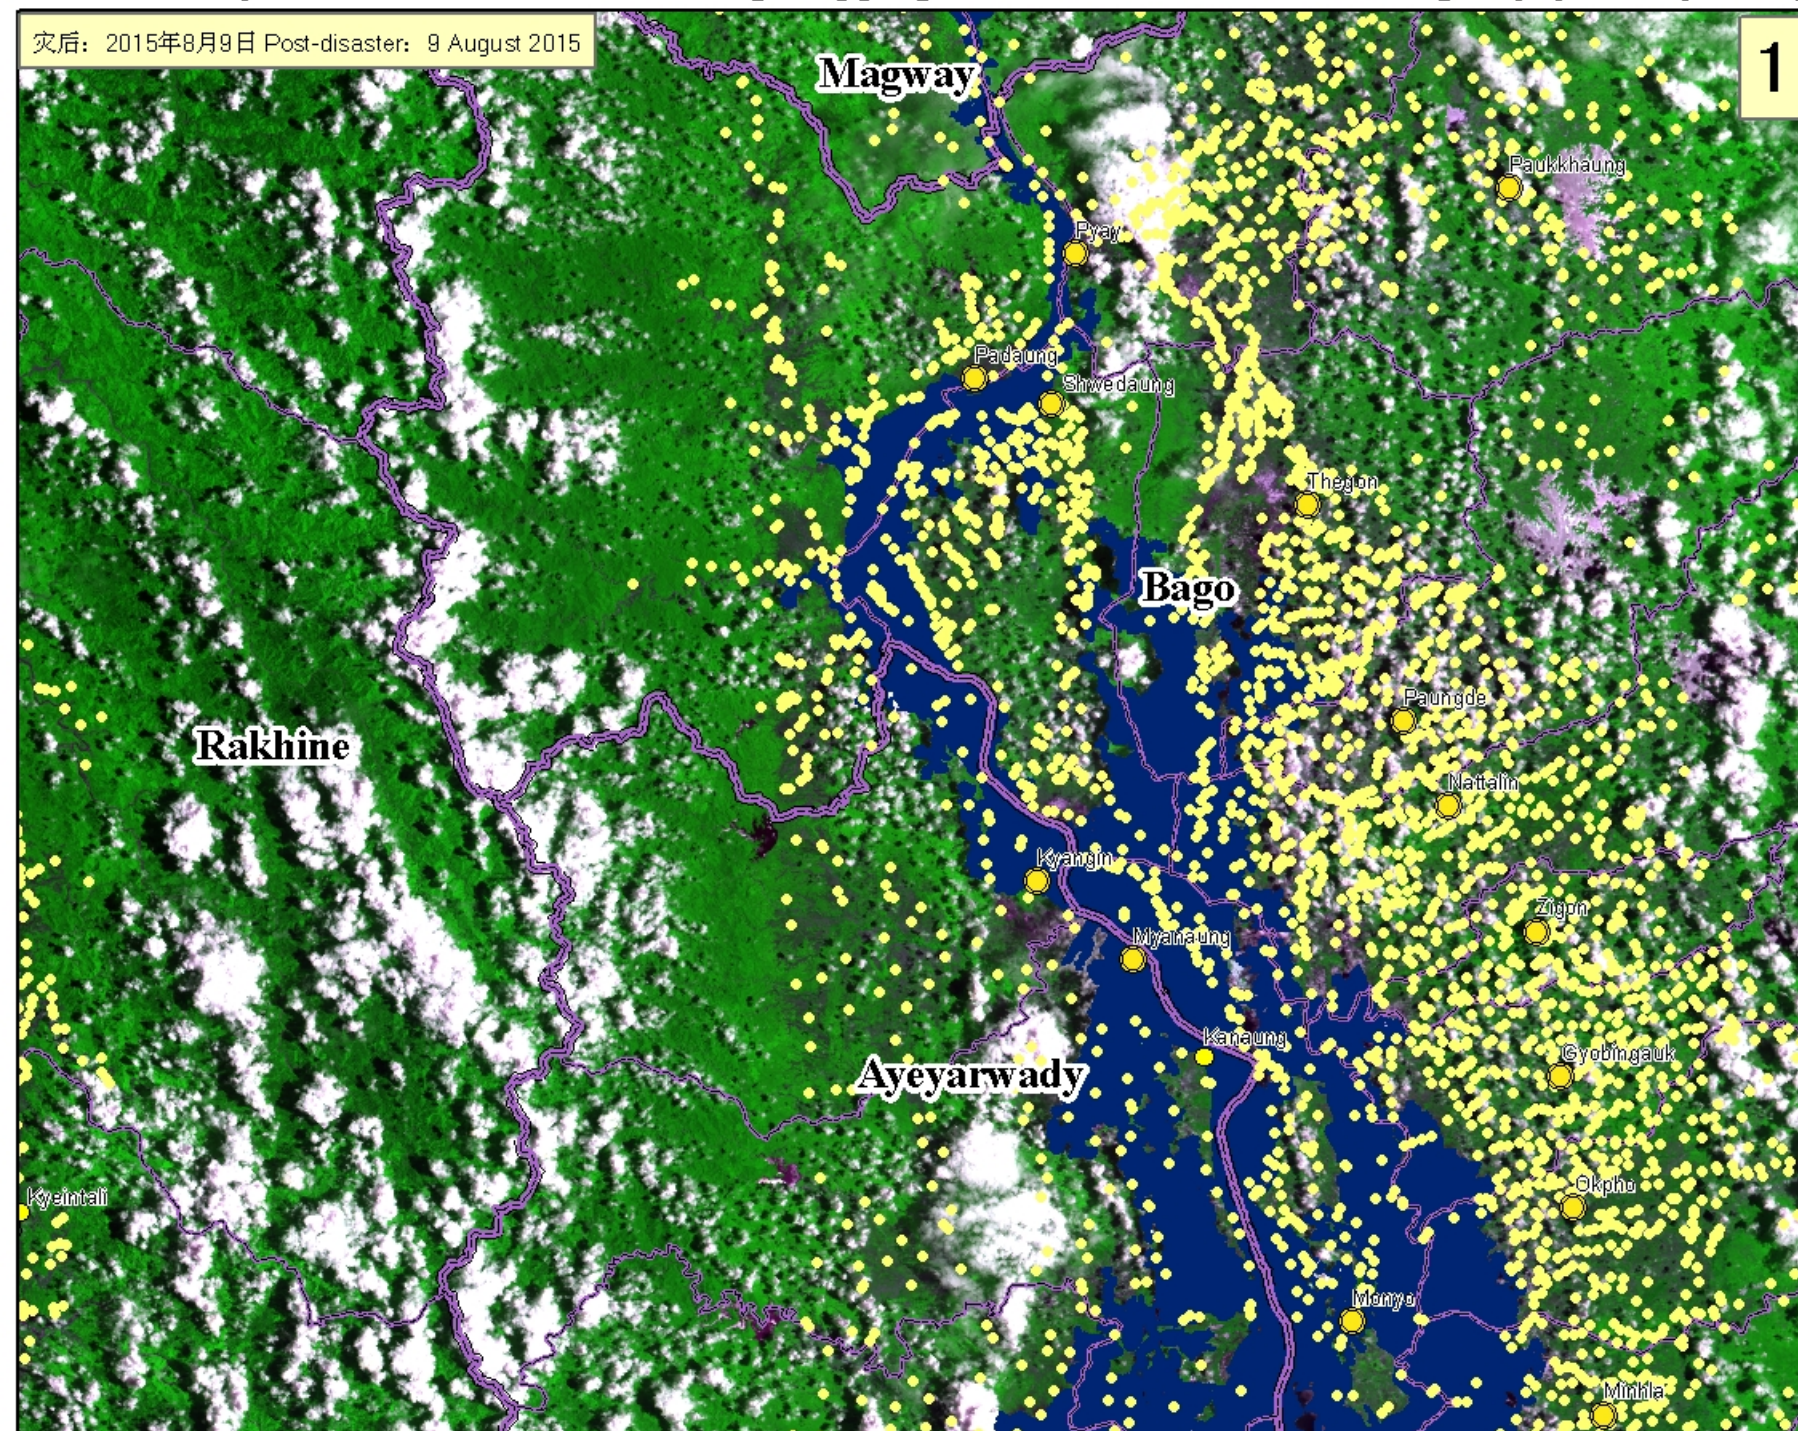
利用8月9日环境减灾卫星卫星对缅甸西部洪涝灾区进行监测, 洪水淹没区面积1713km<sup>2</sup>, 影响385个村。

The flood area is 1713km<sup>2</sup>. 385 Villages were inundated based on China HJ-1 satellite remote sensing.
