# 2015年缅甸洪涝灾害遥感监测产品

2015 Myanmar Flood Remote Sensing Mapping-Flooded Area in Yangon,Rakhine,Bago&Ayeyarwady on August 9th

图件编号 Map ID: FL-2015-008-026

灾后: 2015年8月9日 Post-disaster: 9 August 2015

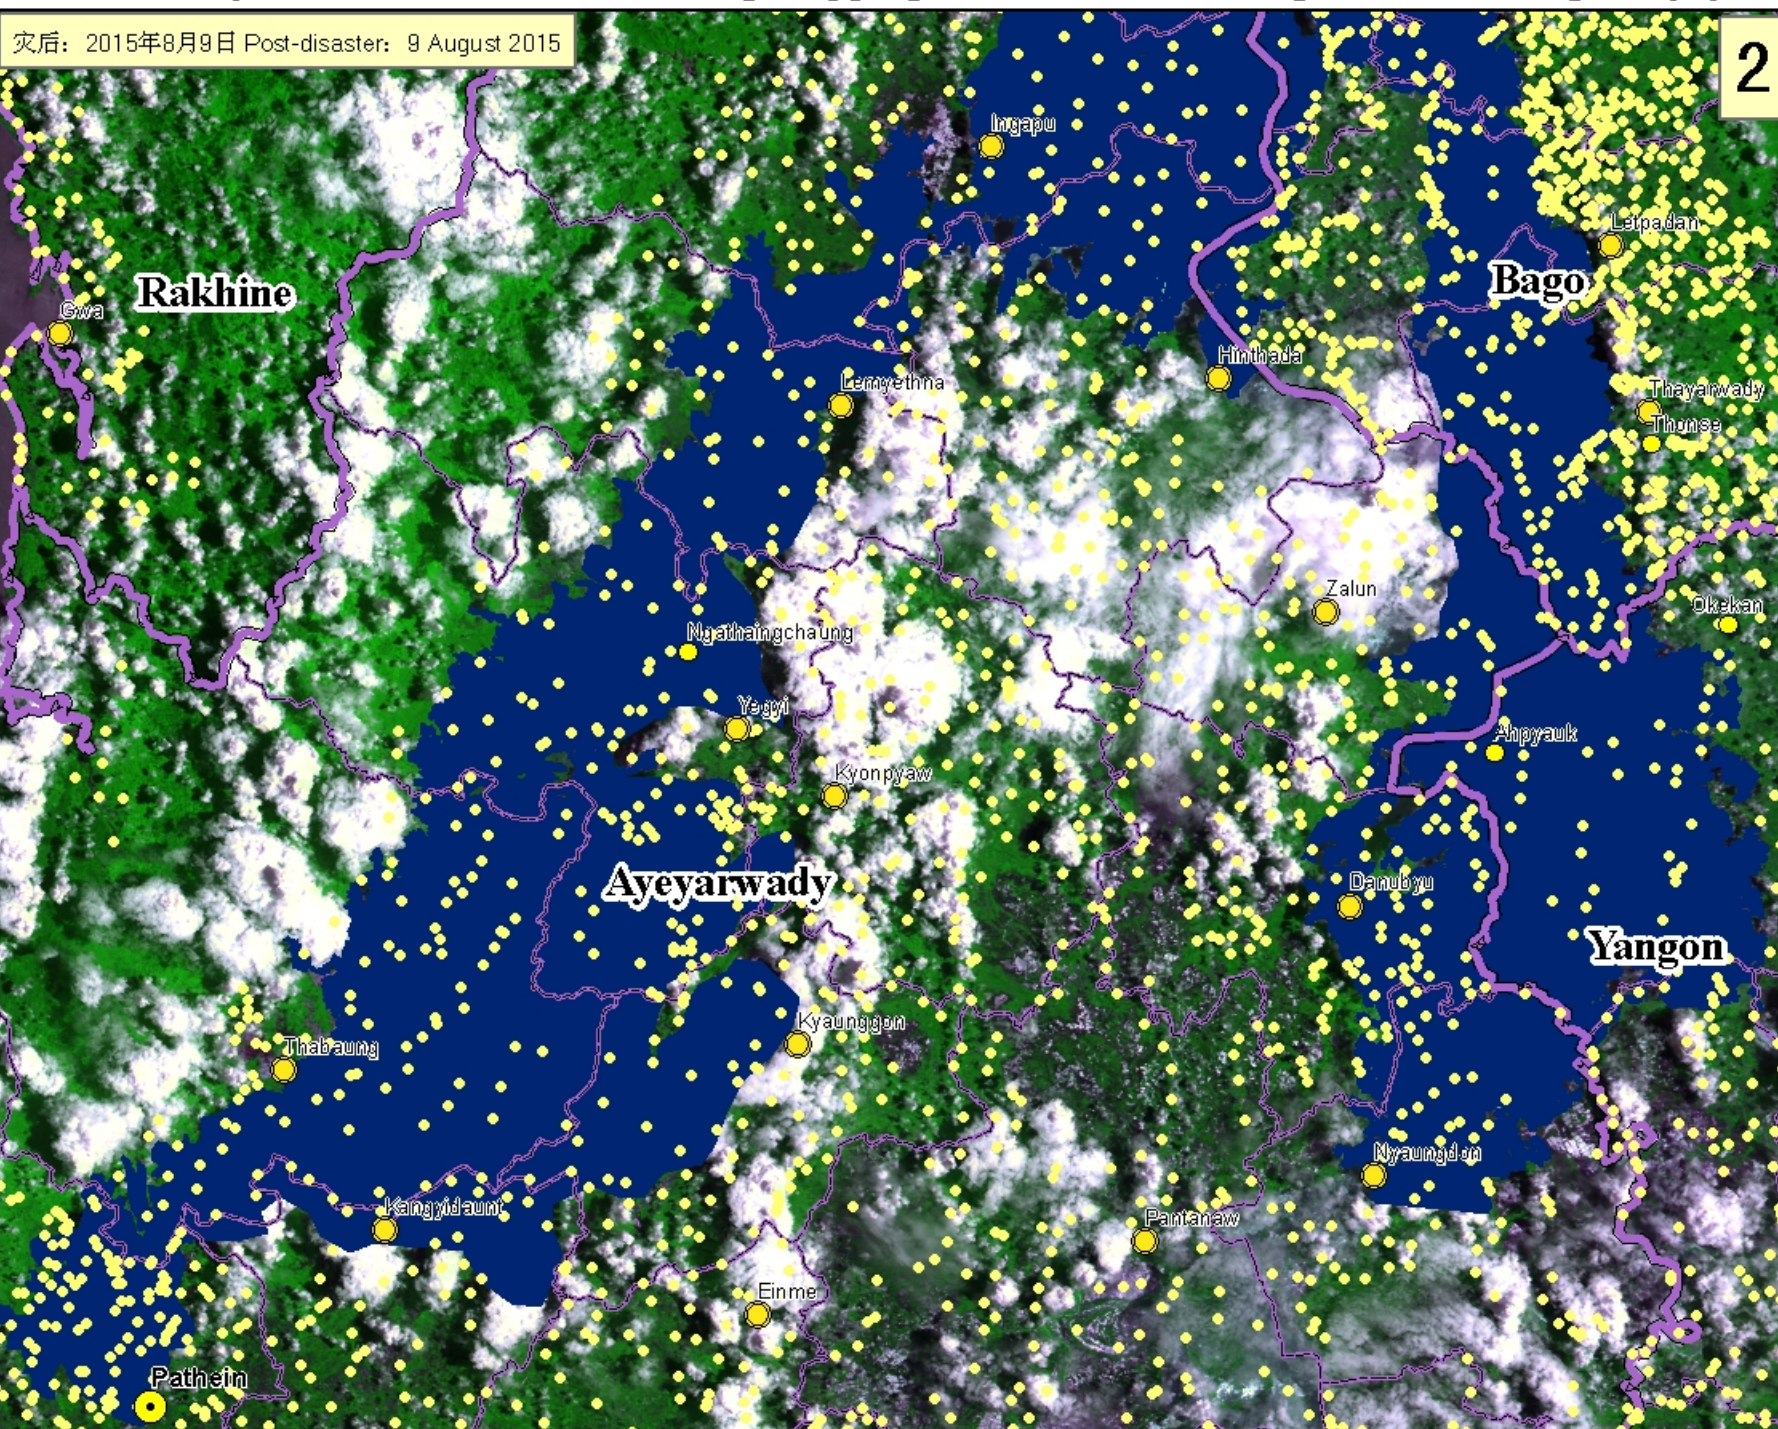
利用8月9日环境减灾卫星卫星对缅甸西部洪涝灾区进行监测, 洪水淹没区面积4702km<sup>2</sup>, 影响631个村。

The flood area is 4702km<sup>2</sup>. 631 Villages were inundated based on China HJ-1 satellite remote sensing.
